Study of Fatigue Fractography of Mild Steel Used in Automotive Industry

Ahmed Ameer Zainulabdeen

Department of Materials Engineering/ University of Technology

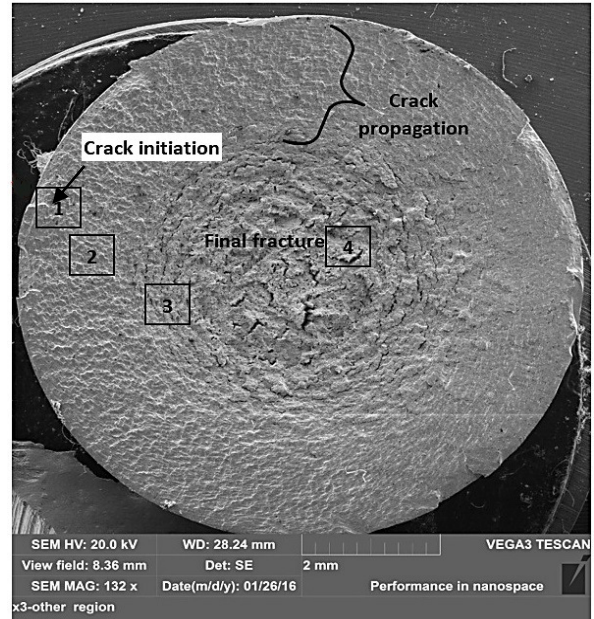
Fig. 6. Fatigue fractography for (St 37) in as received condition at high stress.

Particular attention is paid to the fractography study, which was done using Scanning Electron Microscope, for samples at high and low stress levels. Fig (6) presents section of fracture surface for specimen at high stress level (380 MPa). For more clarify the failure zones marked with number from 1 to 4. It can be shown from Fig (7) that the crack initiate from the surface and propagate quickly with small extension. At the same time, the final catastrophic failure zone was wider comparing to that of crack progress zone. This is attributed to high levels of load in this region.

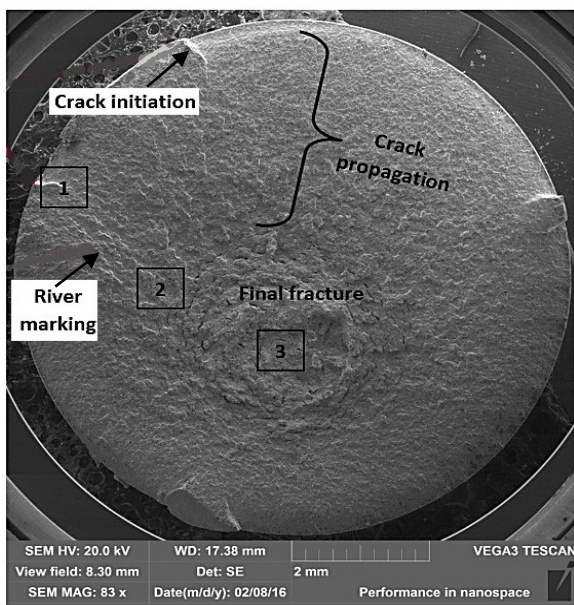
Fig .8. Fatigue fractography for sample in as received condition at low stress.

Fig (8) represents fracture surface for specimen at low stress levels. Fig reveal different features than previous one (high stress levels) due to difference in loading levels. It's clear that there is wider crack propagation zone because the crack

has more time to advance before failure. More than initiation spot was noticed and the final catastrophic failure zone was smaller. Also river marks were noticed in the propagation zone which refer to crack advancing direction toward final fracture.

In addition to, by viewing the fractography in more details and reviewing the previous literature [9], it can be concluding that this configuration of fracture topography indicates the low stress with high stress concentration conditions. The failure zones marked with number from 1 to 3 as shown in Fig (8).

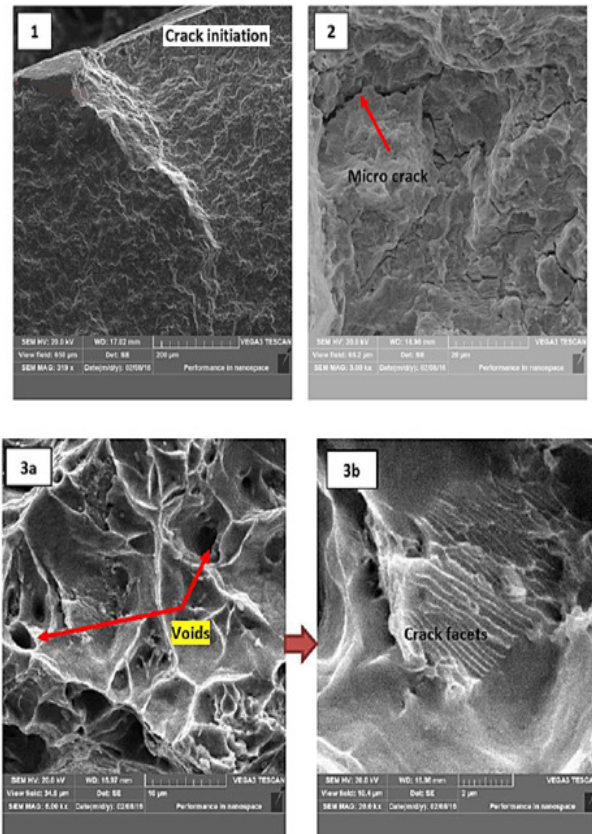
Fig. 9. Fatigue fractography for sample in as received condition at low stress.

For more analysis, failure zones divided in Fig (9) into three areas and marked with number from 1 to 3. first zone (1) shows the crack initiation zone with many river marks, while zone (2) shows the evolution of micro cracks with circumferential direction around the final rupture. Zone (3a) indicates the final fracture with formation of voids as a part of ductile fracture phenomena. Zone (3b) represents a magnifying zone of the same zone (3a) which reveal crack facet which is the main feature of Transgranular cleavage fracture. This type of failure (Cleavage fracture) is familiar for BCC structures especially steels [10]. Also it was noticed that the final fracture is off-center, i.e. shifted toward the opposite side of final overload, this result is in a good agreement with Shipley et al [11].
