RECONSTRUCTION OF NEGRELLI'S VIADUCT FROM A GEOTECHNICAL ENGINEERING POINT OF VIEW

LINDA ČERNÁ VYDROVÁ^{a,b}

^b HOCHTIEF, a. s., Division Traffic Infrastructure, Plzeňská 16, 150 00 Prague, Czech Republic

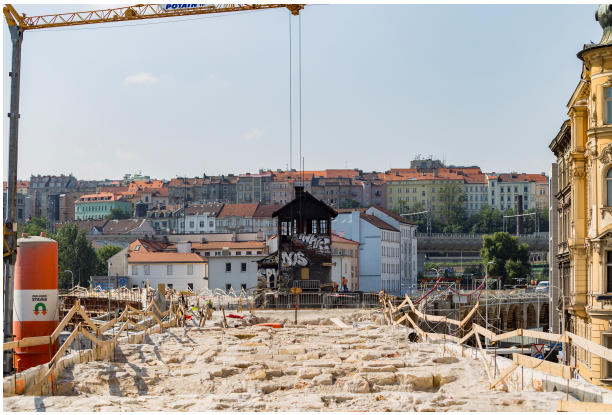
The main reason for the reconstruction of the bridge was the poor technical condition of the arches, see Figure 2. Due to defects in the waterproofing and drainage systems that resulted in water leaks into the structure, the arches have suffered a number of flaws and thus required repairs of the masonry or replacement of the masonry components. It has proved necessary to replace and renew the drainage system of the bridge, to strengthen the foundation of the selected

FIGURE 2. View of the exposed sandstone arches of the viaduct.

piers and to reinforce the masonry with grouting. In some cases, considering the extent of damage to the masonry, it is necessary to dismantle the arches completely, to replace the worn-out stone blocks by new ones and then to re-mason the arches and the piers as well, if this also is necessary.

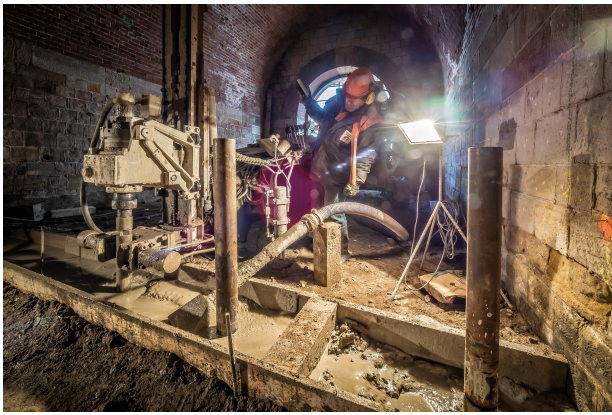
FIGURE 3. Special foundation works at the former custom house.

The selected piers were underpinned with jet grouted columns. The pilot bores through the existing foundation masonry of the bridge piers were driven using a full-face percussion rotary drilling method (submersible hammer) with a drill hole diameter of 150 mm with an air flush; a hydraulic drilling rig on a tracked undercarriage MSV 741/20 (producer: ZS, a. s.) and a compressor Atlas Copco XAHS were also used, as depicted in Figure 3.
