ANALYTICAL RESULTS OF THE STABILITY OF SOME LIMESTONE
ISLANDS IN HA LONG BAY, QUANG NINH PROVINCE OF
VIETNAM, A WORLD NATURAL HERITAGE

Phi Truong Thanh

Hanoi University of Natural Resources and Environment, Vietnam
Corresponding author: thanhgislab@gmail.com

Received Date: 04 September 2019, Accepted Date: 17 November 2019, Published Date: 26 December 2019

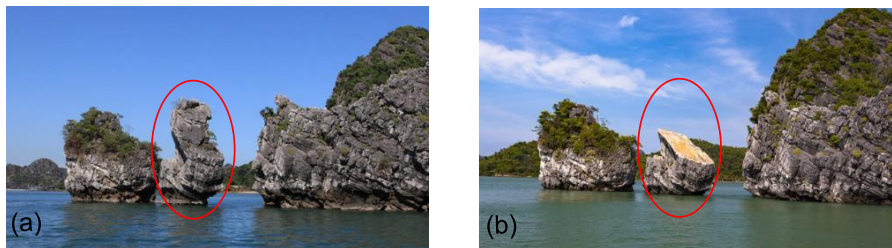
However, in the year 2016, due to the impact of failure has led to the disappearance of the head of the Thien Nga island (Pl. 1b), affecting the sustainable development of the heritage area.

Plate (1): The head of Thien Nga island (HL-06) was cut due to the plane failure (a and b).

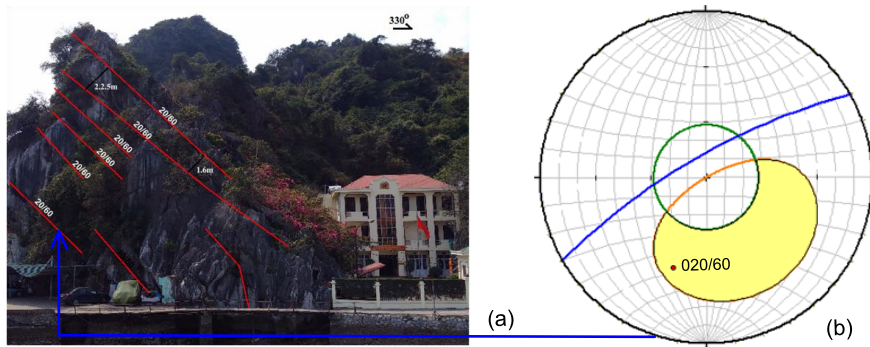
The survey location is ash-gray limestone block, this limestone block has many large fractures with orientation $020^0/60^0$, parallel to each other and divided into layers with the thickness varies in the range of 3-8m (Pl.2a). The analytical results according to Hoek and Bray (2004)'s application have determined, it is possible to occur plane failure on the fracture orientation $020^0/60^0$ and slope orientation $300^0/75^0$ (Pl.2b).

Plate (2): (a) Photo of survey location HL-01, (b) Plane failure can occur on the fracture orientation $020^0/60^0$ and slope orientation $300^0/75^0$.

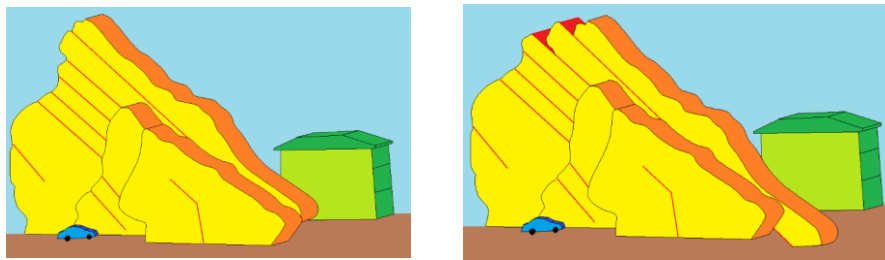
Figure (1): 3D model of limestone block and its potential failure at survey location HL-01.

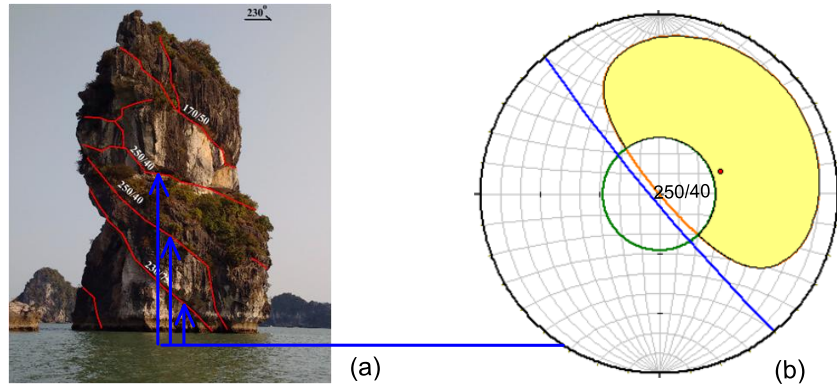
The survey location is a limestone island. It has white-gray color and block structure. The fracture orientations are $170^0/50^0$, $250^0/40^0$, $060^0/55^0$, $230^0/75^0$ (Pl.3a). The analytical results according to Hoek and Bray (2004)'s application have determined, it is possible to occur plane failure on the fracture orientation $250^0/40^0$ and slope orientation $230^0/85-90^0$ (Pl.3b).

Plate (3): (a) Photo of survey location HL-02, (b) Plane failure can occur on the fracture orientation $250^{\circ}/40^{\circ}$ and slope orientation of $230^{\circ}/85-90^{\circ}$.

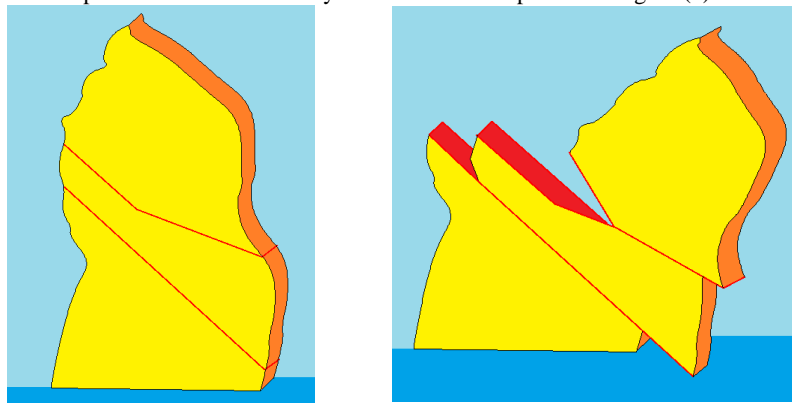
Figure (2): 3D model of limestone block and potential failure at survey location HL-02.

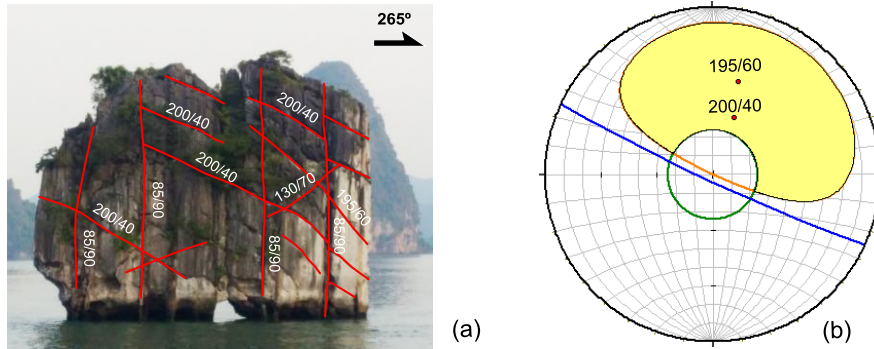
Dinh Huong Island has a block structure, which is divided into layers by different fracture systems (Pl.4a). The analytical results according to Hoek and Bray (2004)'s application have determined, it is possible to occur plane failure on the fracture orientations: $195^{\circ}/60^{\circ}$, $200^{\circ}/40^{\circ}$ and slope orientation $205^{\circ}/85-90^{\circ}$ (Pl.4b).

Plate (4): (a) Photo of survey location HL-03, (b) Plane failure can occur on the fracture orientations: $195^{\circ}/60^{\circ}$, $200^{\circ}/40^{\circ}$ and slope orientation $205^{\circ}/85-90^{\circ}$.

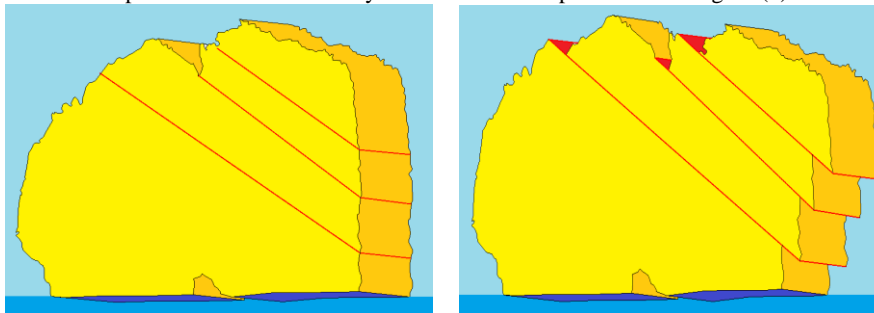
Figure (3): 3D model of limestone block and potential failure at survey location HL-03.

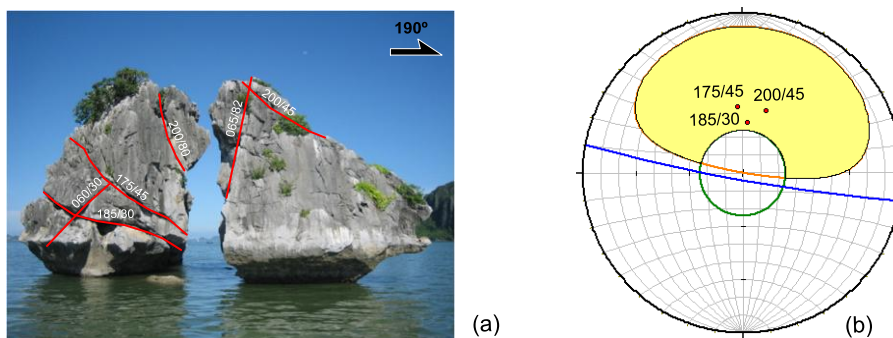
The Ga Choi Island is composed of limestone, thick layered of Bac Son formation (P1.5a). The fracture orientations: $175^{\circ}/45^{\circ}$, $185^{\circ}/30^{\circ}$ and $200^{\circ}/45^{\circ}$ can occur plane failure in the direction of slope 190° and fracture orientations: $060^{\circ}/50^{\circ}$ và $065^{\circ}/82^{\circ}$ can occur plane failure on the slope orientation $060^{\circ}/85-90^{\circ}$, (P1.5b).

Plate (5): (a) Photo of survey location HL-04, (b) Plane failure can occur on the fracture orientations: $175^{\circ}/45^{\circ}$, $185^{\circ}/30^{\circ}$ and $200^{\circ}/45^{\circ}$ and slope orientation $190^{\circ}/85-90^{\circ}$.

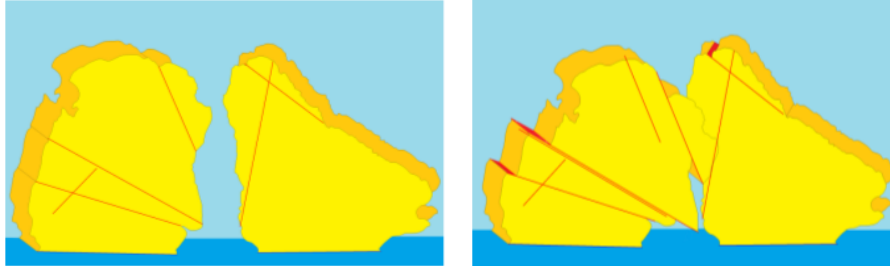
Figure (4): 3D model of limestone block and potential failure at survey location HL-04.

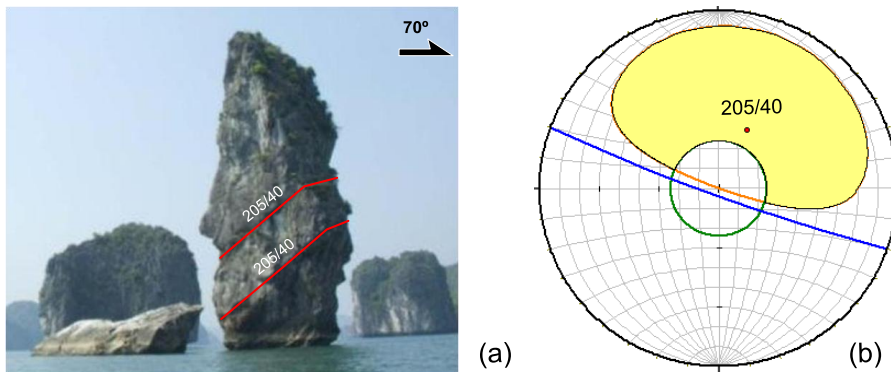
The survey location is a small island, about 44.2m high and has a pen-shaped cylinder (Pl.6a). The limestone is solid, block structure; the fracture develops in the NW - SE direction with sparse density. The analytical results according to Hoek and Bray (2004)'s application have determined, it is possible to occur plane failure on the fracture orientation $205^{\circ}/40^{\circ}$ and slope orientation $200^{\circ}/85-90^{\circ}$ (Pl. 6b).

Plate (6): (a) Photo of survey location HL-05, (b) Plane failure can occur on the fracture orientation $205^{\circ}/40^{\circ}$ and slope orientation $200^{\circ}/85-90^{\circ}$.

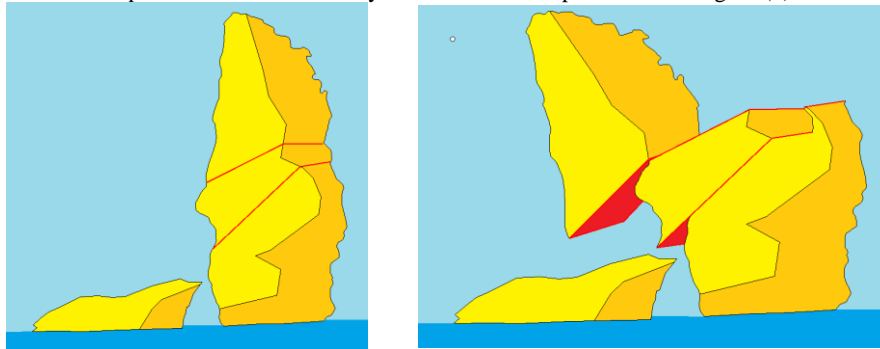
Figure (5): 3D model of limestone block and potential failure at survey location HL-05

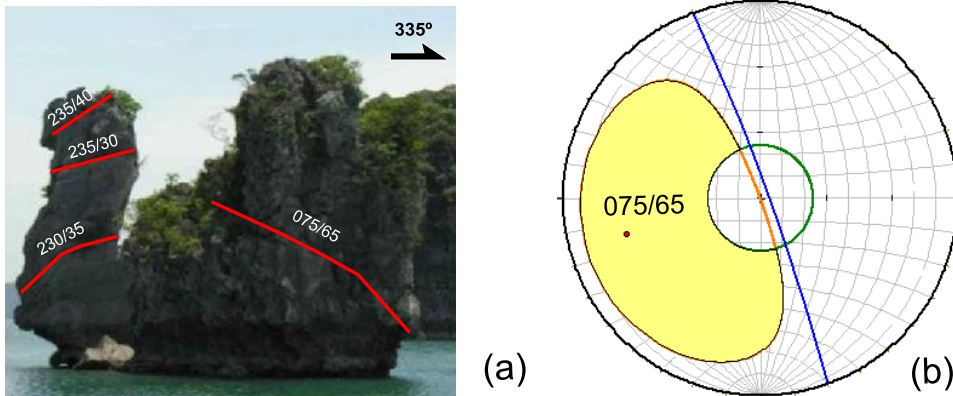
The Thien Nga Island consists of two small blocks, composed of limestone with thin layers, rich silic, belonging to Cat Ba formation (Pls. 7a, 8a). The analytical results according to Hoek and Bray (2004)'s application have determined, it is possible to occur plane failure on the fracture orientations: $230^{\circ}/40^{\circ}$ and $075^{\circ}/70^{\circ}$ and slope orientations: $230^{\circ}/85-90^{\circ}$ and $070^{\circ}/85-90^{\circ}$ (Pls. 7b, 8b).

Plate (7): (a) Photo of survey location HL-06, (a) Plane failure can occur on the fracture orientation $075^{\circ}/70^{\circ}$ and slope orientation $230^{\circ}/85-90^{\circ}$.

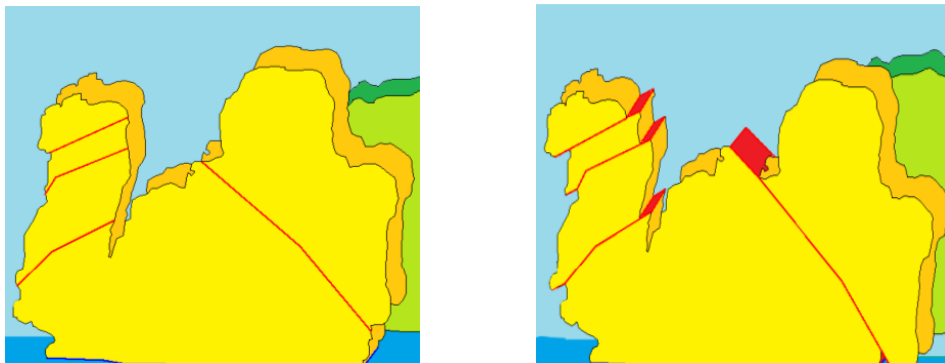
Figure (6): 3D model of limestone block and potential failure at survey location HL-06.

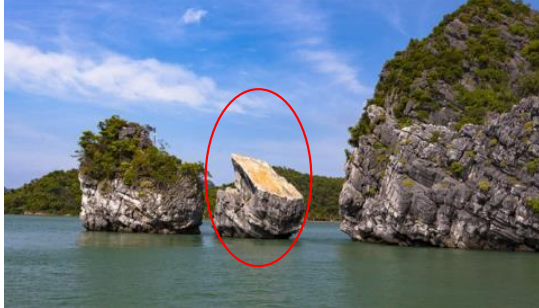
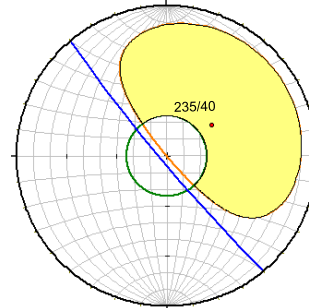
(a) **(b)**
Plate (8): A head of Thien Nga Island (a) is cut by plane failure of fracture orientation $235^0/40^0$ (b).

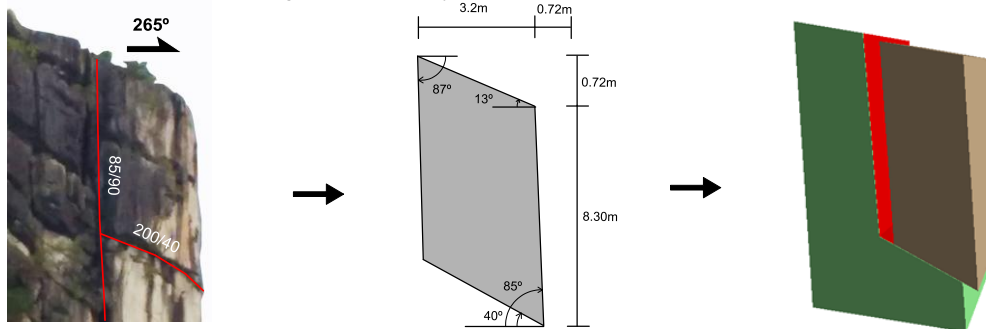
Plate (9): Model of plane failure block of the fracture orientation $200^0/40^0$ of Dinh Huong Island at survey location HL-03 in the case of it has tension crack.

The calculated results of input parameters: Slope angle = 85 degrees; Slope height = 8.3 m; Unit weight = 2.67 t/m^3 ; Failure plane = 40 degrees; Tension crack = 87 degrees; Upper face = 13 degrees; Friction angle = 35 degrees; Cohesion = 4.2 t/m^2 have determined the safety factor to be 1.31.

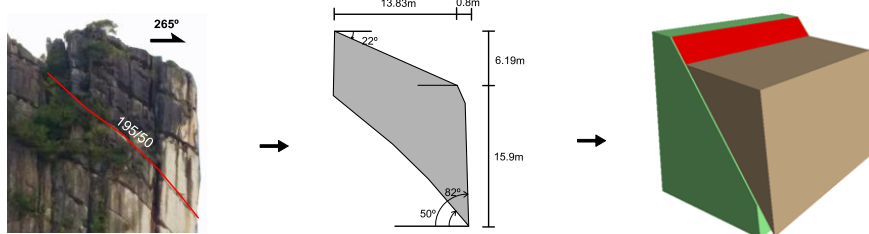
Plate (10): Model of plane failure block of the fracture orientation $195^{\circ}/50^{\circ}$ of Dinh Huong Island at survey location HL-03 in the case of it has not tension crack.

The calculated results of input parameters: Slope angle = 82 degrees; Slope height = 15.9 m; Unit weight = 2.67 t/m^3 ; Failure plane = 50 degrees; Upper face = 22 degrees; Friction angle = 35 degrees; Cohesion = 4.2 t/m^2 have determined the safety factor to be 0.91.

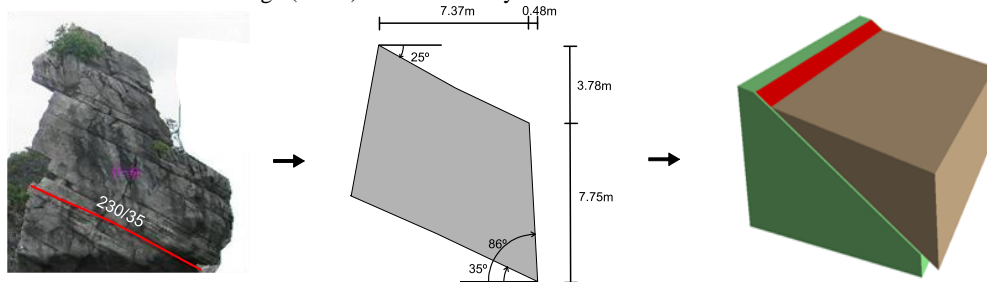
Plate (11): Model of plane failure block of the fracture orientation $230^{\circ}/35^{\circ}$ of Thien Nga (Swan) Island.

The calculated results of input parameters: Slope angle = 86 degrees; Slope height = 7.75 m; Failure plane = 40 degrees; Upper face = 25 degrees; Friction angle = 35 degrees; Cohesion = 4.2 t/m^2 have determined the safety factor to be 1.80.

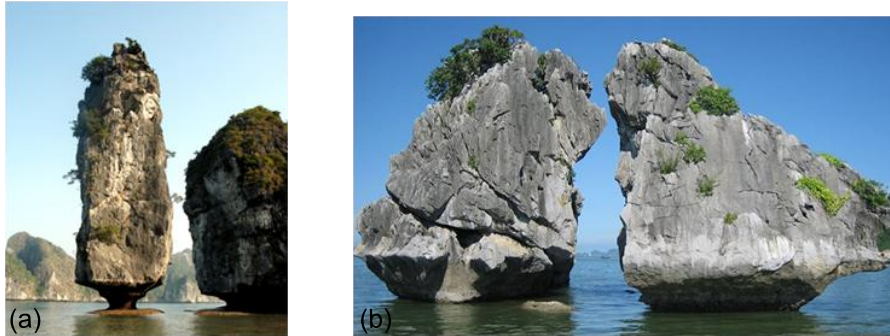
Besides, the limestone islands in the Ha Long bay have also affected by ocean waves and chemical corrosion (Pl.12).

Plate (12): (a) Foot of a stone tower, (b) Ga Choi island is gnawed by ocean waves and chemical corrosion.
