The restoration of the Basilica Minore di Maria SS. Incaldana in Mondragone (northern Campania): the role of color

Francesco Miraglia¹

The Basilica Minore di Maria SS. Incaldana, located in Mondragone (a city of Northern Campania), for many years was affected by many degradation pathologies.

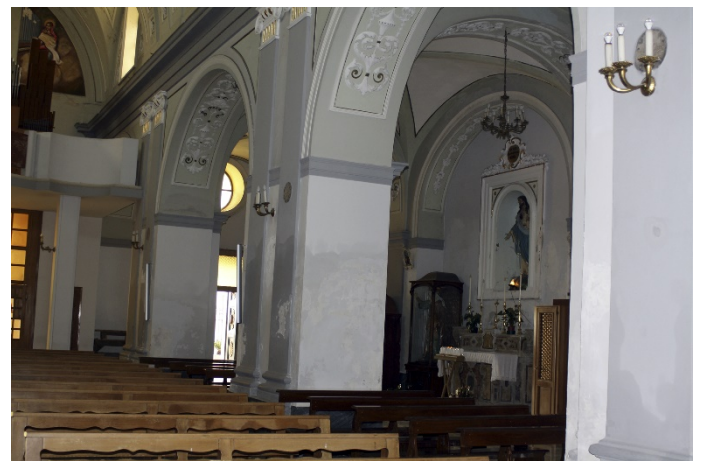
Several pathologies of degradation, according to the recommendations of the “Ente Italiano di Unificazione” (UNI 11182/2006), have been found in the church and on its external facade, mostly related to capillary rising damp.

They are, for the internal environments: *detachment*, *missing part* (also found in other glossaries as *lacuna*), *discolouration* (also found in other glossaries as *chromatic alteration*), *efflorescence* (Fig. 2). On the external surfaces, on the other hand, the pathologies found may refer to *missing part*, *discolouration* and *crack*. Despite various analyzes of coloring and historical documents, no historicized colors were identified.

Fig. 2. Basilica Minore di Maria SS. Incaldana, left nave before restoration work.

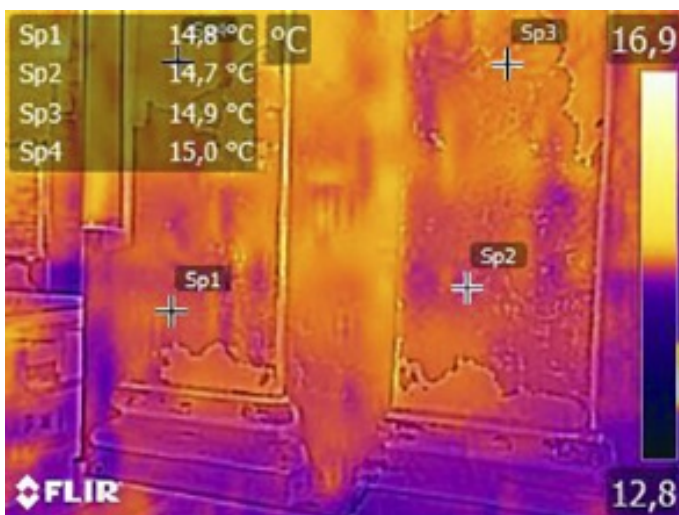
Thermography made it possible to visualize absolute values and temperature variations of the objects, to verify the presence of pathologies of the various stone elements (Fig. 3).

Fig. 3. Basilica Minore di Maria SS. Incaldana, thermographic analysis.

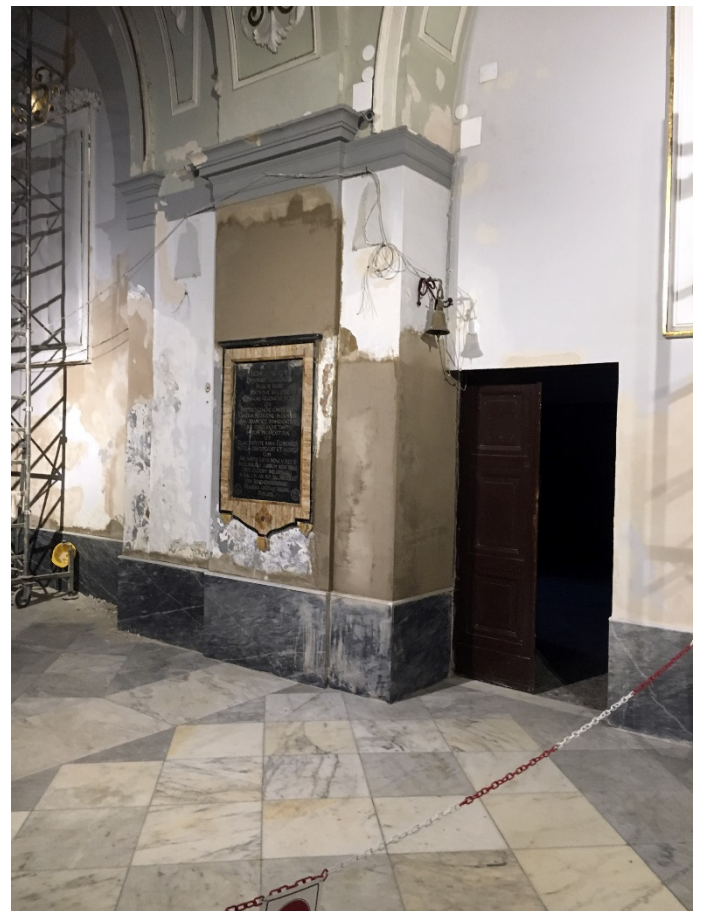
Fig. 4. Basilica Minore di Maria SS. Incaldana, right nave during restoration work.

Plasters based on certified lime and selected aggregates were chosen to give a material support to the new colourings, also based on lime, that could prevent - in the long term - oxidation or loss of adhesion. The plaster additions, which concerned a significant portion of the vertical surfaces, were made using three products, with various grain sizes (Fig. 4).

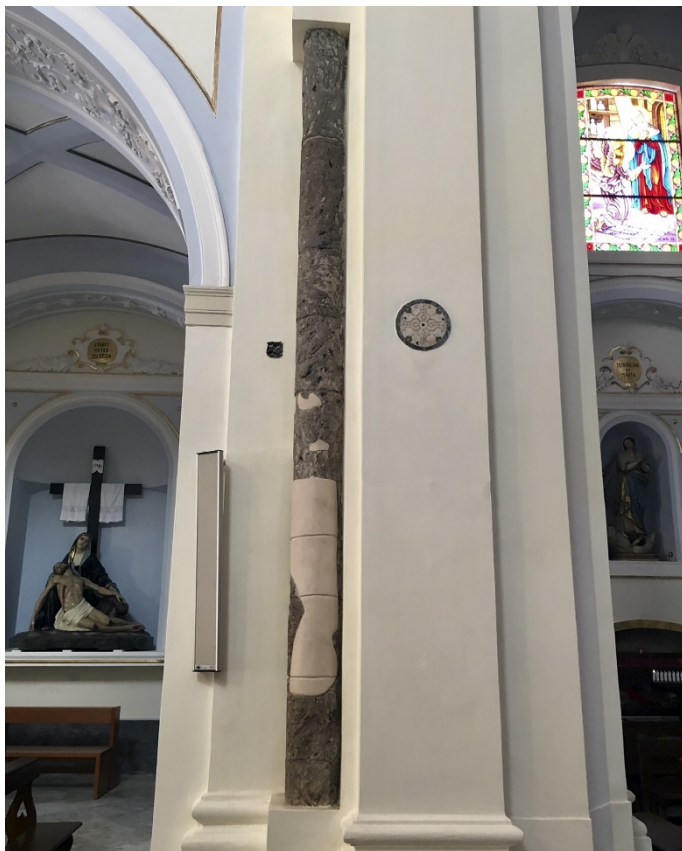
Attention was also paid on the scientific analysis of the complex stratifications of the structure, through the creation of two stratigraphic windows on the pillars of the central nave, located in correspondence with the transept, to assume useful information on the presence of as many circular pillars in tufa, constituent of the original late 15th century church (Fig. 5, Fig. 6).

Fig. 5. Basilica Minore di Maria SS. Incaldana, left nave, stratigraphic window.

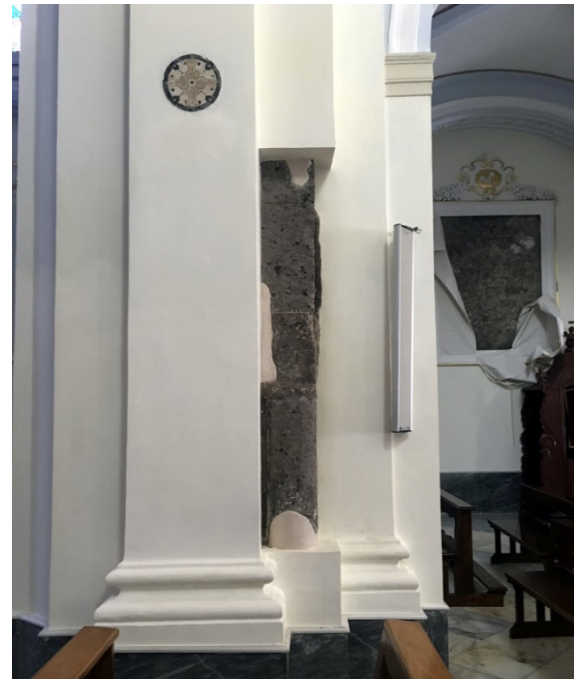
Fig. 6. Basilica Minore di Maria SS. Incaldana, right nave, stratigraphic window.

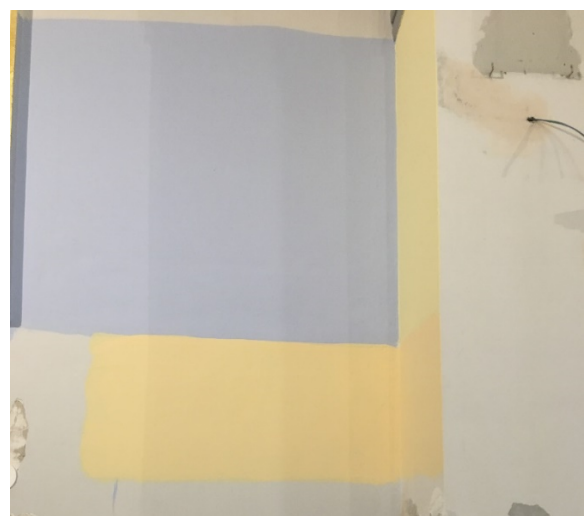
Fig. 7. Basilica Minore di Maria SS. Incaldana, testing of the new colors for the superintendence approval.

The new colors, approved by the Superintendence for Architectural Heritage and Landscape, were also chosen for their figure: starting from a neutral color (white), they became, in correspondence with the upper portions of the structure (arches and vaults) more lively (sand and indigo) (Fig. 7, Fig. 8).

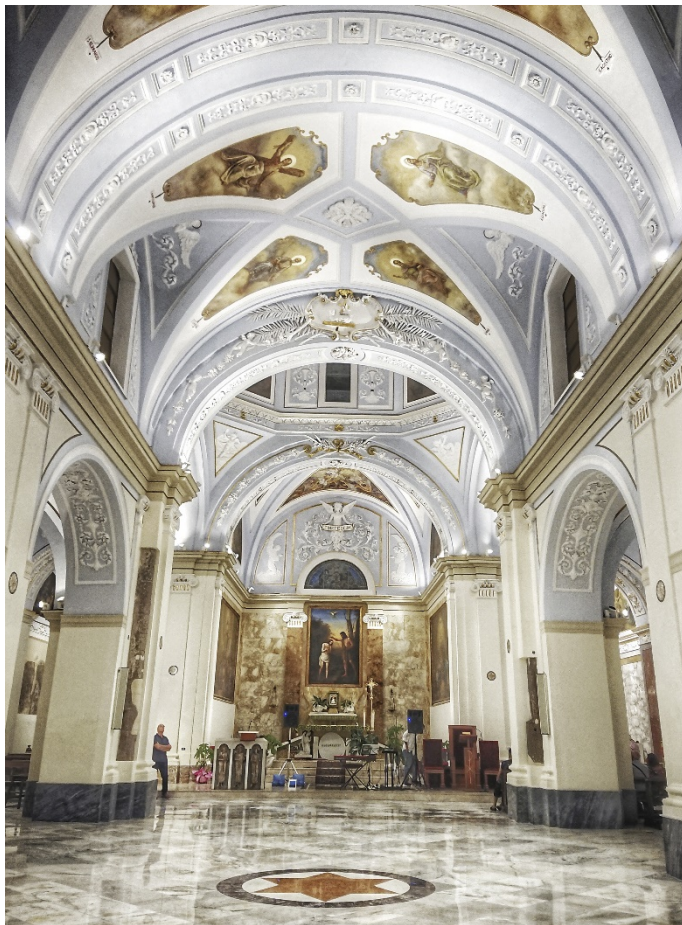
Fig. 8. Basilica Minore di Maria SS. Incaldana, central nave after restoration work (Ph: Angelo Razzano).

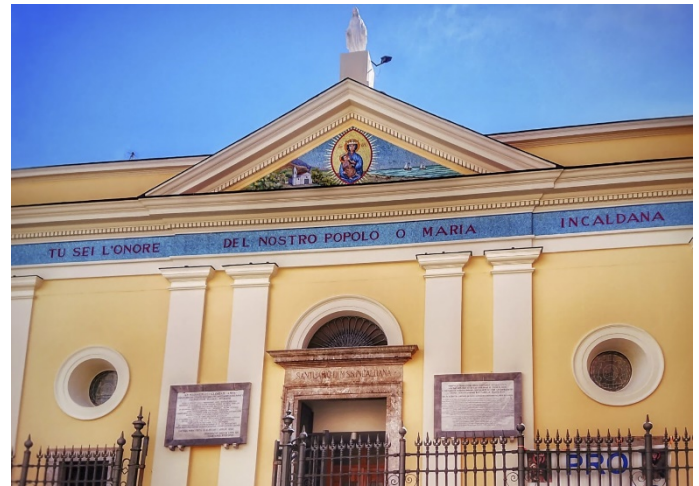
Fig. 9. Basilica Minore di Maria SS. Incaldana, external façade after restoration work (Ph: Angelo Razzano).

In order to restore the wide external front, instead, colors equal to the pre-existing ones have been identified, varying the brightness to make them softer. The white of the high overhanging pilasters, therefore, was interspersed with the yellow of the walls (Fig. 9).
