# Some practical crack path examples

Les P. Pook

**ABSTRACT.** It is well known that many engineering structures and components, as well as consumer items, contain cracks or crack-like flaws. It is widely recognised that crack growth must be considered both in design and in the analysis of failures. The complete solution of a crack growth problem includes determination of the crack path. Macroscopic aspects of crack paths have been of industrial interest for a very long time. At the present state of the art the factors controlling the path taken by a crack are not completely understood. Eight brief case studies are presented. These are taken from the author's professional and personal experience of macroscopic crack paths over many years. They have been chosen to illustrate various aspects of crack paths. One example is in a component from a major structure, three examples are in laboratory specimens, and four are in nuisance failures. Such nuisance failures cause, in total, a great deal of inconvenience and expensive, but do not normally receive much publicity.

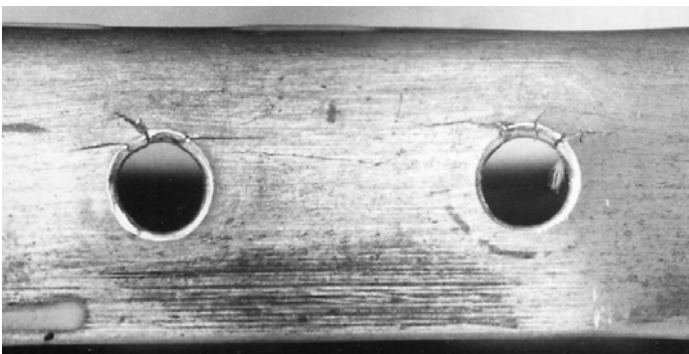
Figure 1: Cracks in undercarriage bay bracket.

The relationship between mode of fatigue loading and paths taken by fatigue cracks has been of interest for a long time [2, 3]. This information can be useful in failure analysis and Figure 1 shows an example from 1961. It is a bracket from an aircraft undercarriage bay which showed unexpected cracking at rivet holes. The bracket was a formed 18 swg (1.2 mm thick) aluminium alloy angle, 10 in  $\times$  0.8 in  $\times$  0.8 in (254 mm  $\times$  20.3 mm  $\times$  20.3 mm). The figure shows a general view of typical cracks observed after the bracket was removed from the bay. Examination of the fracture surfaces of the cracks showed that fatigue cracks had originated at both surfaces of the bracket at the rivet hole corner and then propagated inwards on elliptical crack fronts, with the two cracks intersecting at or near the centre line of the sheet. Figure 2 shows the fracture surface of a typical crack. This indicates that failure was caused by out of plane alternating

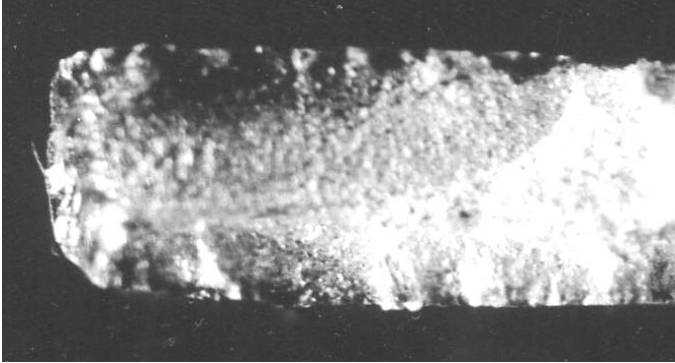
bending fatigue loads, which were not anticipated by the designer. Examination of the fracture surfaces at high magnification showed the presence of striations and hence confirmed that cracking was due to fatigue. This is an example of the useful crack path information which can be obtained from simple examination of a failed component with the naked eye.

Figure 2. Surface of crack in an undercarriage bay bracket.

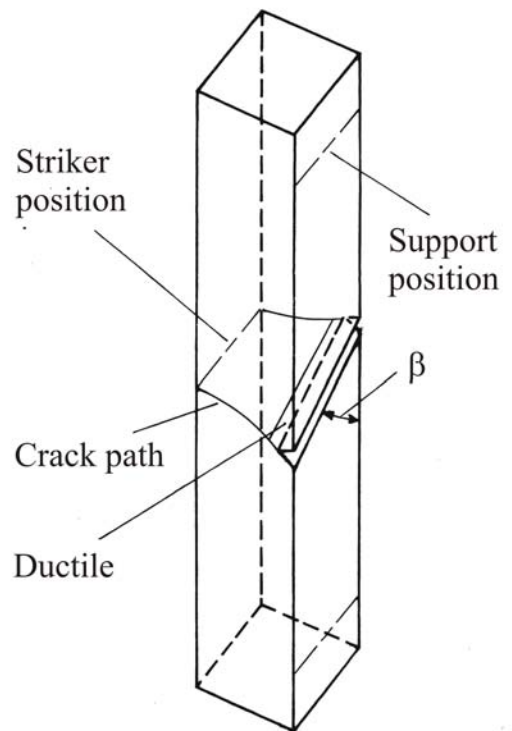
Figure 3. Angle notch Charpy specimen, crack initiation along notch tip.

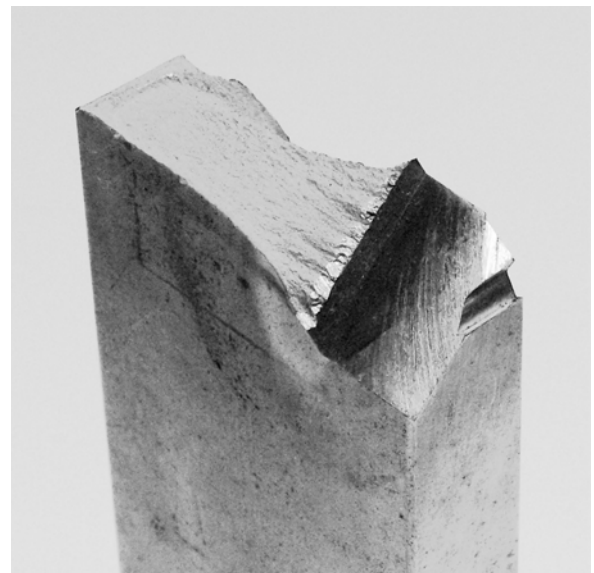
Figure 4. Fracture surface of DTD 5050 5½% Zn aluminium angle notch fracture toughness test specimen, initial  $\beta = 45^\circ$ .

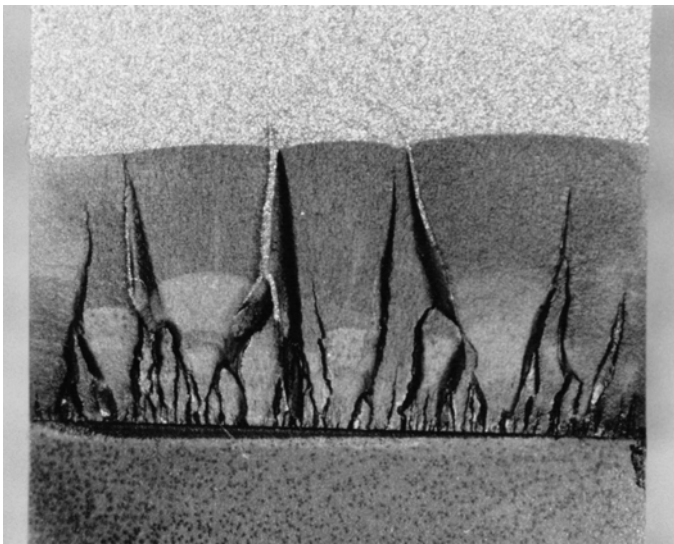
Some fatigue tests were carried out in 1989 on 20 mm thick medium strength structural steel angle notch specimens [7] with initial  $\beta$  values of 75°, 60° and 45°. Figure 5 shows the fracture surface of one of the specimens, initial  $\beta = 60^\circ$ . The light area at the top is where the specimen was broken open in liquid nitrogen. These examples illustrate the strong tendency to Mode I crack growth in isotropic materials under essentially elastic conditions.

Figure 5. Fracture surface of medium strength structural steel angle notch fatigue test specimen, initial  $\beta = 60^\circ$ .

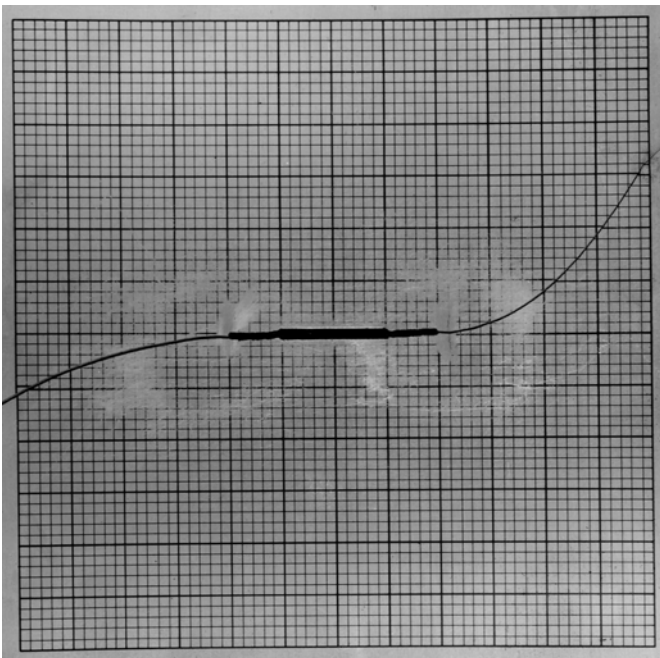
Figure 6. Crack path in a Waspaloy sheet under biaxial fatigue load. The grid is 2.54 mm.

the fatigue load perpendicular to the crack was kept constant. Cracks were first grown from each end of an initial slit under uniaxial loading. An in phase load was then applied parallel to the crack, and crack path behaviour observed. Figure 6 shows the crack path for a load parallel to the crack of twice the load perpendicular to the crack. The crack path became unstable and deviated from its initial path as soon as the load parallel to the crack was applied. At the time the tests were carried out it wasn't possible to do more than describe the results. However, reanalysis of these and other results in 1997 [1, 10] showed it was possible to correlate crack path stability in terms of a parameter called the  $T$ -stress ratio.

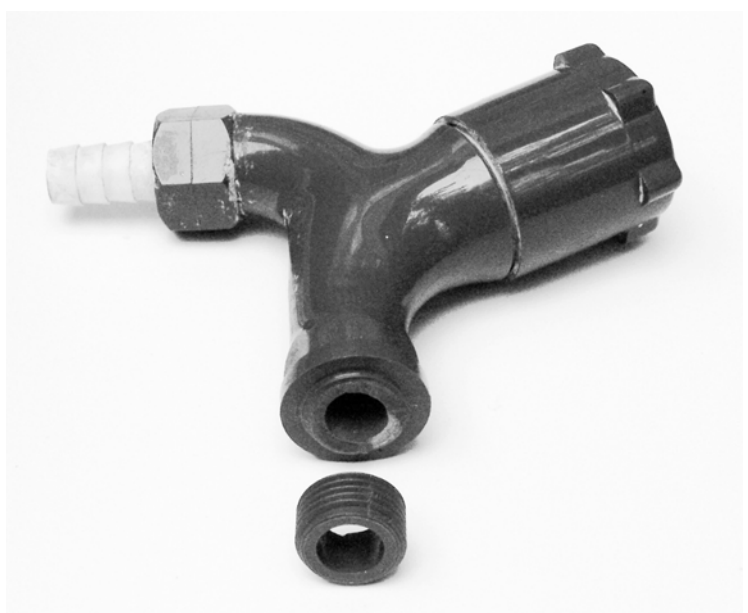
In 1991 a plastic domestic tap in the author's utility room was observed to be leaking where it was screwed into a fitting on the supply pipe. The tap had a fitting for a hose pipe, and appeared to be a replacement for the original brass tap. When an attempt was made to unscrew the tap it failed completely. The two parts of the broken tap are shown in Figure 7 and a close up of the fracture surface in Figure 8. The dark area is fatigue and the light area the final static failure. The age of the tap at the time of failure is unknown, but as one fatigue cycle is applied each time a tap is turned on and off it is likely that thousands of cycles had been applied. Safety critical pressure containing components are often designed to leak-before-break [11] in order to avoid catastrophic failure. It is fortunate that the tap did so otherwise the utility room would probably have been flooded. The failed tap was replaced with a brass tap, and it was observed that the detail design in the vicinity of the threads was exactly the same. The replacement tap is still in use. The episode is an example of the danger of using a different material for a component without making appropriate changes to detail design.

Figure 7. Plastic domestic tap.

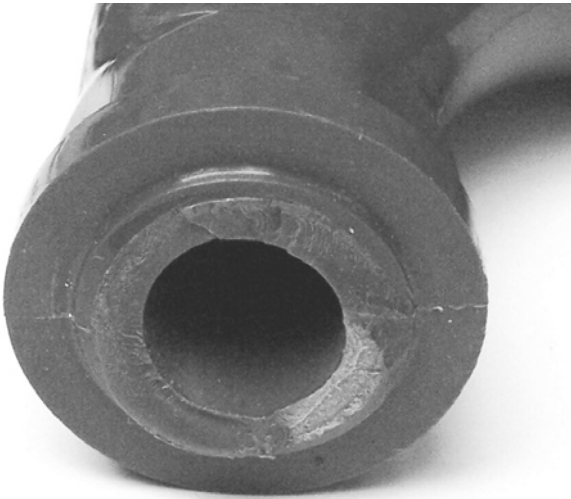
Figure 8. Crack surface of plastic domestic tap.

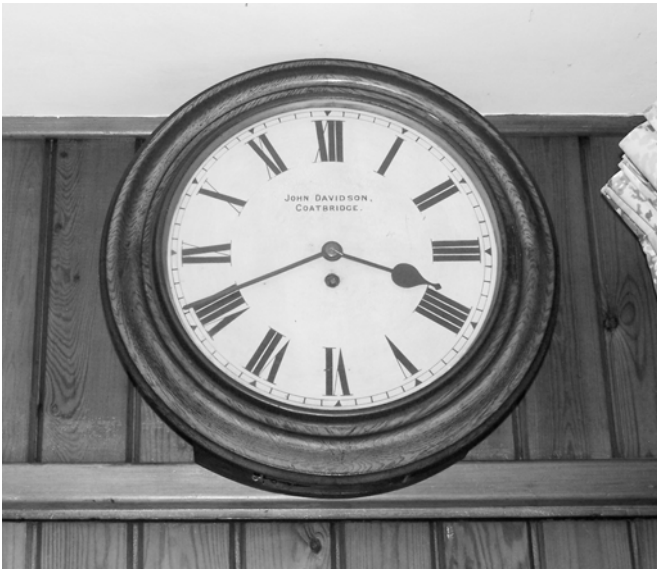
Figure 9. Wall clock by John Davidson, Coatbridge.

ple shown in Figure 9 was originally used in a school, but since 1968 it has been in use in the author's kitchen. In 1994 the mainspring failed while the clock was being wound. Examination showed that this was the final failure following fatigue crack growth. A general view of the failed mainspring is shown in Figure 10. Fatigue has been a problem in clock mainsprings for centuries, and traditionally they are designed using rules of thumb based on experience [12], rather than by detailed analysis. The total fatigue life is not known, but the clock is wound weekly so it must be thousands of cycles.

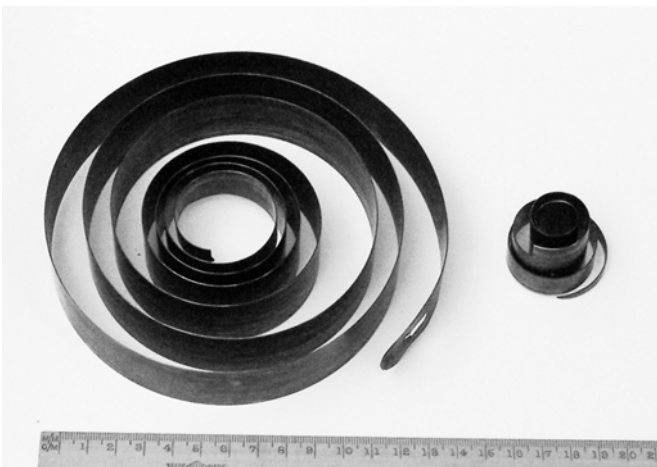
Figure 10. Failed wall clock mainspring.

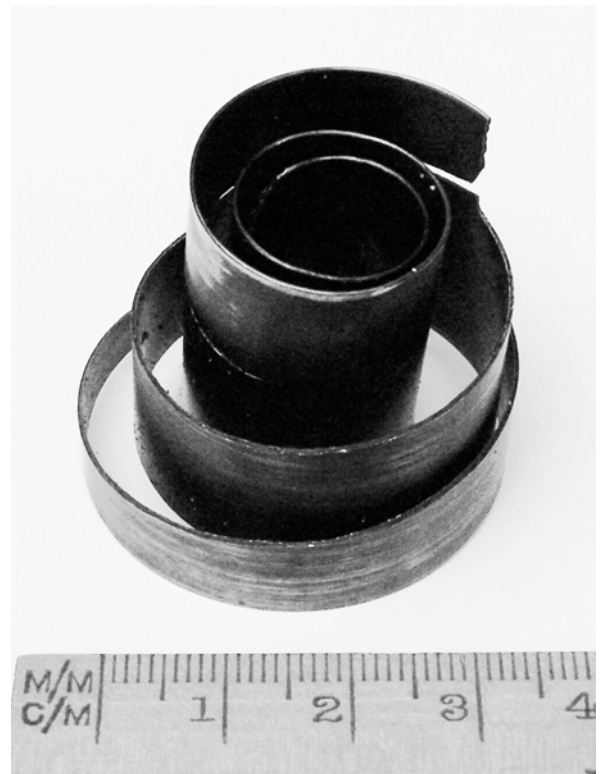
A clock mainspring is loaded in bending, with loading and unloading moving along the spring as it is wound and unwinds. When a mainspring breaks in fatigue the crack is usually straight across the spring, with crack growth predominantly through the thickness. However, in this particular mainspring crack path behaviour is unusually complicated, and details are shown in Figure 11. A fatigue crack initiated at a corner at one edge of the 27 mm wide mainspring. Initially, crack growth was across the spring (downwards in the picture) but after about 9 mm of growth the crack turned sharply towards the outer end of the spring (right in the picture), and then grew in a spiral fashion towards the other edge of the spring until the final failure took place. During this crack growth two secondary cracks initiated, and then joined so that a small triangular piece of spring became detached. The joined secondary crack then grew in a spiral fashion towards the centre of the spring, but did not contribute to the final failure. This is an example of a nuisance fatigue failure which did not have serious consequences. Such failures are not normally investigated at all. The offending component is simply replaced. In this particular case the replacement mainspring is still intact after 12 years.

Figure 11. Centre portion of failed wall clock mainspring.

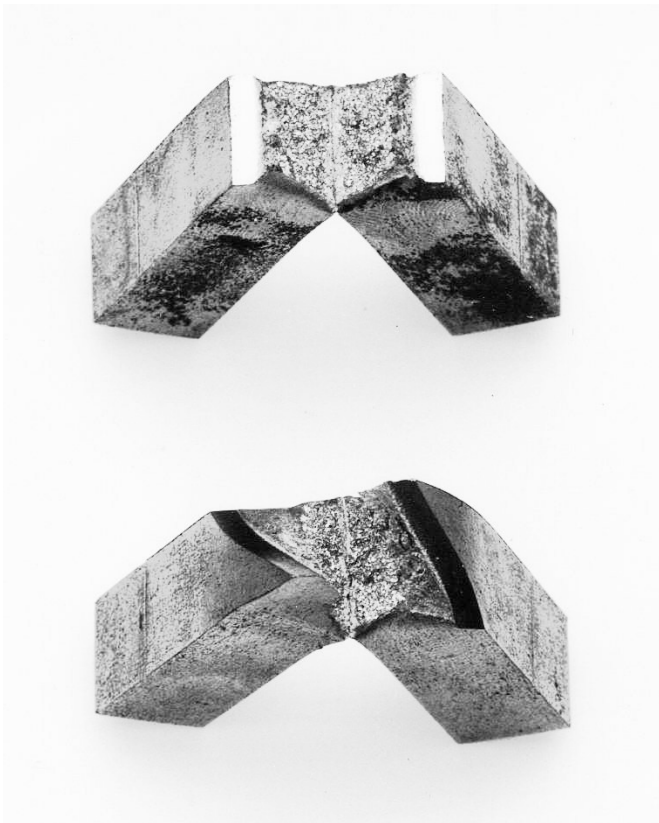
Figure 12. Fracture appearance of mild steel Charpy specimens tested at 10 C. Top, standard specimen,  $\beta = 90^\circ$ . Bottom, angle notch specimen,  $\beta = 45^\circ$ .

The fracture surface appearance of the angle notch specimens is controlled by a tendency towards square (Mode I) crack growth, but modified by plasticity and by crack path constraint due to the initial notch. The value of  $\beta$  has little effect on either the 50 per cent crystalline transition temperature, or on the temperature below which fractures are crystalline. Shear lips for  $\beta = 75^\circ$  and  $60^\circ$  are similar to those on standard Charpy specimens, but could not be distinguished for  $\beta = 45^\circ$ . In the transition region fracture surfaces are initially ductile. The amount of initial ductile crack growth increases with increasing temperature. Crack initiation is along the notch tip, and in the notch plane, so the initial crack growth is mixed mode. For  $\beta = 75^\circ$  and  $60^\circ$  a crack twists as it grows, becoming Mode I as it approaches the striker position (Figure 3). For  $\beta = 45^\circ$  there is an abrupt transition to Mode I crack growth (Figure 13).

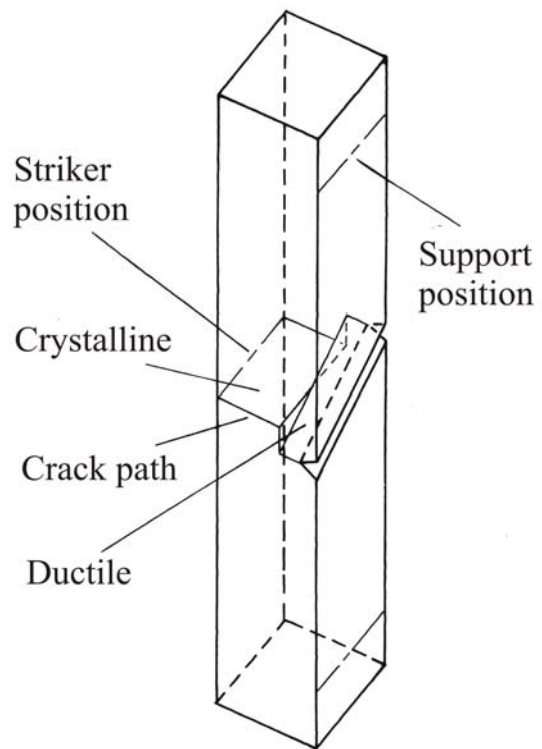
Figure 13. Angle notch Charpy specimen, abrupt transition to crystalline crack growth.

This Mode I growth is at least initially crystalline. At below about  $-15^\circ\text{C}$  fracture surfaces of the angle notch specimens are fully crystalline. Crack origins are Mode I. For  $\beta = 75^\circ$  and  $60^\circ$  there are a number of individual Mode I crack origins along a notch tip, linked by vertical cliffs (apparently Mode III). The initial Mode I cracks link up as a crack grows, and overall a crack twists as it approaches the striker position. For  $\beta = 45^\circ$  the tendency to Mode I crack growth is so marked that the crack path is not constrained by the notch. At intermediate absorbed energy levels there is one crack origin at the centre of a notch, and crack growth is Mode I throughout (Figure

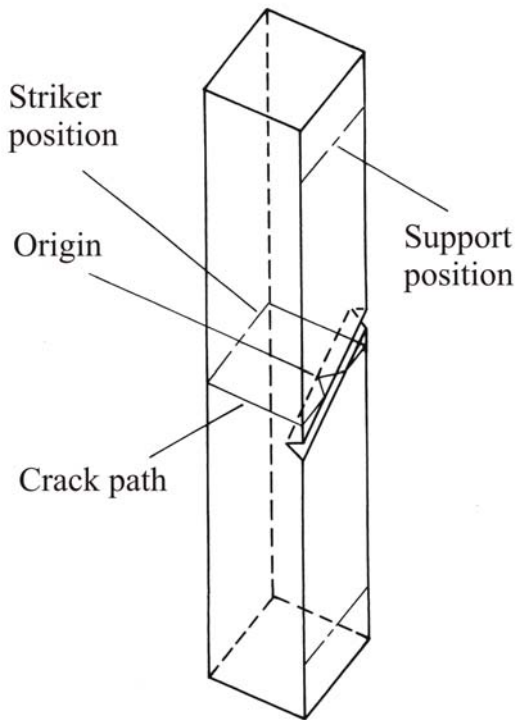
Figure 14. Angle notch Charpy specimen, crack origin at centre of notch.

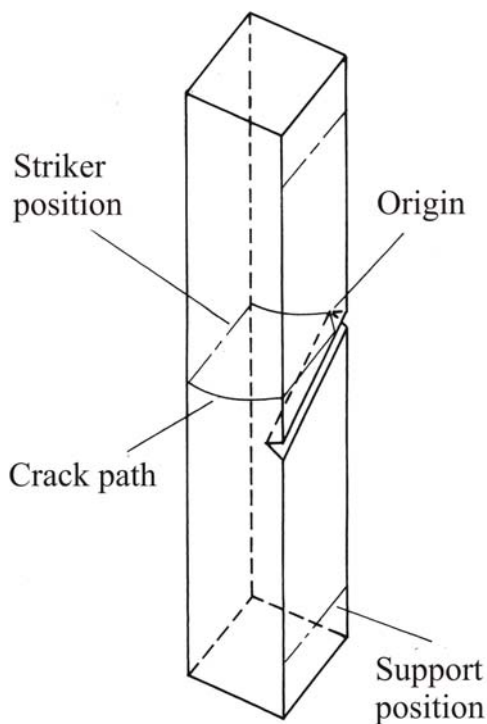
14). At high absorbed energy levels there are crack origins at both notch corners. The cracks follow curved, apparently Mode I paths, as shown schematically for a single crack in Figure 15. The two paths merge as they approach the striker position.

Figure 15. Angle notch Charpy specimen, crack origin at notch corner.

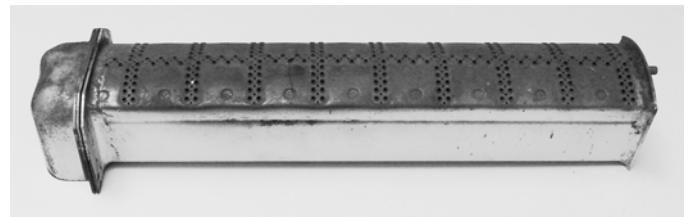
During routine maintenance in 2002 one of the two burners in the gas fired domestic central heating boiler installed in the author's house was found to be cracked due to thermal fatigue. A general view of the burner is shown in Figure 16, and the crack is shown in Figure 17. The boiler was about 12 years old so, assuming it fired about 10 times per day, about 44,000 thermal fatigue cycles had been applied. The burner consists of a steel box with a series of small and large holes on top to distribute the gas to the flame above the box. The larger holes have reinforced perimeters. An internal wire mesh, just visible in Figure 17, helps to distribute the gas evenly. Cracking appears to have initiated at three places on the perimeter of a smaller hole, grown into two larger holes with a small triangular piece becoming detached, and then two cracks grew across most of the width of the box, resulting in improper combustion. The designer did not appear to have appreciated the point that stress concentration factors are largely independent of hole size. The reinforcement had prevented crack initiation at the large holes but its absence had allowed cracking at a small hole. This is another example of a nuisance fatigue failure. Annual inspection was recommended by the boiler manufacturer. This ensured that the cracking was detected before it became dangerous, and the burner was replaced.

Figure 16. Burner from domestic central heating boiler.

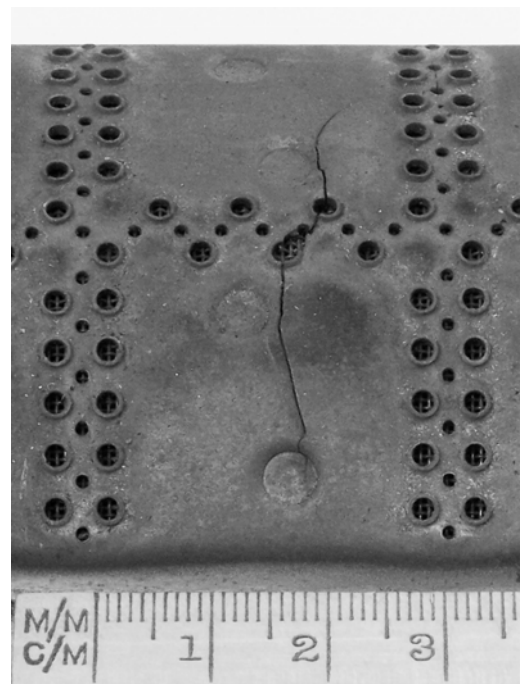
Figure 17. Crack in burner from domestic central heating boiler.

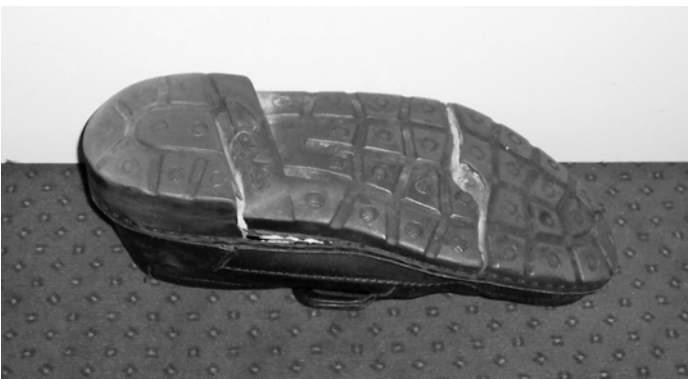
In 2005 the author found that the plastic soles of pair of walking shoes had become badly cracked and one no longer fitted properly. This more severely damaged shoe is shown in Figure 18. The sole of a shoe is subjected to repeated bending. Going uphill a sole is also subjected to repeated tension as the rearward force applied by the wearer's heel is transferred to the ground. This particular pair of shoes had covered several hundred kilometres, which is equivalent to around  $3 \times 10^5$  cycles. In the shoe shown two separate cracks had initiated in grooves near the toe, grown past each other and then curved together, in a well known crack path behaviour [15], so that a piece of sole became detached. The heel had also cracked and, in what appears to have been the final event that reduced the stiffness of the shoe so much that it became unusable, the sole separated from the upper at the end of this crack. The use of a plastic, instead of rubber, for the soles has reduced the rate of wear but led to fatigue failure. This is another example where a change of material has resulted in fatigue cracking.

Figure 18. Cracks in sole of walking shoe.
