Power Quality Problems Caused by Termites on 138-kV Underground Cables

Romeu Fuscaldi¹, Fernando H. Silveira², Alberto De Conti³, and Silvério Visacro⁴

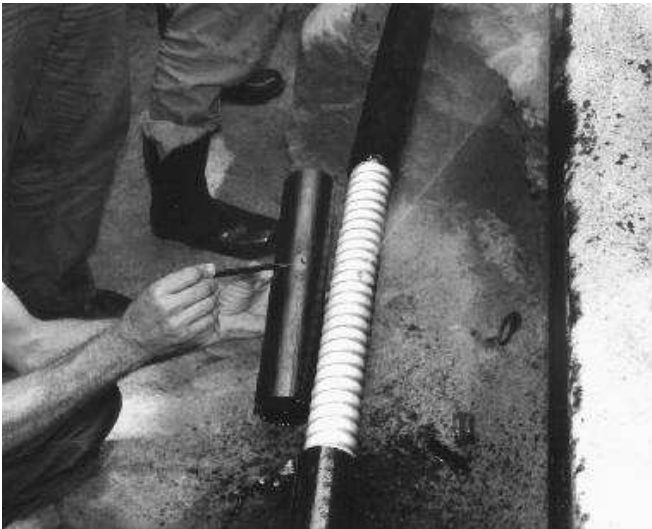
Since 1986 termites have been causing serious damages to 138-kV underground cables installed in Belo Horizonte. For reasons yet to be determined, they create punctures in the PVC layer covering the cable. This leaves the corrugated aluminum sheath exposed, which ultimately leads to a corrosion process that culminates with oil leakage to the ground. If a significant volume of insulating oil is drained out of the cable, a short circuit may occur. This event has devastating consequences to the system operation, leading to outages and requiring very long and expensive maintenance service. Fig. 4 illustrates the oil leakage caused by a puncture due to termites on a 138-kV transmission line.

Fig. 4. Oil leakage found in the maintenance of the 138 kV transmission line Adelaide – Carlos Prates in 1997.

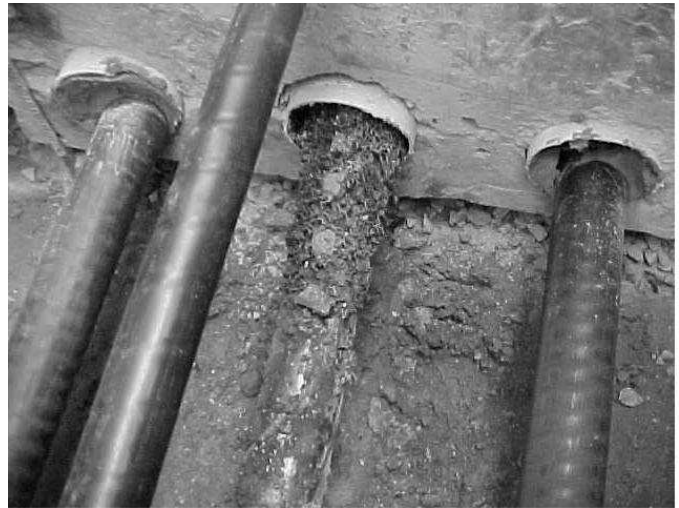
of the cables, biologists have been investigating possible reasons for the attacks performed by these insects. Two possible explanations are currently discussed: (i) termites are attracted by the paper (organic material) inside the cable, which serves as food; (ii) termites are likely to build their houses in the vicinity of cables because of the higher temperatures on the external surface of the cable. Fig. 5 illustrates a colony of termites found on the external surface of a 138-kV underground cable.

Fig. 5. Typical colony of termites found around the cables.

Regardless of the cause, it is not possible to avoid termite attacks to underground cables already in operation. In the case of new projects, an alternative would be the use of a lead armor, which is more resistant to the corrosion process than aluminum.
