Analysis of the Damage of Boiler Bottom Slope Pipe in Steam Power Plant

Rusnaldy, Mohammad Tauviqirrahman^a, Norman Iskandar^b

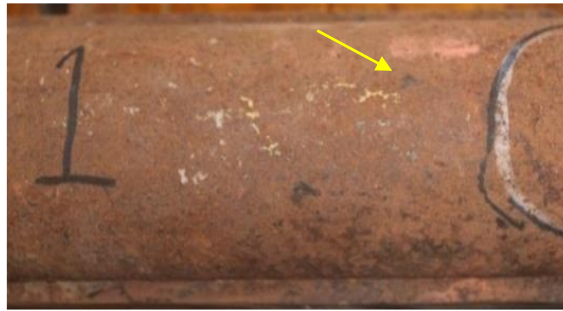
Bottom slope pipe on boiler system had been experienced damage in form of dent caused by plastic deformation (see Figure 1). The pipe is one located in lower furnace area on boiler system. Inside bottom slope pipe is fluids in liquid phase to be evaporated. On the outside of pipe, there is available pulverized fine coal. This fuel then blown into furnace and then ignited with the fire and combusted with other fuel. Additional air for combustion was supplied into furnace until perfect combustion occurred.

Figure 1.1 Pipe with damage (shown by arrow) caused by impact of foreign object

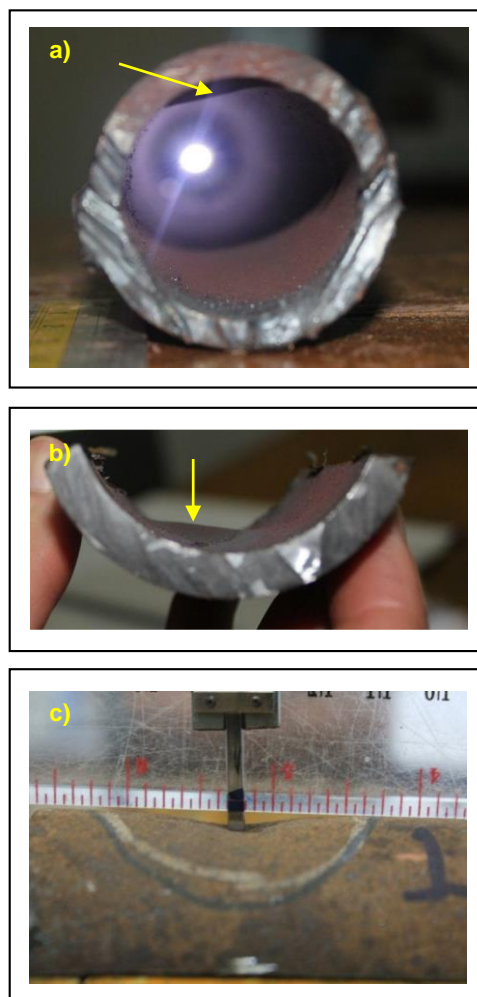
Figure 3.1 Visual Inspection on Damage Pipe

The photograph of damaged pipe can be seen in Figure 3.1. The feature of inside pipe (Figure 3.1a) showed the part of pipe deformed inside (dark area shown by the arrow). Other side was in good condition. No sign of excessive corrosion and deposit. The arrow showed feature of inside part of pipe which plastically deformed, but no crack

or hole shown in this area (Figure 3.1b). From measurement, the depth of biggest measured plastic was 3.10 mm (Figure 3.1c).

1. Defect caused by plastic deformation was found on the pipe. The plastic deformation likely was caused by impact of foreign object from outside of pipe.
2. Excessive deposit was not found inside the pipe.
3. Damaged related to corrosion was not found inside pipe, such as pitting corrosion, caustic corrosion and other type of corrosion which endangered the pipe, like common damaged inside the pipe of boiler [2, 3].
4. Crack and hole was not found inside the pipe in area experience plastic deformation.

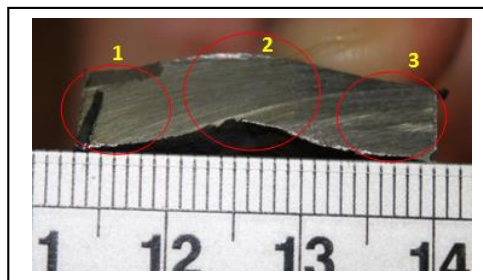
Figure 3.1 Observation Area of Microstructure and Hardness Test

In order to proof the occurrence of plastic deformation on defect, microstructure analysis on defects area was conducted (location 2) and on area outside defect area (location 1 and 3) in Figure 3.1. The hardness test also was conducted on the area experienced plastic deformation. The Result of microstructure photograph was depicted in Figure 3.2 and 3.3.

Location	HRB
Free from defect	84,8 – 89,7
Area 1	91,1 – 93,4
Area 2	95,9 – 96,0
Area 3	92,0 – 92,5

1. Defect was occurred by plastic deformation and initiated by foreign object impact from outside pipe. The impact occurred on temperature under recrystallization (cold forming).
2. From the result of hardness test, it supported the hypothesis where hardness value on defect area higher that free of defect area. Increase of hardness was a proof on plastic deformation in cold forming condition on defect area.

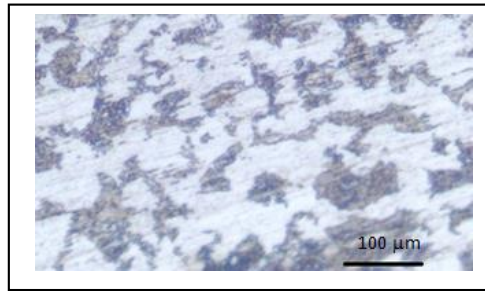
Figure 3.2 Microstructure of Area free from Defect

Photograph of microstructure outside defect area (free from defect area) was given in Figure 4. From the structure, it can be shown that ferrite and pearlite phase was on the material. Microstructure photograph of defect area can be seen in Figure 5. The grain in defect area experienced stretching which indicate plastic deformation was occurred. Plastic deformation also occurred on temperature below recrystallization (cold forming).

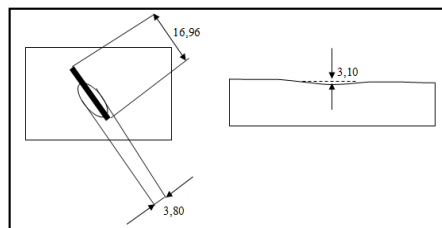
Figure 3.4 Sketch on Pipe Defect, Top View (left), Side View (right) (dimension in mm)

Figure 6 showed the sketch of "defect" with dimension of real measurement dimension on the pipe. Based on the sketch, the foreign object fall into pipe and causing defect on pipe was simulated by employing finite element based computer software to acquire detail body of foreign object which consisted of dimension, volume, and mass [5]. By simulation, the prediction of impact speed of foreign object to pipe also was simulated.

In computer simulation, foreign object was assumed in shape of polygon modeled in various dimension. The result of simulation showed that foreign object dimension most imitate defect shape on pipe described in Figure 6 as the one with thickness of 2 mm, with length and width 16.96 mm both. From simulation results, it can be concluded that the condition of foreign object likely to fall into pipe was in volume of 575.28 mm³, with mass of 4.5 gram, and speed of impact of 26 m/s (or equals to free fall from 34.5 m high). It means that the foreign object felt into pipe even though has relatively small size but able to make defect on pipe (because of plastic deformation) when the object felt from relatively high altitude. The speed of impact caused by gravitational acceleration is function of height. Table 6 showed the prediction on fallen foreign object.

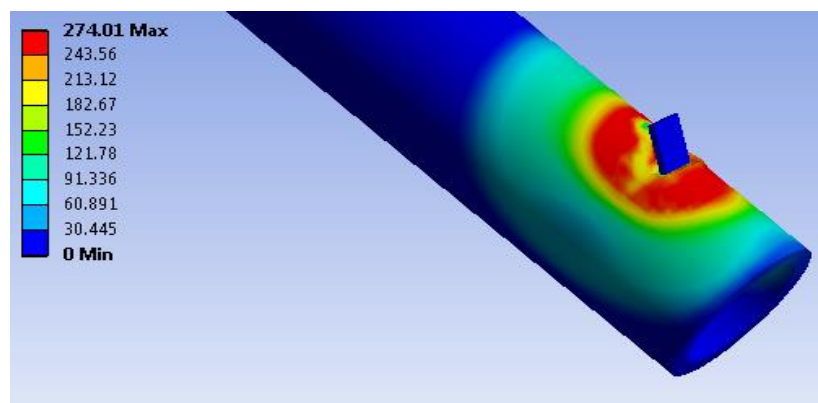
Figure 3.5 Distribution of von Misses stress (in MPa) right after foreign object impacted on pipe

Figure 3.5 showed the distribution of von Misses stress just after foreign object hit the pipe with certain speed. Based on the contour, it can be concluded that maximum von Misses stress was 274 MPa. If the value of stress was compared with yield strength (σ_y) of initial design specification (275 MPa), theoretically the pipe was not experienced plastic deformation. But, in fact pipe was plastically deformed caused by impact (see Figure 8). Likely, the impact was occurred on high temperature condition but still below recrystallization temperature. Increasing of temperature lowered value of yield strength. The operational life of pipe which is relatively long (around 87.600 hours) and exposed to high temperature gases also give likely cause of lowering of the strength since the yield strength of material is a function of temperature.

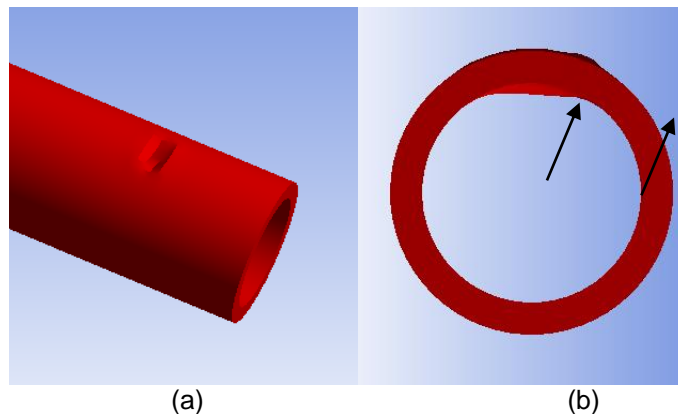
Figure 3.6 Deformation on pipe, (a) isometric view, (b) front view
(Note: Arrow showed plastic deformation in the shape of indentation inside pipe).

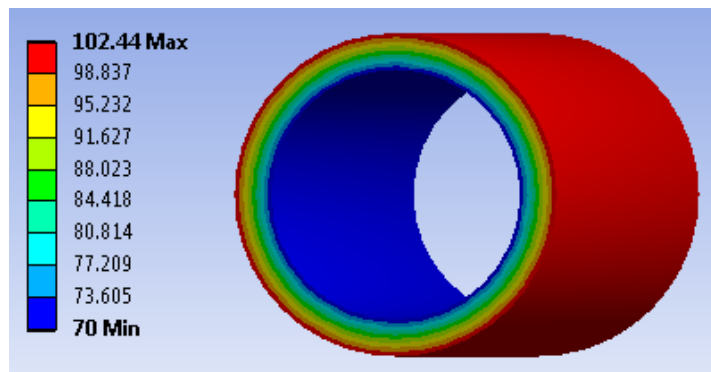
Figure 3.7 Temperature Distribution in Pipe Caused by Thermal Load (in°C).

On simulation, the pipe was conditioned in exposure of radiation from combusted gas on 1200 °C in accordance with real condition. Based on contour of temperature distribution in the pipe (Figure 9), the temperature in the surface of pipe still in ranged of 100 °C, which means far from recrystallization temperature of material. Therefore, plastic deformation caused by foreign object impact was occurred in cold forming condition. This result was in accordance with previous metallurgical analysis.
