## AN APPRAISAL AND ANALYSIS OF BOILER PIPES IN AL-MUSAIB ELECTRIC POWER STATION

### ABSTRACT

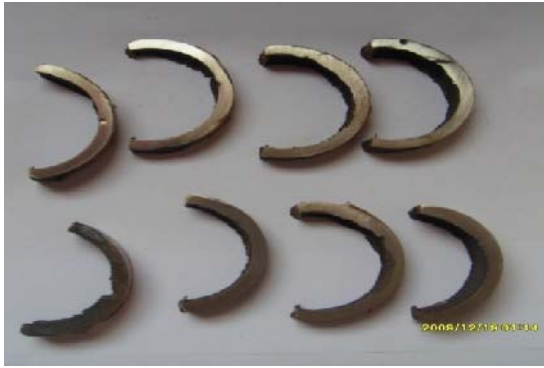
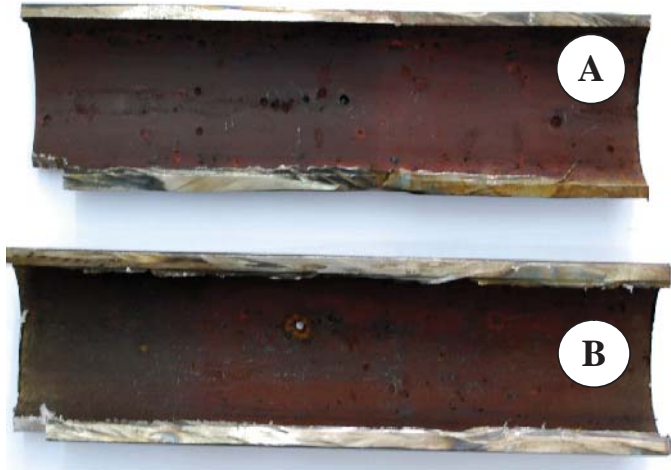
The manner in which each of the failed pipes failed was identical. **Figure 2** is a representative photograph of the appearance of the failed pipes. The failures appeared to have started at the inner surface of the pipe and propagated across the thickness.

**Figure (2):** A-Longitudinal cross section of damaged and undamaged boiler pipes.  
 B- Half rings samples taken from each pipe.

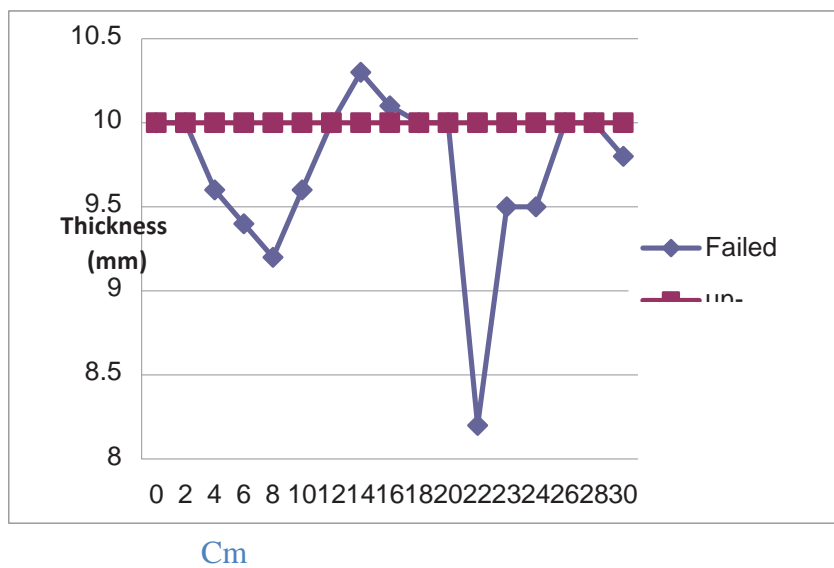
In this paper, the failed pipes have not burst but they suffer from a sever pitting corrosion and erosion. Measuring thickness along the pipe samples can give a clear indication about the corrosion-erosion along the steam side as can be seen in **figure (4)**.

Erosion of investigated pipes is so clear according to the figures above. The degradation in thickness along the pipe reflects the ideas about some expected kind of erosion has occurred. Pipe no.6/coil 92 had been eroded clearly in the locations (2-12 cm) and (20-26 cm) in the 30 cm long investigated.

**Figure (4):** Thickness measurement along the failed and un-failed pipe no.6/coil92.

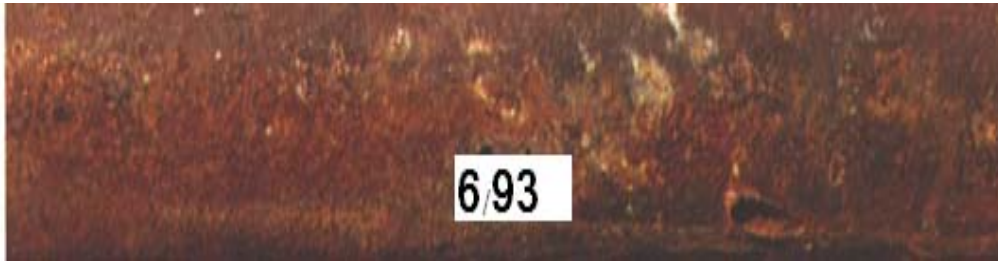
Tubes 6/coil93 and 7/coil48 had few crack openings and deep pits around it. From the **figures** (5), it is evident that pitting started at the surface of the tube near the crack and progressed downwards undercutting the surface. It was also observed that depth of the pit increased as one moves away from the crack. No chemical attack was found on the steam-side of the tube wall.

One of the roof panel tubes of boiler 6, designated as 6/93 in **Fig.** (5) had a swollen portion with many un-regularities and pitting on it. Longitudinal section of the failed area, cleaned with inhibited 3% hydrochloric acid solution, revealed that the fine cracks had initiated at the steam -side of the tube. Some of the cracks had crossed the entire thickness of the tube and had opening at the other side.

**Figure (5):** surface of pipe (6/93).

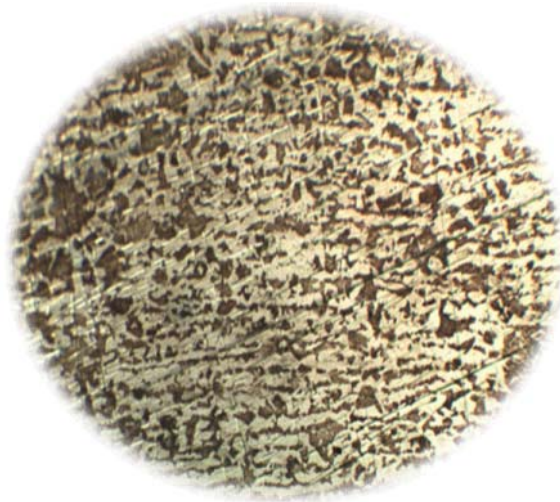
**Figure (6):** Micrograph structure of the un-failed pipe no. 6/93, (200X)

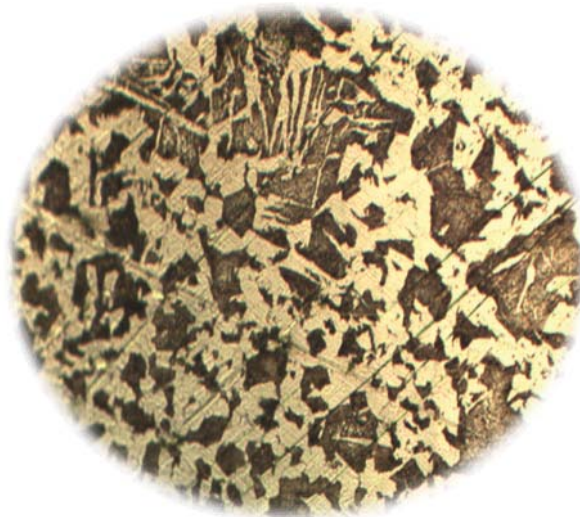
Microscopic studies of cross-section of failure zone of boiler tube 6/93 and 7/48 show quenched microstructure with small amount of carbides present at the grain boundaries (**Fig. 6** and **7**). On comparing the above microstructures of failed area with un-failed area of tube 6/93, 7/48, the former appears as quenched overheated microstructures.

This shows that the exposure temperatures of the above failed areas have exceeded the lower critical temperature and were exposed to this temperature for quite long time. Knowing that, the strength of steel is nearly constant up to about 454°C.

**Figure (7):** Micrograph structure of the failed pipe no. 6/93, (200X)

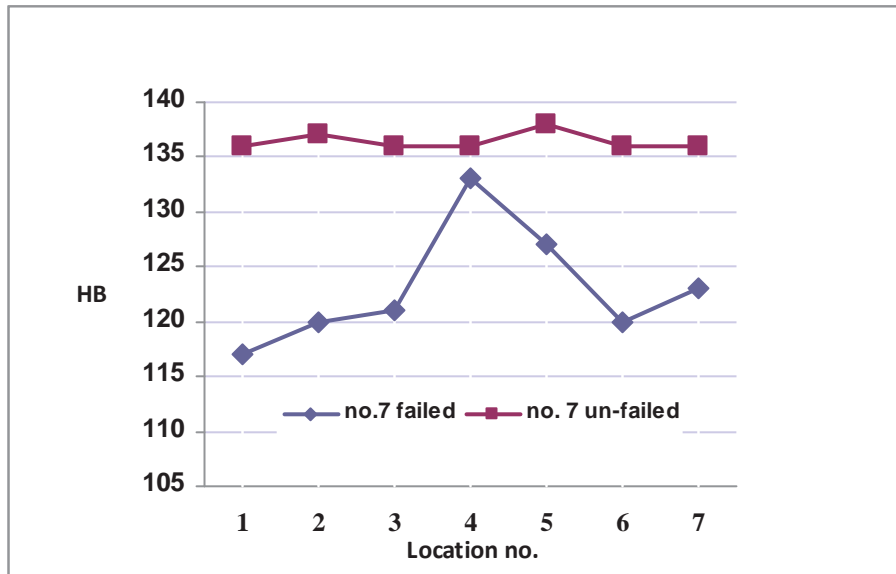
It is clear from both figures down that a noticeable difference between the failed and un-failed hardness results. In **figure (9)**, pipe no.7 in coil 48 shows a distinct difference in hardness numbers, gave a clear picture about what is going on in this pipe. The first indication put that, a softening phenomenon has occurred clearly in this failed pipe. Furthermore the swinging of hardness numbers

and their drops in comparison with the un-failed pipe gives an indication that, the pipe has subjected to an overheating during its operation.

Figure (9): Comparison between hardness results of failed and un-failed pipe no. 7/coil no.48

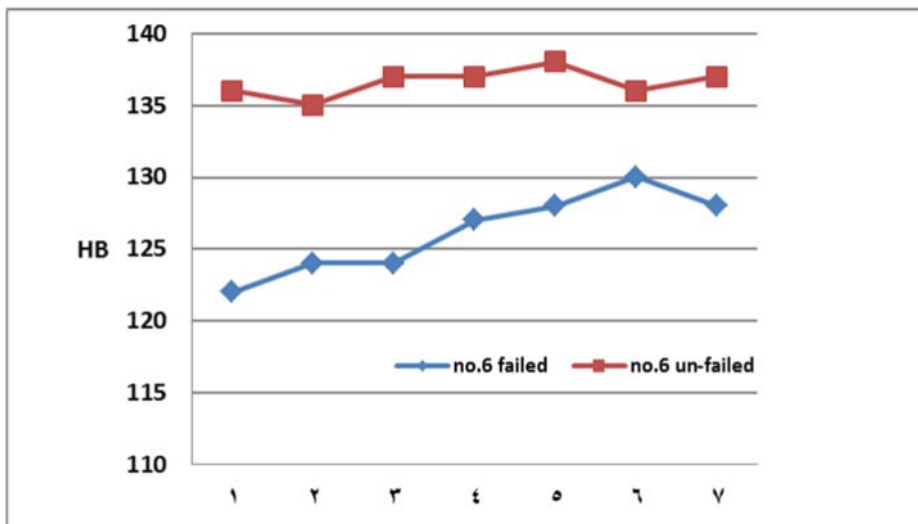
Figure (10): Comparison between hardness results of failed and un-failed pipe no. 6/coil no.93
