# Negligence of geological Investigations site leading to slope failure incidents: a case study from Saih Al Ahmar in Bidbid, Northern Oman

Talal Al-Hosni\* and Sobhi Nasir

Department of Earth Sciences, College of Science, Sultan Qaboos University, P.O. Box 36, Al-Khod, PC 123, Muscat, Sultanate of Oman, \*Email: hosni@squ.edu.om.

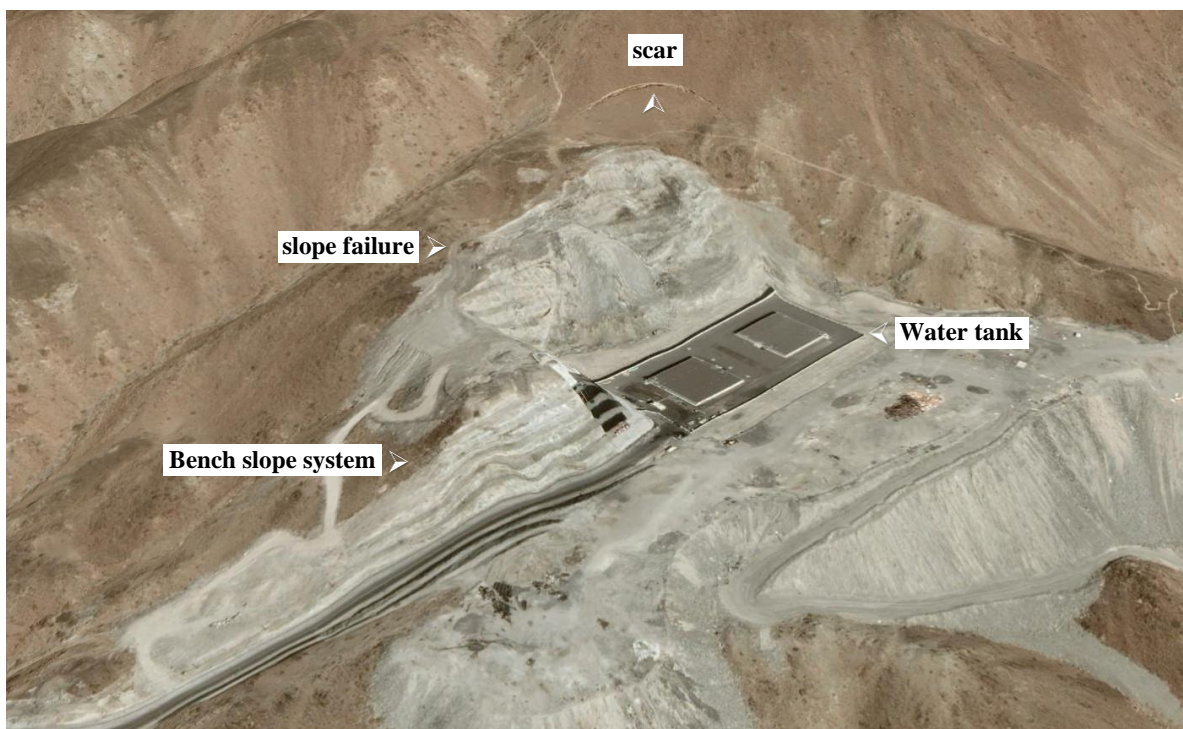
The landslide area lies around GPS UTM 40Q: 614650 m E, 2596623 m N (Figure 2). The Saih Al Ahmar water tank area in Bidbid traverses a geologically complex part of the Samail Ophiolite, where the topography of the ophiolitic rock sequence is characterized by steep slopes of 50-60°. The area is dissected by seasonal watercourses of wadis following the major fractures and forming the drainage pattern in the area.

**Figure 2.** Landsat Google image (20 Mar 2021) showing the water tank and slope failure above it.

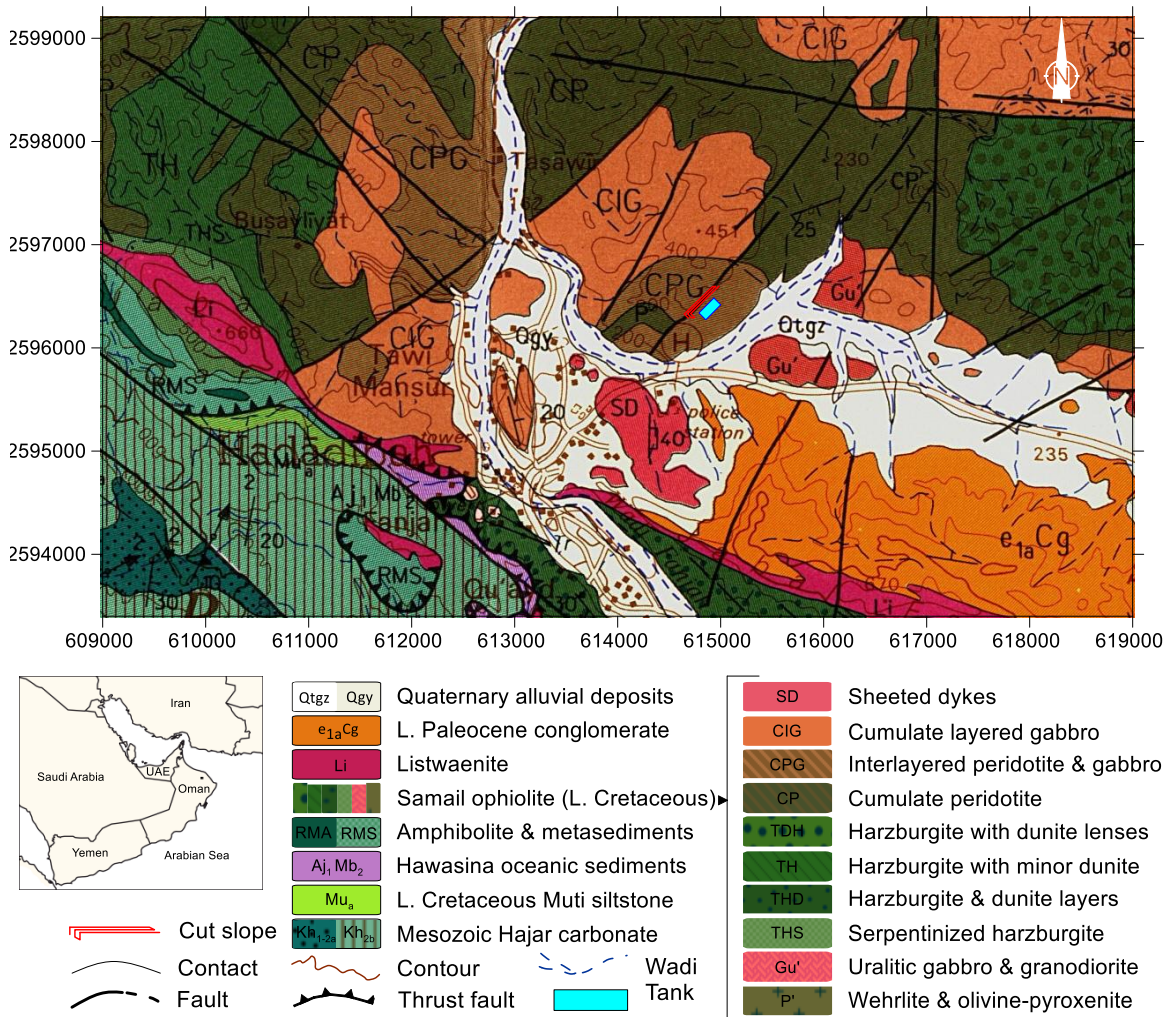
Figure 3. Geological map after Villey *et al.* (1986) to show the location of the slope failure and the geology of Saih Al Ahmar (Bidbid, Northern Oman) [19].

The landslide area is characterized by northwest-trending mountain ranges and NW and NE wadis (valleys) bounded by many NE, EW and NW faults (Figure 3). Viewing the failed slope from above (Figure 6), there is evidence of significant displacement at the back scarp with both loss of level and forward displacement on the scale of meters on the low side of the scarp. Tension cracks or dilated rock joints showing similar trends to the line of the back-scarp are located at levels higher than the back-scarp. A fault zone passing into the failed slope can be observed on the collapsed area and is apparently expressed as a series of tension cracks running across the failed area. There are blocks of rock mass that have rotated outwards from the slope within the vicinity of the tension cracks. A central portion of the failed area where the bench and berms have failed has been replaced with a slope of rock scree and disintegrated rock mass. At its maximum extent, the rock scree nearly extends to the face of the rock cutting. The amount of displacement on the back-scarp varies, ranging from around 0.2 to 3 m. The overall impression from the surveys is that a large-scale deep-seated failure surface or zone had formed within the hillside. The major orientations of induced fractures are N-NW and N-NE and they extend clearly across the area and within the slope above the water tank.

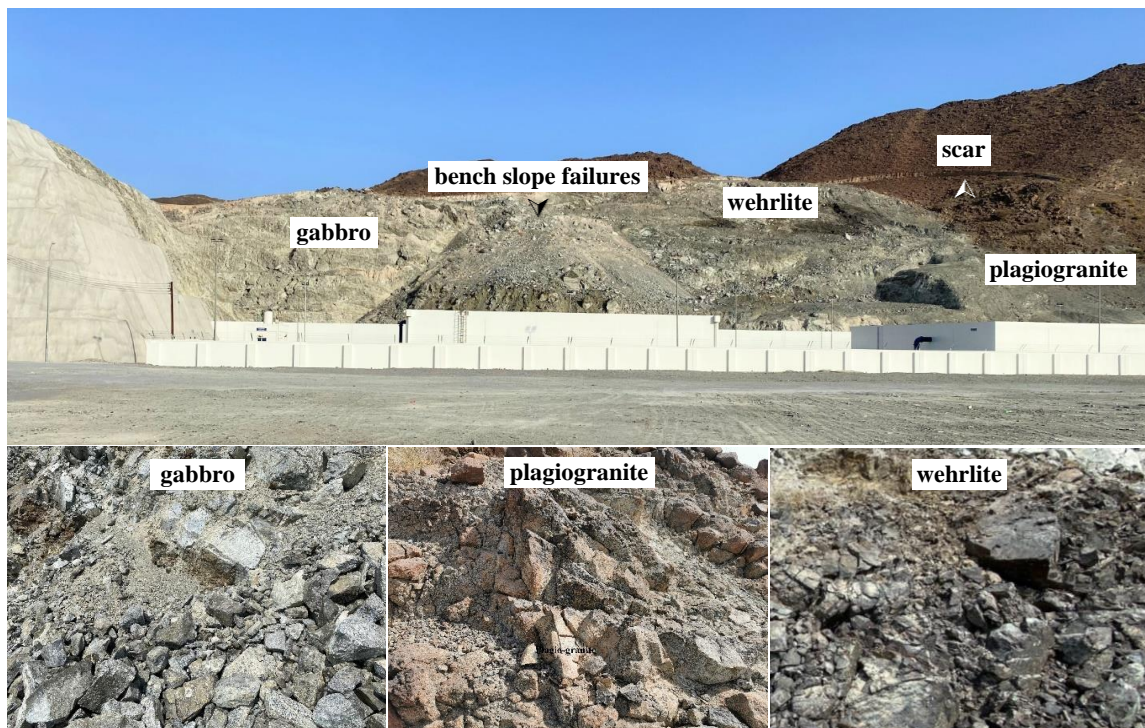
Based on the geologic mapping on the excavated slopes, the corresponding rock masses are classified into two main groups (Figure 4): - Group 1) Slightly weathered and highly fractured, highly jointed, moderately strong to strong gabbro and plagiogranite, and Group 2) Highly weathered and fractured, very weak to weak peridotite rocks (harzburgite, dunite and wehrlite). The rock strength (UCS) is 100 to 140 MPa for group 1 and 35 to 80 MPa for group 2 (Figure 5 and Table 1). The Schmidt Rebound Hardness test found values varying between 47 to 60 for rocks of group 1, and 14 to 35 for rocks of group 2. The low values of the UCS and Schmidt rebound hardness of group 2 rocks indicate poor surface conditions (Figure 5). The compressive strength values of rocks from group 1 (Gabbro) is relatively high, but these rocks are highly fractured and highly jointed in the field.

**Figure 4.** The excavated slopes are made of weak peridotite rocks (harzburgite, dunite and wehrlite) and strong gabbro and plagiogranite.

The area traverses a sequence of highly deformed gabbro underlain by highly weathered and serpentinized peridotites (dunite, wehrlite and Harzburgite) of the Samail ophiolite (Figure 4). The movement was facilitated by the varying shear strengths of different rock masses in contact with each other, mainly along the contacts between the harzburgite, wehrlite, plagiogranite and the gabbro. The Gabbro rests on the soft peridotite that becomes highly plastic when serpentinized. This plasticity increases the possibility of slippage, which is multiplied by the gravitation forces along the steeply dipping planes and contact zones between different lithologies, which do not bond well. Serpentinized peridotite rocks are present along the fracture surface of the rock formation and may have acted as a lubricant and greatly enhanced the slope slide. The weak harzburgite and wehrlite within the slope would have

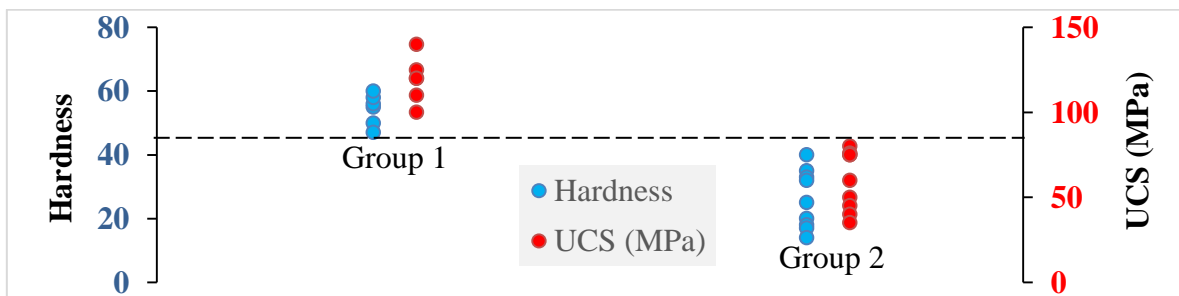
**Figure 5.** High values of the uniaxial compressive strength (UCS) and Schmidt rebound hardness for rocks of group 1 (gabbro) compared to that of group 2 (peridotite).

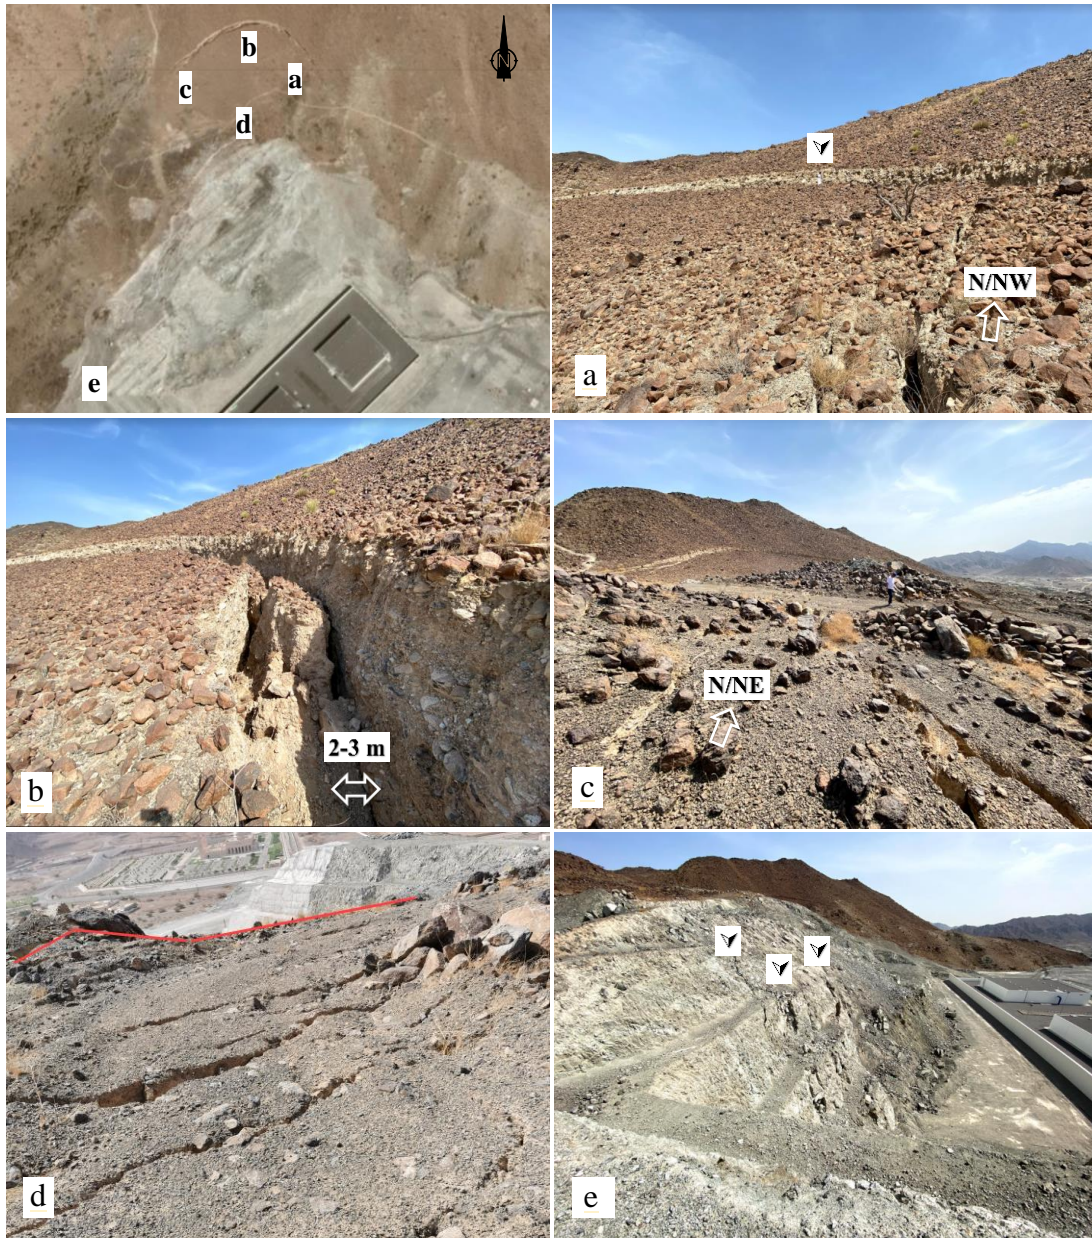
The collapsed cut slope occurs at an elevation of 71 m above tank level, and the equivalent slope angle is 50 to 70° for the excavated slopes. The height of the mountain is 388 m above sea level. The major orientation of the failure surface is undulated with strike orientation ranges between 330° and 355° and between 020° and 040° dipping very steeply towards the south and southwest. This landslide is rotational as the surface of rupture is curved concavely upward (Figure 6).

**Figure 6.** The surface of rupture is curved concavely upward (a), the vertical displacement is 1.8m in the center decreasing towards the sides (b), while the horizontal displacement is up to 3m (b) and the major orientations of induced fractures are  $330^{\circ}$  to  $355^{\circ}$  (N/NW) and  $020^{\circ}$  to  $040^{\circ}$  (N/NE) (a and c). The fractures extend clearly with the slope above the tank area (d and e).

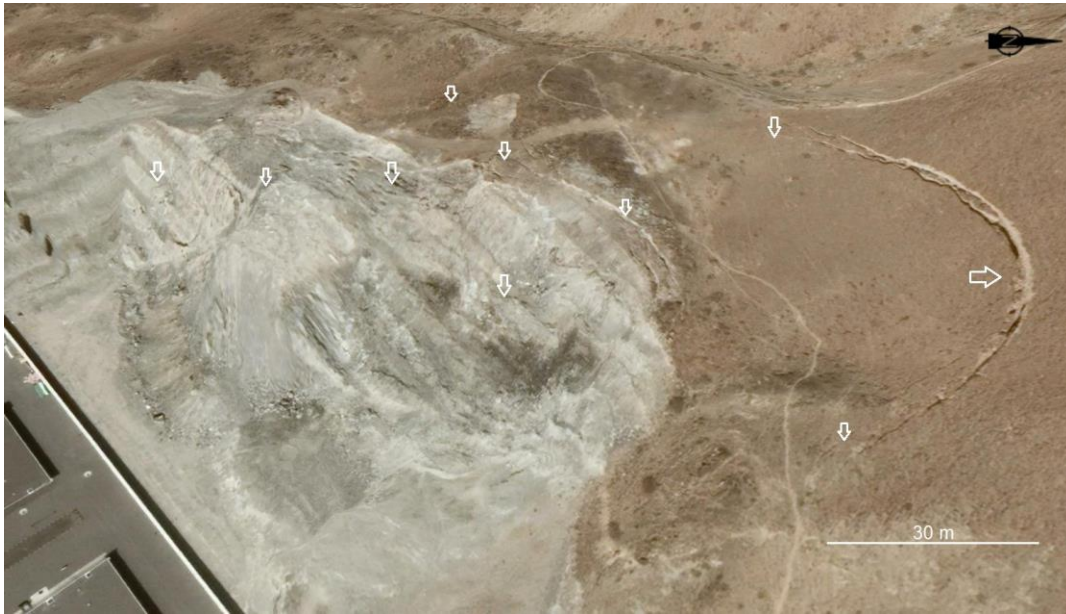
**Figure 7.** Collapse of benches initiating large fractures parallel to the main slide area.

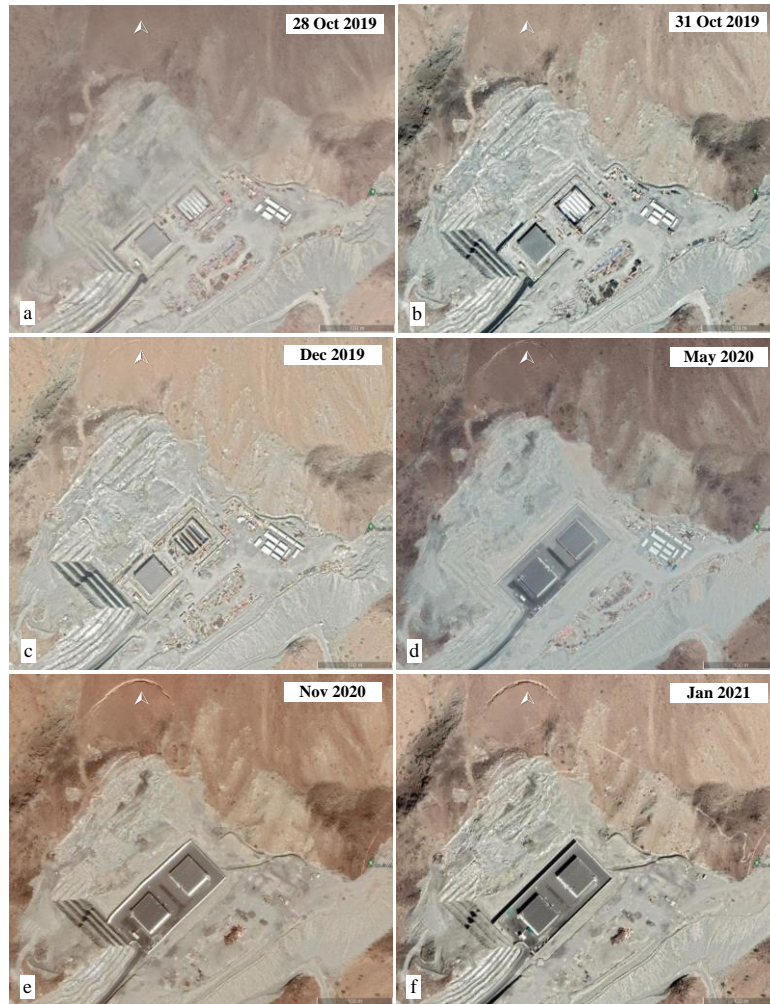
Google satellite images show that slope failure started between 28 and 31 October 2019 as a result of major slope excavation and removal of the toe support for constructing the water tank area (Figure 8). Upon approaching the failed section, the cut benches and berm lines show a convergence, resulting from the forward displacement of the failed slope. For this region, the sense of slip movement is estimated as south to southeast. In comparing the imagery pre- and post-failure, it is found that certain key characteristic features on the berms as detected on the 2019-2021 imagery had displaced downslope by distances of 0.2 to 3 m. The images of 2021 (Figures 7 and 8) show more clearly the surface of the tension cracks and many features that trend in the same fashion as fractures and joint set, indicating that there are likely to be many planes of weakness parallel to the fault zone running through the failed slope. There are also other surface cracks that are trending nearly perpendicular to the slope.

**Figure 8.** Satellite images (a-f) show that slope failure started between 28 and 31 October 2019 (a and b) as a result of major slope excavation and removal of the toe support in order to construct the tank.
