Impacts on water transport networks after three widespread volcanic ashfalls in Andean Patagonian lakes

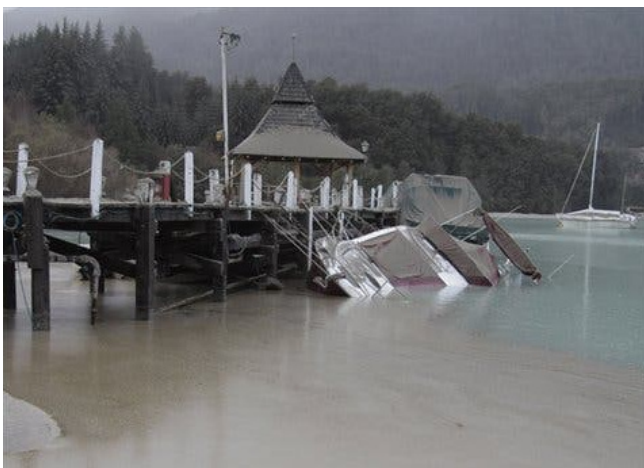
Figure 4: Example of a heeled-over secondary passenger ship, moored at Bahía Manzano (northwestern Lago Nahuel Huapi) after the 2011–2012 Cordón Caulle volcanic eruption. Photo courtesy of Carlos Tavalla.

Moderate and uneven loads associated with heavy ashfall deposition (Table 3A–3C) have been observed to tilt, pitch, and heave various berthed ships in Patagonia, causing the breakage of moorings. However, the capsizing of ships as large as primary passenger ships was possibly the most striking consequence for shipping of explosive volcanic eruptions in the region (e.g. Figure 4).

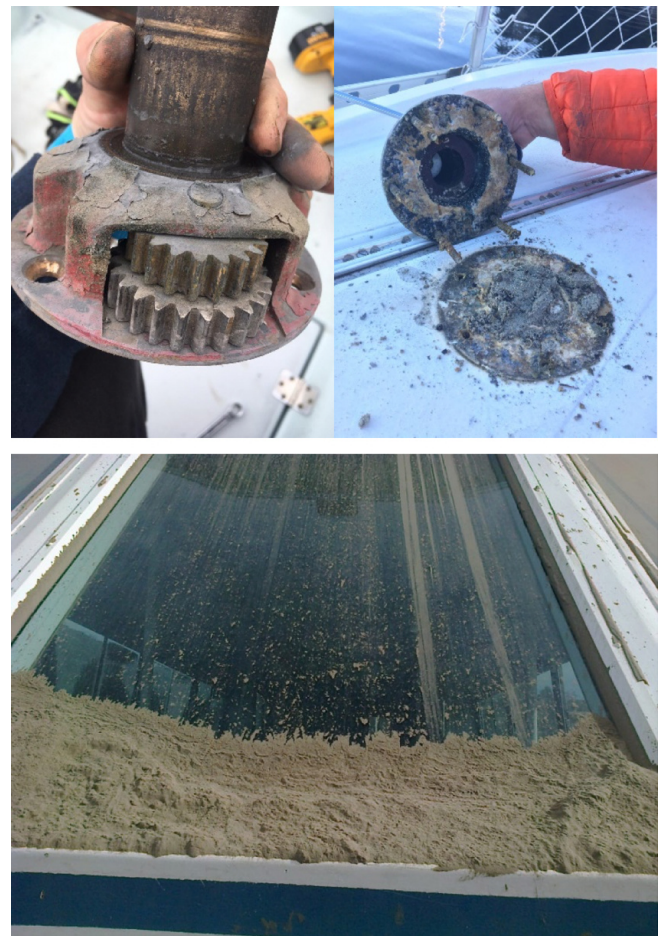
Volcanic ash can cause different types of deterioration on decks, and damage any uncovered equipment exposed to airborne ash and/or ash deposition (e.g. Figure 5).

Figure 5: At the top, effects of volcanic ash on motor-sailors at *Club Náutico Bariloche* (*Lago Nahuel Huapi*) after 2011–2012 *Cordón Caulle* volcanic eruption. Photos courtesy of *Club Náutico Bariloche*. Below, deep abrasion on the *Catamarán José Julián* wind glasses, in *Puerto Canoa* (*Lago Huechulafquen*), requiring full replacement after the 2015 Calbuco volcanic eruption. Photo courtesy of *Catamarán José Julián*.

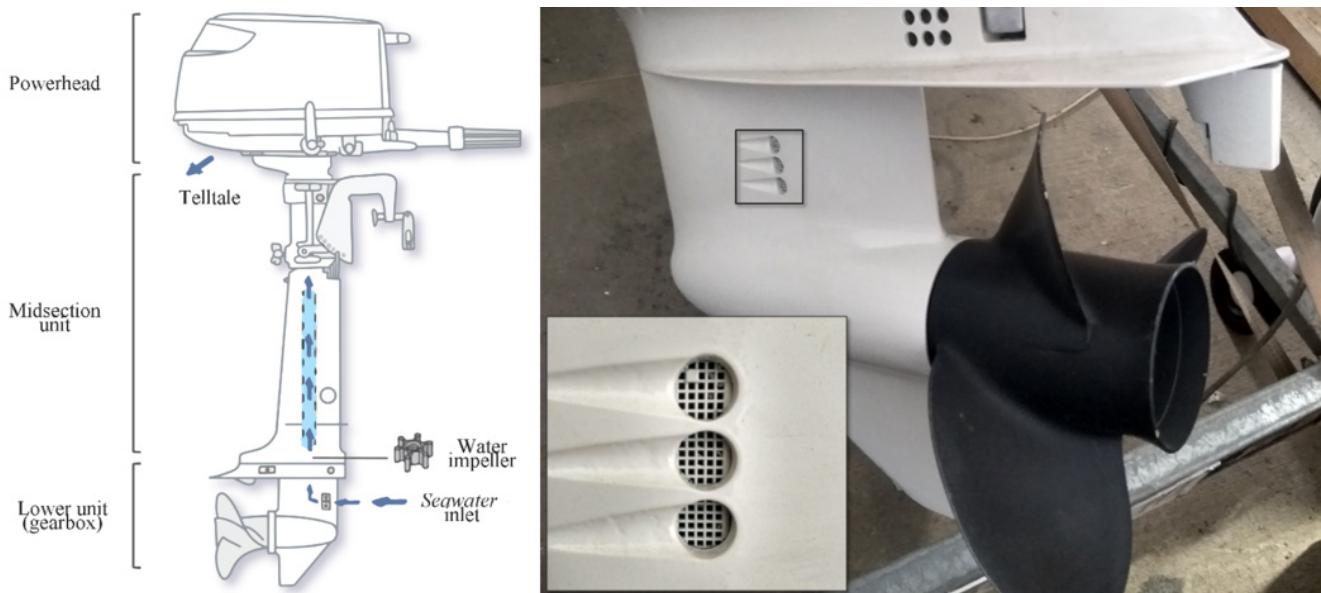
Waterborne ash can easily affect cooling systems at multiple system stages. Coarse fragments have been observed to clog seawater inlets, impeding water entrances (Figure 6), while smaller fragments can skip regular outer filters, or even extra pre-filters installed at water intakes (Section 5), and clog the inner stages of the cooling system. In larger primary passenger ships, thin pumice fragments have largely clogged inner regular and extra (Section 5) water strainers and have been observed blocking radiators and the thinner piping that constitute larger and more sophisticated systems, more laborious to clear and repair (Figure 7). Abrasive fragments had also damaged internal components in the cooling system, such as pump impellers, requiring replacement.

Figure 6: To the left, a schematic diagram of an outboard engine, illustrating the seawater circulation pattern through the cooling system. To the right, pumice fragments stuck in the seawater inlet in the “*Tsunami*” ship’s outboard engine, after a field trip (in northwestern *Lago Nahuel Huapi*) held in October 2021, a decade after the 2011–2012 Cordón Caulle volcanic eruption).

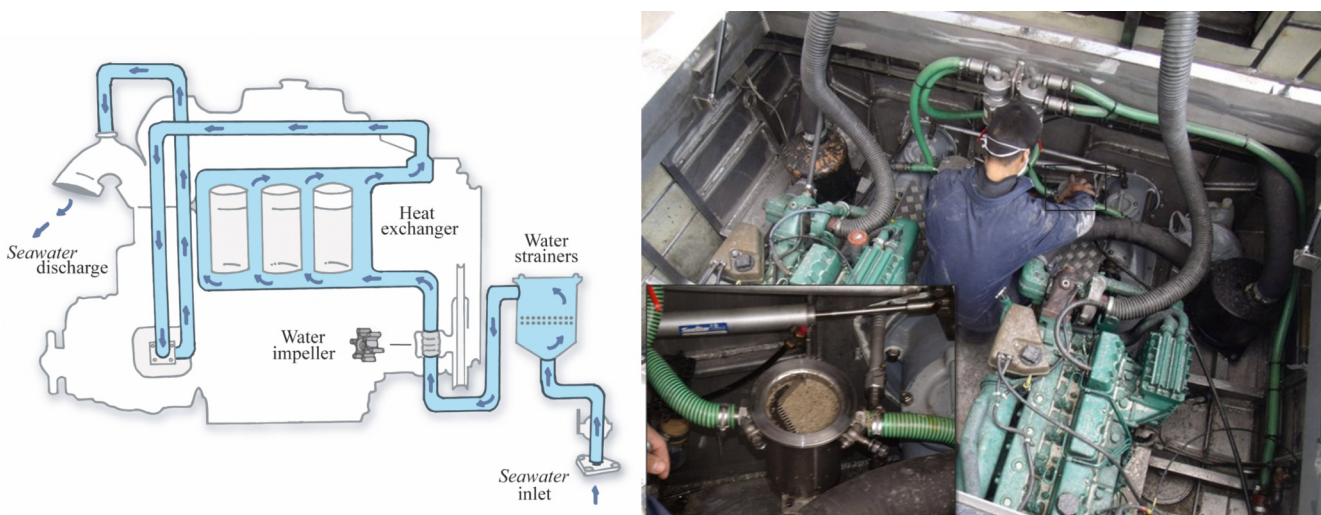
Figure 7: To the left, a schematic diagram of a marine diesel engine, illustrating the seawater circulation pattern through an open cooling system. To the right, manual clearances of pumice from clogged strainers in a primary passenger ship at *Puerto Pañuelo* (*Lago Nahuel Huapi*) during the 2011–2012 Cordón Caulle volcanic eruption. Photo courtesy of Martín Pereira.

Many improvised measures were used by ship managers to avoid clogging of the engines' cooling systems. The usage of pre-filters at water intakes, such as rudimentary mesh filters, or additional inner strainers installed in larger ships, proved to be a very effective strategy to prevent blockages and damage to the engine, although not infallible. For larger ships, sailing at limited speeds was tested to allow the proper performance of extra filters. However, inadequate cooling due to low rates of *seawater* flow causes significant reductions in the lifespan of numerous engine components, leading to irreversible damage. The possibility to bypass parallel cooling circuits, allowing seafarers to clean one clogged strainer while the other remained in function, represented traits of resilience for larger ships while navigating through ash-contaminated waters, without the need to stop cooling. For smaller outboard motors, the stream of water flowing from the telltale ([Figure 6](#)) was used to visually monitor an adequate rate of cooling water flow, with relative success. The deeper *seawater* inlets on outboard motors appeared to confer resilience to the effects of pumice rafts [[Salgado et al. 2022](#)]. It is important to note that no additional filtration can be installed in waterjets because of the extremely high water flow they require.

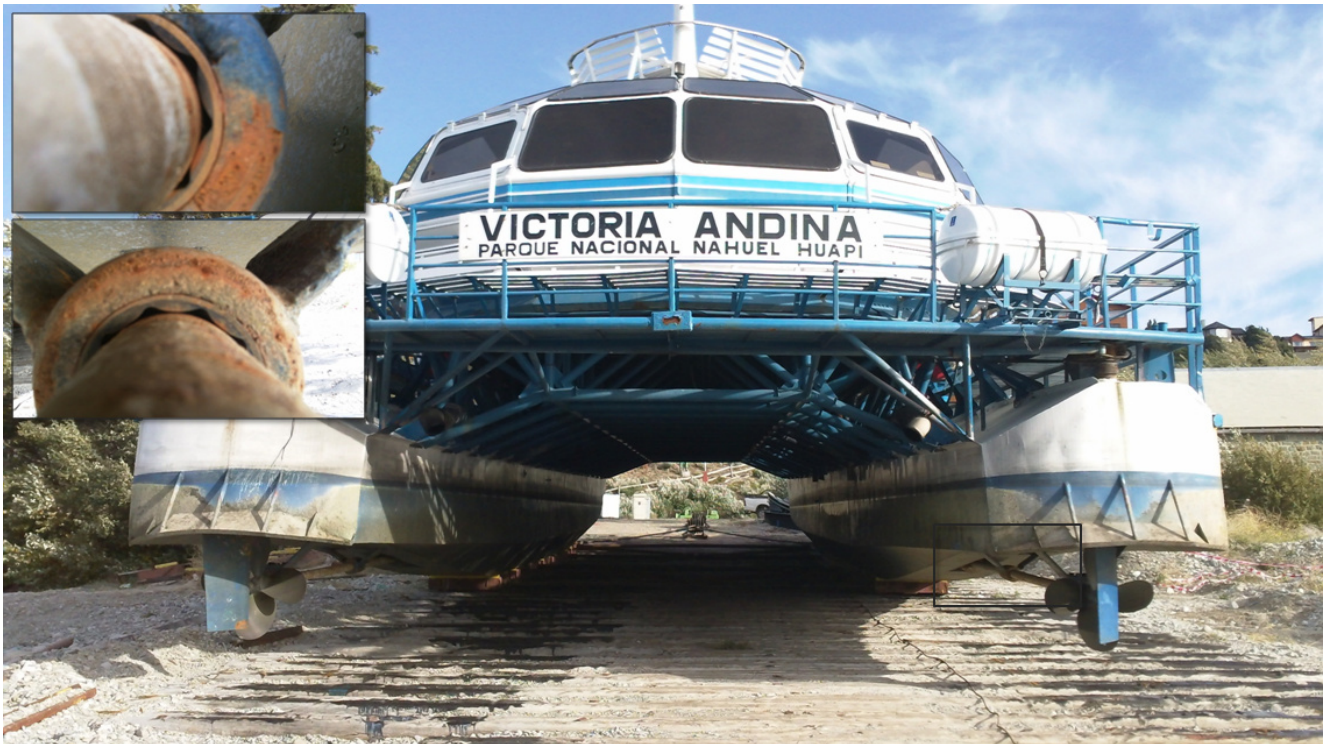
Figure 8: Detail image of corroded bearing-supports and worn rubber bearing-pads that carry the submerged tail shafts in the *Catamarán Victoria Andina*, identified in dry docks during 2012. Photos courtesy of Martín Pereira.

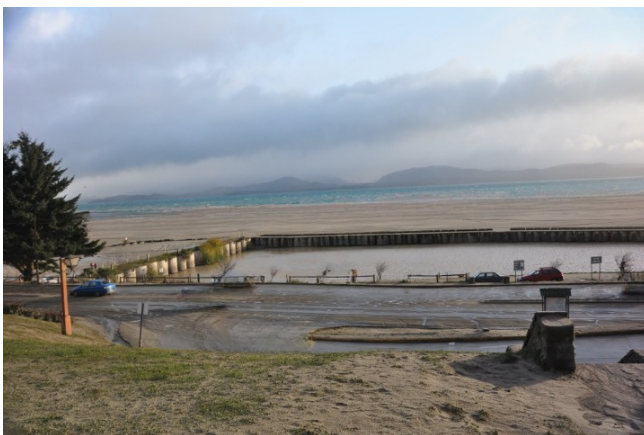
Figure 9: Massive pumice rafts generated after the 2011–2012 volcanic eruption entering the inner basin of Puerto San Carlos in Bariloche (*Lago Nahuel Huapi*).

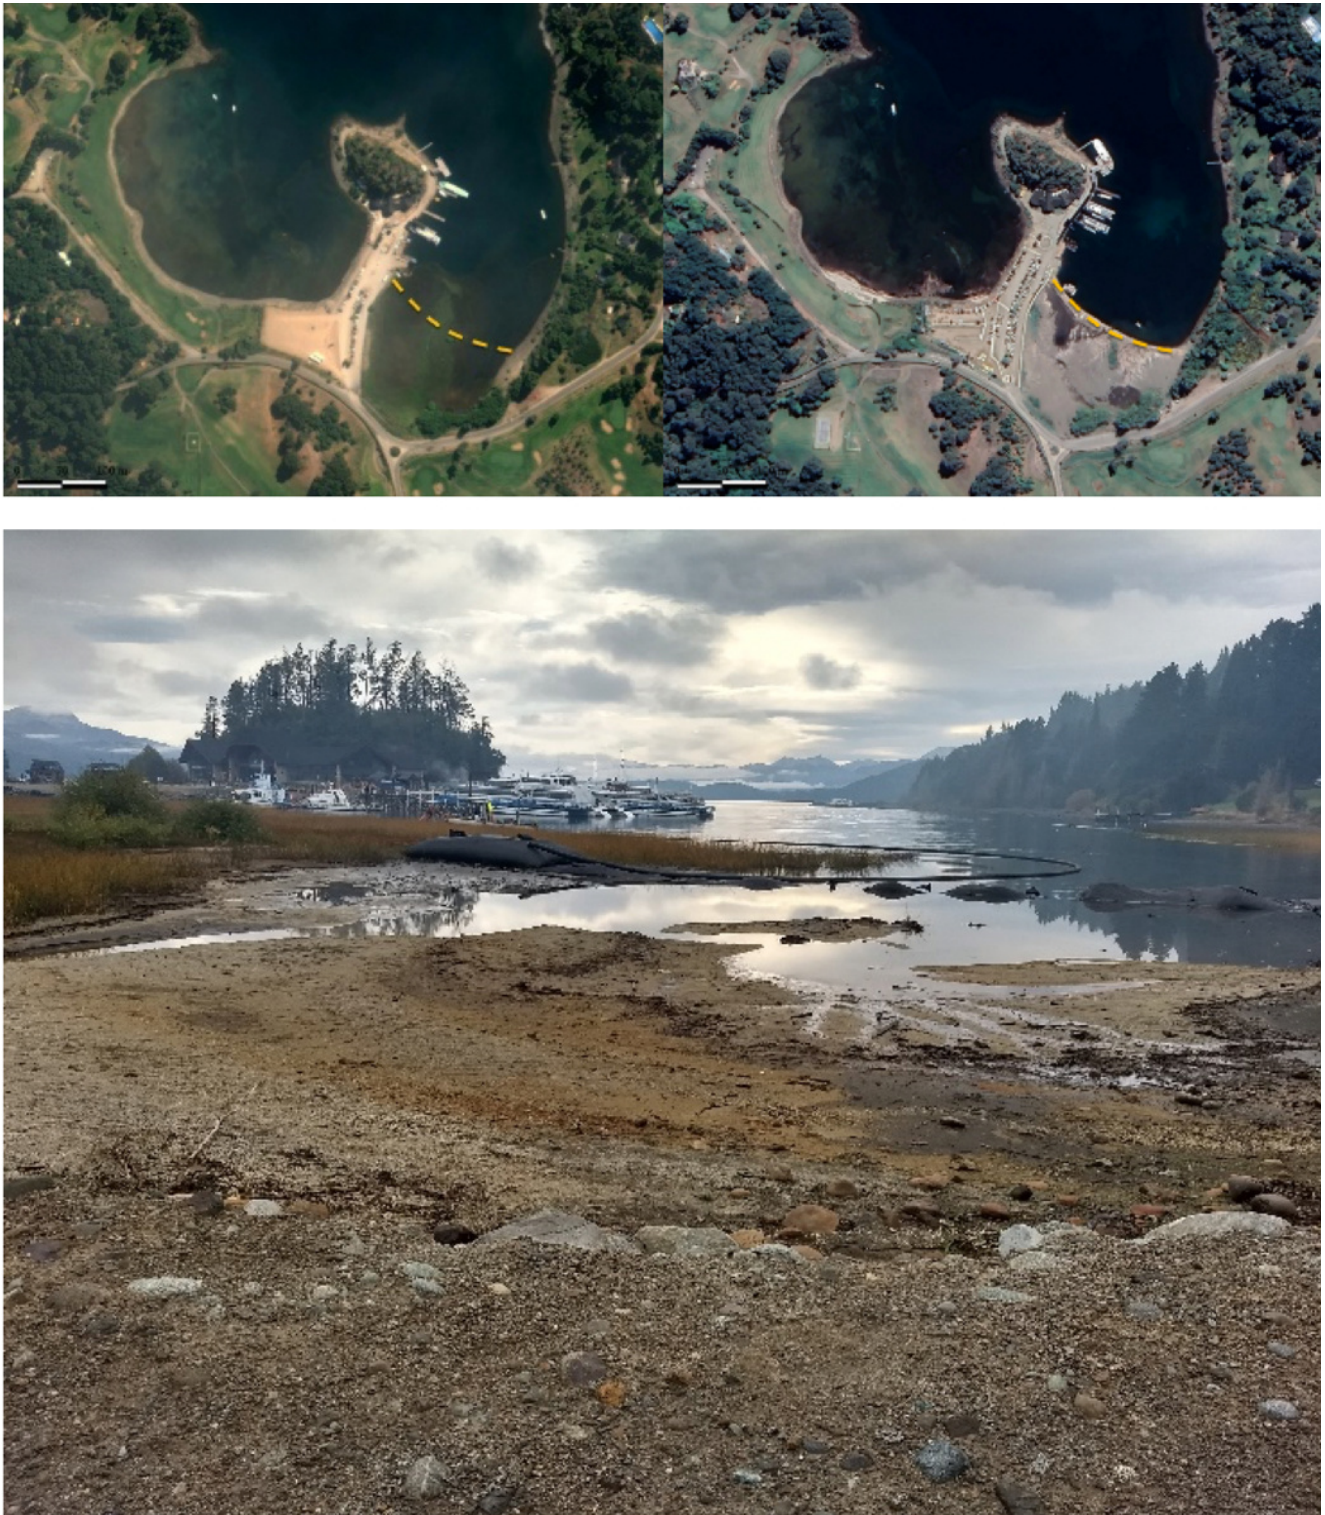
Figure 10: Aerial view of *Puerto Pañuelo*, before the volcanic eruption (February 2011) at the top left; and ten years later (November 2021) at the top right. The dashed line indicates the position of the gabion wall constructed to retain tephra dredged from the bay since 2011. Below, dredging works in *Puerto Pañuelo*, many years after the 2011–2012 volcanic eruption, still removing great amounts of settled tephra from the inner basin (May 2019).

plementary Material 1) only partially fulfilled their intended function of diverting pumice rafts to the spillway, in the weeks following the primary ashfall. Conversely, a shorter barrier intermittently set up at *Club Náutico Bariloche* (Section S2.3, Supplementary Material 1) between the harbor's breakwater and the shoreline's revetment was considered widely successful in avoiding the entrance of pumice rafts to the bay when the wind blew occasionally from the east (Figure 9). In all these three cases, great accumulations of settled ash on the ports' sea-side domain required laborious and expensive dredging work for managing water-depth and remobilization issues. The input of waterborne ash into harbors can endure even decades after the primary ashfall event (related to the drifting and sinking of pumice rafts, fluvial discharges, shoreline processes, etc.), which prolongs the need for remediation and increases the demand of more intricate works. In *Puerto Pañuelo*, remediation works entailed the construction of a gabion wall to retain the bulk of volcanic ash dredged from the harbor and hurled to the beach, avoiding re-entry into the water (Figure 10).

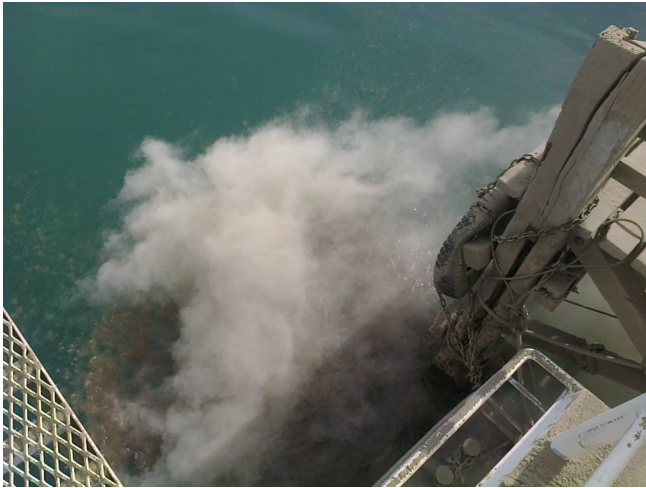
Figure 11: Remobilization of subaqueous ash deposits at *Puerto Canoa* (*Lago Huechulafquen*) by action of the *Catamarán José Julián* propellers, many months after the 2015 Calbuco volcanic eruption.

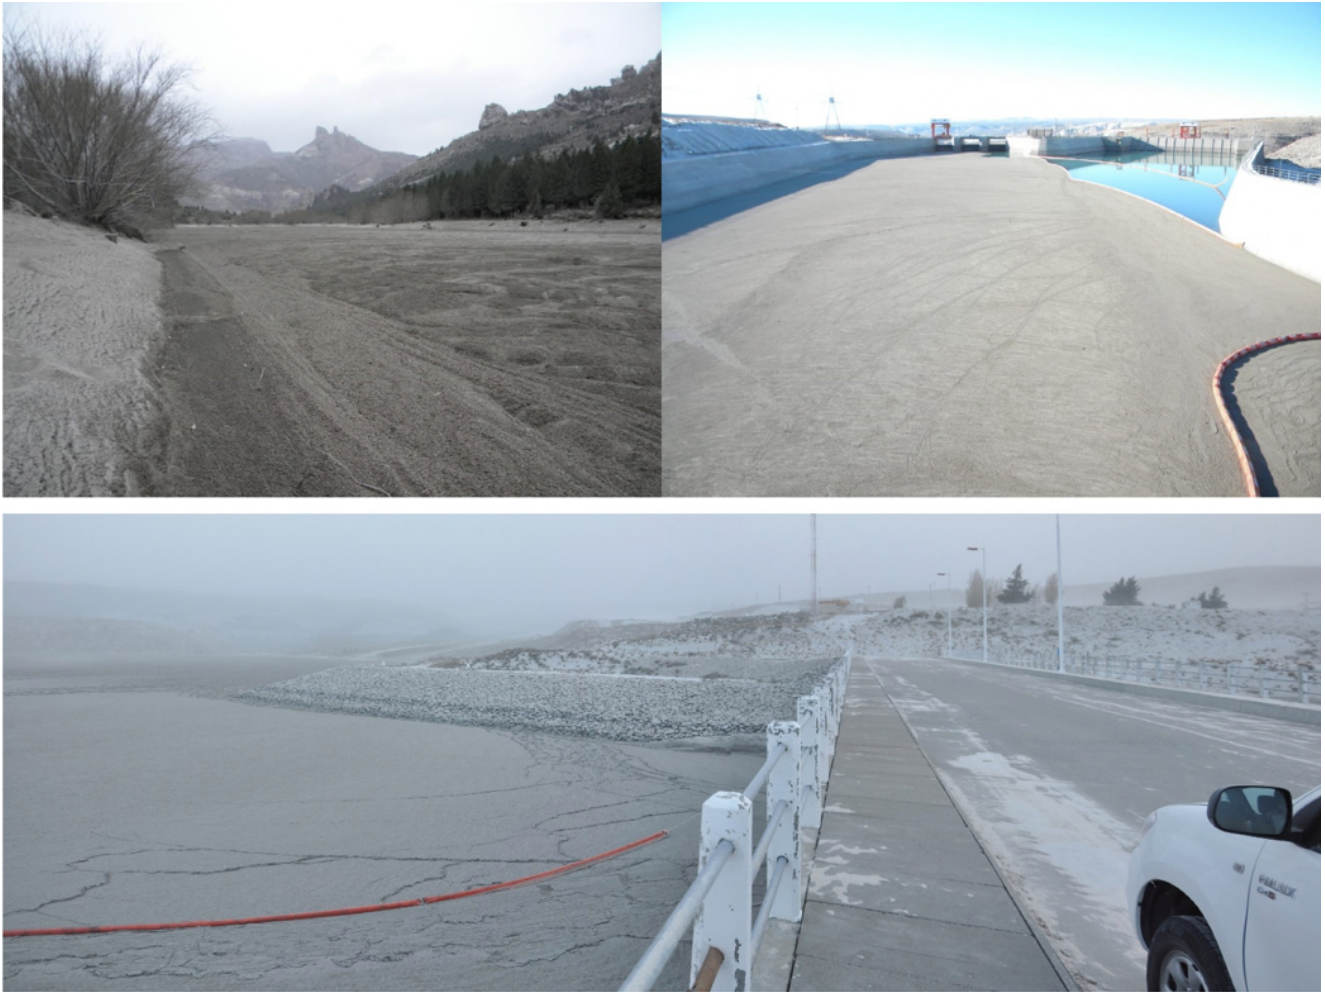
ivers, affecting downstream waterways and infrastructure. During the 2011–2012 Cordón Caulle volcanic eruption, large masses of floating pumice drifted along the *Río Limay* (Section S2.4, [Supplementary Material 1](#)), the single outflow from *Lago Nahuel Huapi*, reaching the 1.050 MW *Alicurá* power dam,

where pumice raft thicknesses of over 40 cm were measured ([Figure 12](#)).

Figure 12: Drafting of floating pumice down the *Río Limay* during the 2011–2012 Cordon Caulle volcanic eruption, and lines of floating barriers attempting to halt and divert away pumice rafts close to the *Alicurá* power dam during the first days of the eruption (below) and the following weeks (at the top right).

Entries of pumice rafts into harbors and other critical sites can be partially halted using *booms*, containment lines of floaters similar to those deployed for oil spills (e.g. [Figure 12](#)). In Patagonia, the setup of these barriers evinced inconsistent results. In *Puerto Pañuelo* for example (Section S2.3, [Supplementary Material 1](#)), booms proved inadequate for halting the ingress of immense volumes of pumice rafts dragged by winds straight into the natural open harbor. Meanwhile, several barriers installed at the *Alicurá* dam (Section S2.4, [Sup-](#)

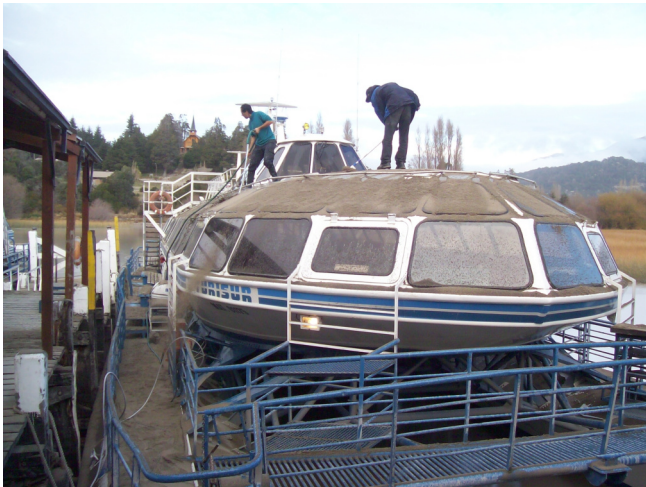
Figure 13: Volcanic ash clean-up in Puerto Pañuelo (Lago Nahuel Huapi), and thin coating of floating pumice developed in-situ in the background (05/06/2011). Photo courtesy of Martín Pereira.

In all cases, even the smallest accumulations of ash on ships and ports required complete removal before resuming full operational capacity (Table 3A–3C). In Patagonia, various clean-up methods have been used, depending on the amount of ash fallen, the characteristics of the ash (as in some cases, wet deposits became cementitious and hard to remove), the type of asset affected, and the availability of clean-up resources. The different strategies undertaken ranged in complexity from coordinated operations, combining dry (shovels, brooms, cloths, vacuums) and wet methods (ballast or bilge pumps, firefighting systems from port sites, or the same ships) (e.g Figure 13), to instances where the wind and rain themselves were allowed to clear ash from ships (mainly in cases of negligible ash-fall) and ports (mainly in remote or difficult-to-access sites). The clearance of large accumulations of ash proved essential in avoiding the effects of ash-loadings on the ships, also extenuating rot and abrasive and corrosive damage to decks and halting the ingress of fine ash into the ship interiors. In such cases, volcanic ash required careful clean-up (including vacuums, low-pressure compressed air, and dry and damp cloths) before resuming activities to avoid damage to frail elec-
