AN INVESTIGATION OF CORROSION OF FRICTION WELDED AND POST-WELD HEAT-TREATED AA6061/SiC/GRAPHITE HYBRID COMPOSITES

KEYWORDS: Corrosion, aluminium, friction welding, PWHT, hybrid composite.

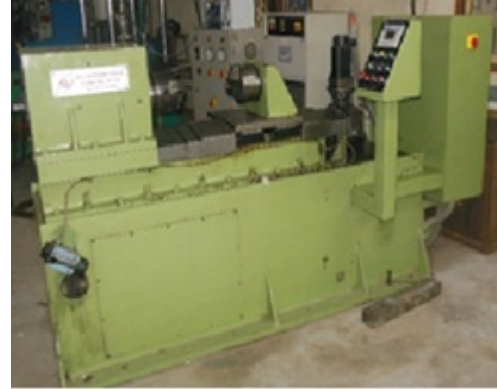
FIGURE 3. Friction welding machine.

The extruded specimens were joined in a continuous drive friction welding machine (model: SPM-FW-3T) as shown in Fig. 3. In this friction welding machine, clamping was done by a hydraulically controlled chuck. The machine was inbuilt with a data acquisition and analysis software. The maximum speed of the machine spindle was 2000 rpm. Friction welding was carried out at a rotational speed of 1600 rpm and an upset load of 3.5 kN for 3 seconds. In total, 32 joints were done and the friction welded joints are shown in Fig. 4. The Fig. 5 shows the As welded condition (AW) cov-

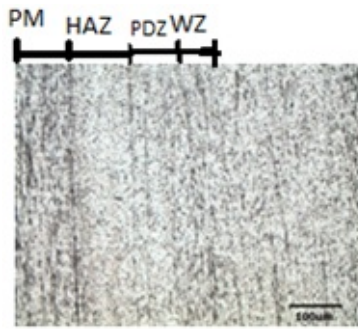
FIGURE 5. AW covering Parent metal, Heat affected Zone, Weld Zone.

ering Parent metal (PM), Heat affected Zone (HAZ) and Weld Zone (WZ).

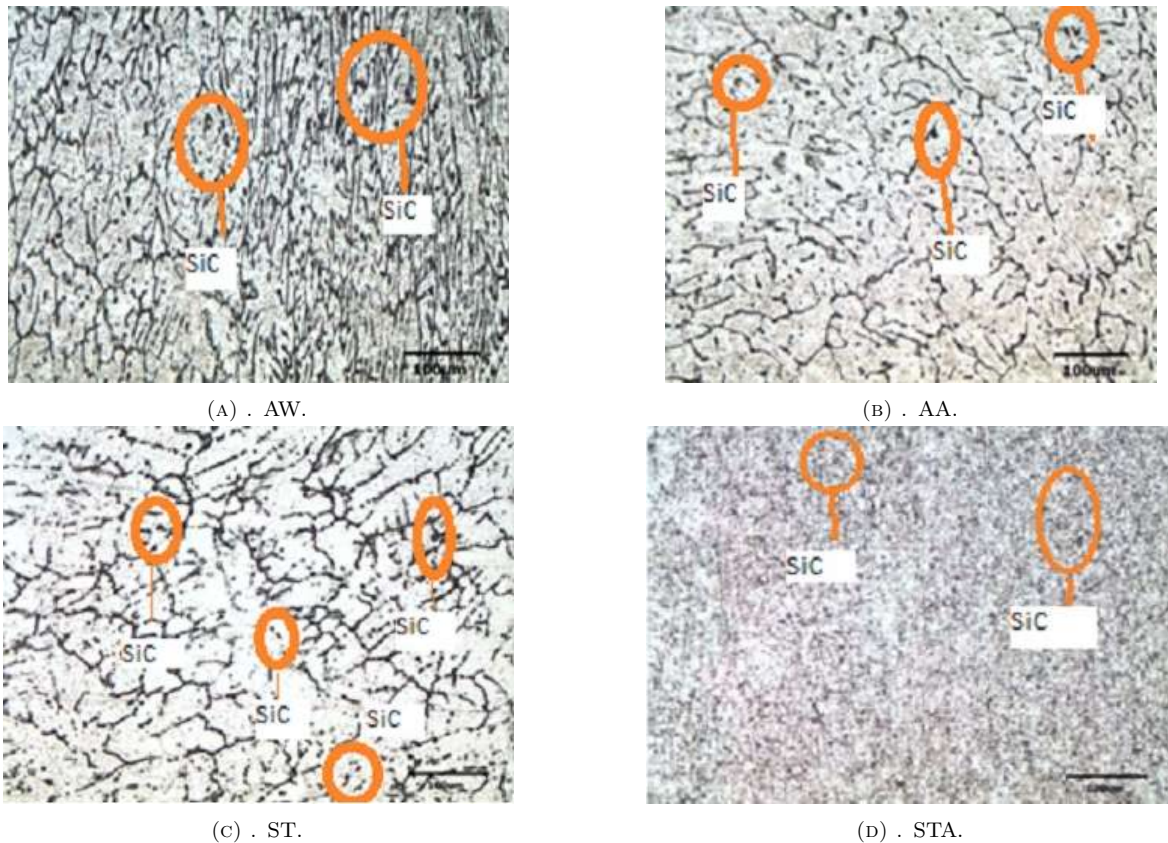
FIGURE 9. Microstructure of weld regions of the samples.

Fig. 9a shows the weld region of the AW sample. The weld region shows eutectic particles along with primary aluminium grains. The micro voids were present in the vicinity of grain boundaries. The grain structure seems to be coarse in this AW sample and the distribution of the reinforcement was also not uniform. The coarse grain structure can be attributed to the effect of severe heat generated during the friction welding process. Fig. 9b shows the weld region of the AA condition. The microstructure shows longer primary α -aluminium grains with eutectic particles. The agglomeration of Silicon carbide particles can be seen from the microstructural image. Due to the post-weld heat treatment process, the grain structure has been improved. Fig. 9c shows the microstructure of the weld region of the ST condition. The microstructure shows fine acicular primary α -aluminium with eutectic particles near the grain boundaries. A fine grain structure was visible. A uniform distribution of reinforcement particles can be seen from the microstructure.

Fig. 9d shows the microstructure of the weld region of the STA condition. The microstructure shows the primary aluminium grains with eutectic particles precipitated along the grain boundaries. The frictional stress during the friction welding process has produced a perpendicular re-orientation in the grain structure.

The grain boundary precipitates seem to be discontinuous and with large spacing between them. The homogenous distribution of reinforcement particles can be visualized from the microstructure. During the heat treatment process, the dissolution of secondary intermetallic precipitation took place and resulted in the formation of fine sub-microscopic particles in the structure. The precipitates expected to form from this alloy are Mg_2Si precipitates. The precipitate formation enhances the strength and corrosion resistance of the composite. Re-precipitation was observed to increase the hardness, while recrystallization of finer grains enhanced the strength.
