RESEARCH FOCUSED ON LOW CARBONATION OF CONCRETE UNDER OLD CEMENT-BASED RENDER

PETER PAULÍK^{a,*}, JAKUB GAŠPÁREK^a, MICHAL BAČUVČÍK^b, IVAN JANOTKA^b

^a Slovak University of Technology, Faculty of civil engineering, Department of concrete structures and bridges, Radlinského 2766/11, 810 05 Bratislava, Slovakia

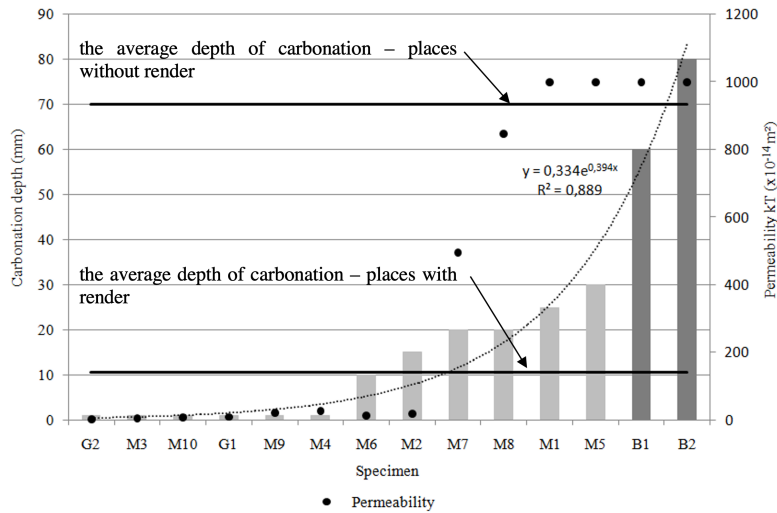
FIGURE 1. The results of in-situ measurements of the depth of carbonation and permeability at the Bridge in Sládkovičovo..

By this procedure, the carbonation depth was measured in-situ at all drilled core samples, which were then taken to the laboratory for further chemical analyses by the TG-DTA method. In-situ research showed a significant dependence between the depth of the carbonation of the underlying concrete and its permeability, which is primarily moderated by the protective render coat (PRC). The graphs in Figures 1 and 2 show this dependence. According to the quality of the PRC, it can be seen that increasing the permeability of the surface also increases the depth of carbonation. In the case of 100-year-old concrete, the

permeability is relatively high. If it is not protected by the PRC or this layer is considerably damaged, the carbonation reaches a considerable depth (dark bars of the diagrams). In contrast, if a 100-year-old concrete is protected by this layer (light bars in the diagrams), although this concrete has a high permeability, the PRC moderates the CO₂ ingress and the depth of carbonation.

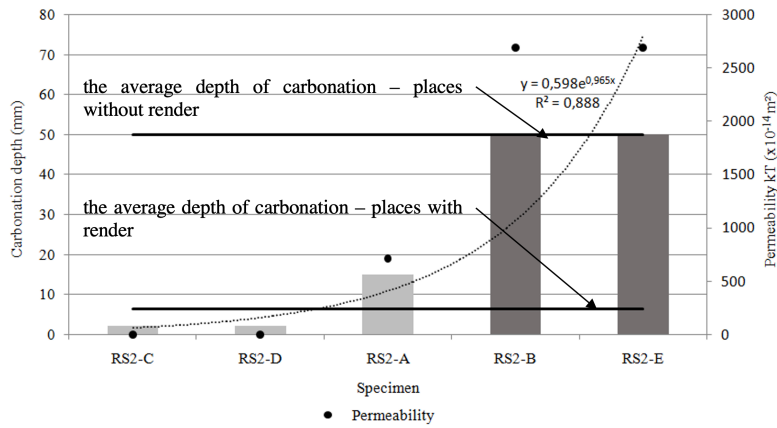
FIGURE 2. The results of in-situ measurements of the depth of carbonation and permeability at the Bridge in Sládkovičovo.

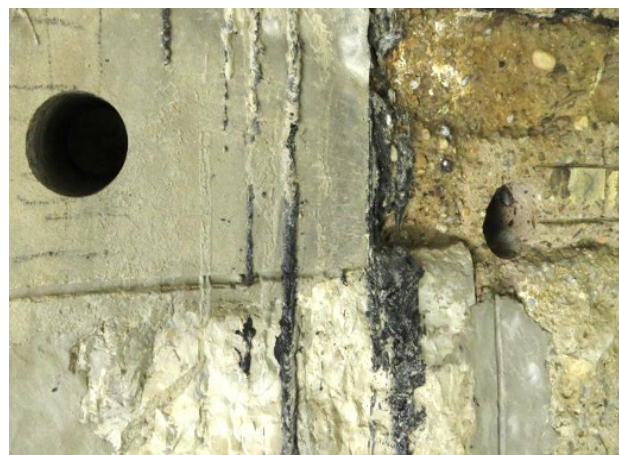
FIGURE 3. Places where drilled core samples were taken from the bridge abutment - on the left: the site with the protective render coat and on the right: the place where the render spalled over time (Bridge in Sládkovičovo).

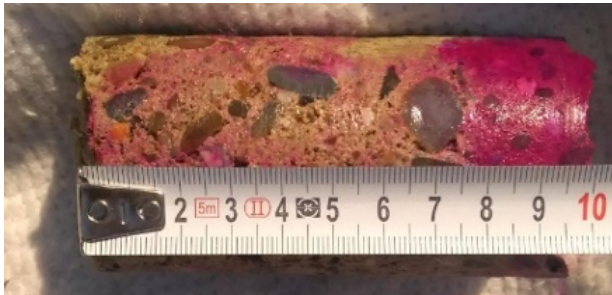
FIGURE 5. The carbonation depth of concrete at the places where the render was missing - sample selected from the measurements performed in 2018 (Bridge in Sládkovičovo).

It might be kept in mind that no chemical admixtures or additions were used at the manufacture of the PRC at the time of the bridge construction 100 years ago. It is stated that the observed low carbonation depth of underlying concrete can be explained by the protective effect of a thin cement render only, which is at some places almost non-permeable for CO₂. At the sites where the PRC was of good quality (Figures 4 and Figures 6), the carbonation of the underlying concrete was negligible (less than 2 mm). Even at the areas where the concrete was covered by a lower quality cement-based render, it had much lower carbonation depth than concrete at the places where the protective render coat spalled over time (Figures 5 and 7).

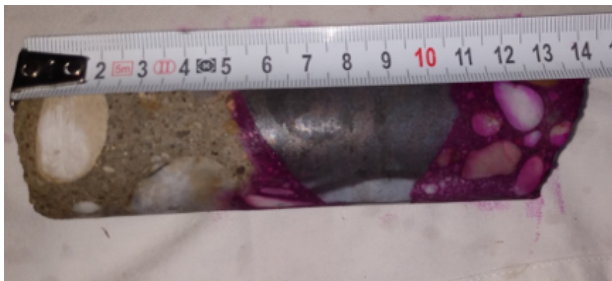
FIGURE 7. The carbonation depth of concrete at the places where this render was missing - sample selected from measurements performed in 2019 (Bridge in Rimavská Sobota).
