EXPERIMENTAL ANALYSIS OF THE RAILWAY TRUSS BRIDGE USING MODERN METHODS

KEYWORDS: Experimental analysis, digital image correlation, LVDT sensors, railway bridge.

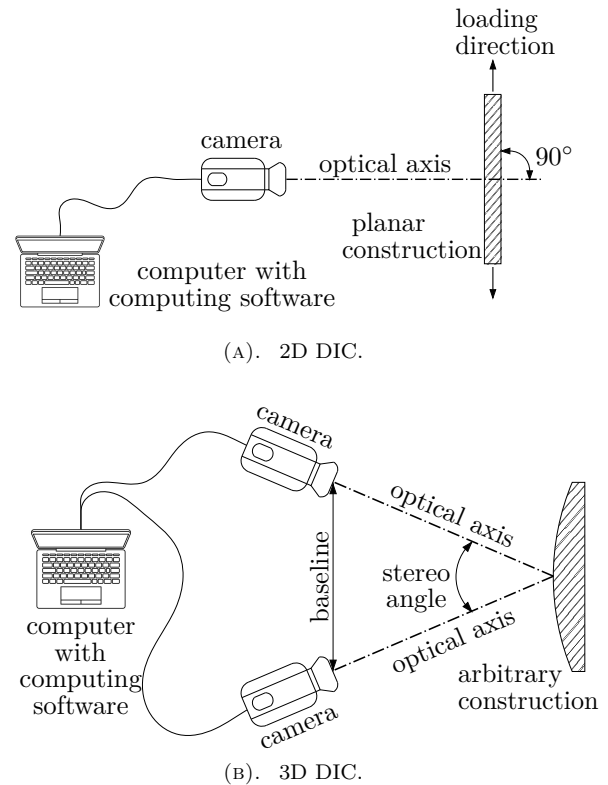
FIGURE 1. Experimental setup and necessary equipment for the DIC method – a camera and a computer with computing software.

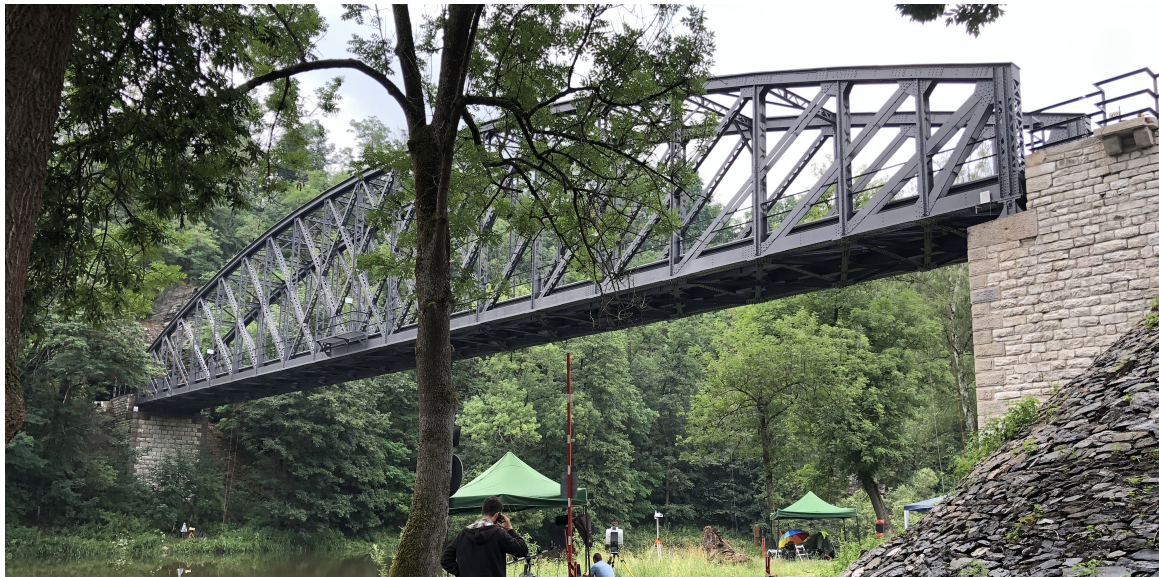
FIGURE 2. The historical railway bridge in Rataje nad Sázavou. The photo was taken during the second stage of the experiment.

A historical steel railway bridge in Rataje nad Sázavou is a part of railway line called “Posázavský Pacifik”. The railway line No. 212 runs from Čerčany to Světla nad Sázavou. On the way to Čerčany, there is a tunnel in close proximity to the bridge. On the other side of the bridge, there is a branch line No. 14 running to Kolín. The bridge crosses river Sázava and a private road. Figure 2 shows photo of the bridge taken in 2022.

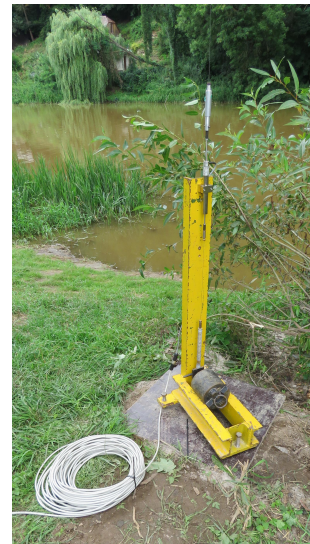
FIGURE 5. The real photo of the measuring system.

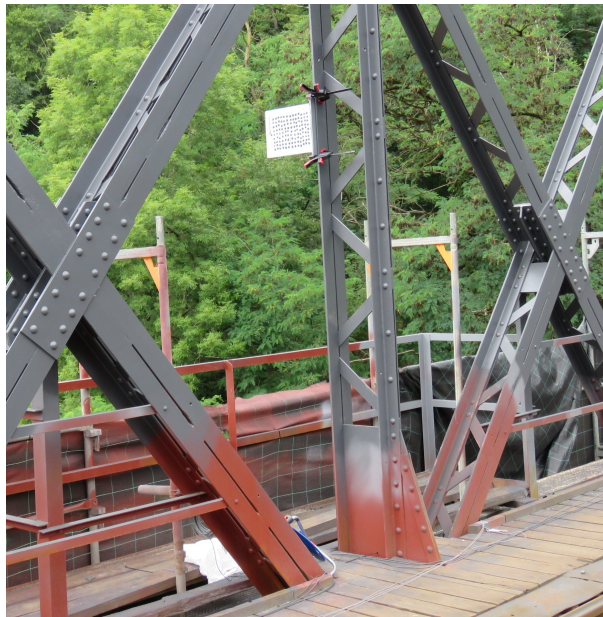
FIGURE 6. The desks with artificial speckle pattern were used to achieve exact location of the tracked points.

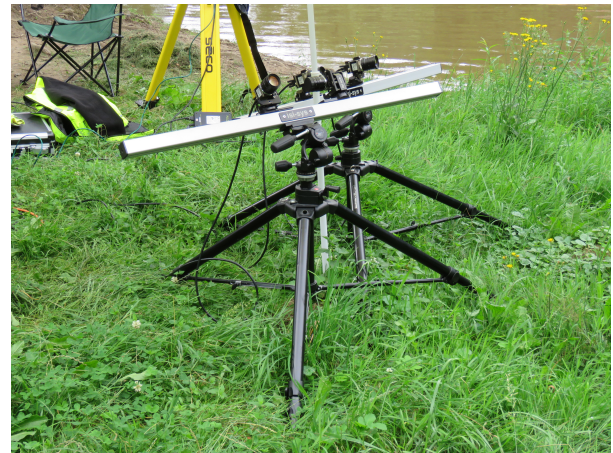
FIGURE 7. The measuring system of the DIC method in the first stage of the experiment.

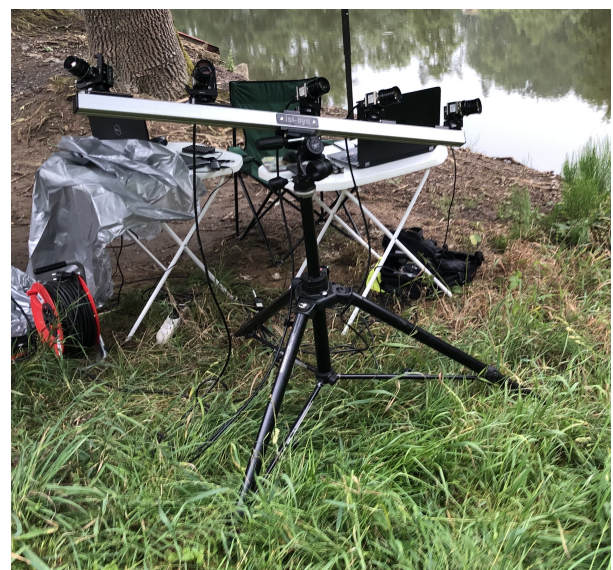
FIGURE 8. The measuring system of the DIC method in the second stage of the experiment.

at two points located on the abutments – Sys1 and Sys5 (Figure 3). It was supposed that these points were fixed and there should not have been any measurable displacements. The cameras were equipped with different cameras lens: Sys1 – $f = 50$ mm; Sys2 – $f = 50$ mm; Sys3 – $f = 50$ mm, Sys4 – $f = 75$ mm, and Sys5 – $f = 75$ mm. All the cameras were attached to only tripod. Figure 8 shows the whole measuring system in the second stage.

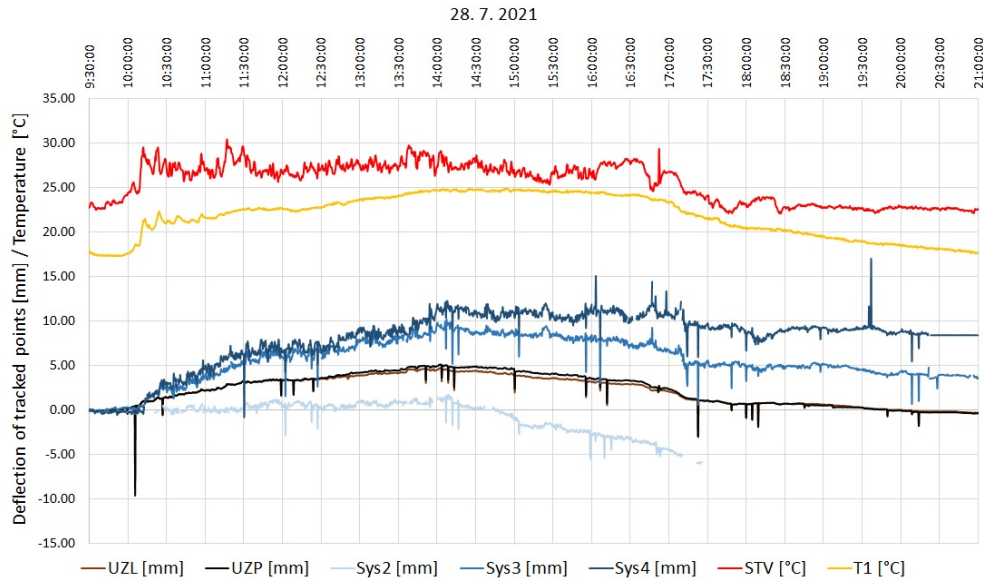
FIGURE 9. Influence of temperature changes on deflections of the tracked points during the first stage of the experiment. Deflections of points UZL, UZP were measured by the LVDT sensors. Deflections of points Sys2, Sys3, and Sys4 were measured by the DIC method. Temperature T1 responds temperature of the construction near the point tracked by the LVDT sensor. Temperature STV responds temperature of the air.

Figure 9 shows influence of temperature changes on deflections of the tracked points. The figure shows a part of the experiment from 28th of July 9:30 to 28th

of July 21:00 when both methods were in operation. It can be seen that the temperature changes had an effect on deflections of the lower chords and the verticals of the main trusses. Compared to initial time 9:30 ($u_{9:30} = 0$), the upward deflection of points UZL, UZP, Sys3, and Sys4 was dominant. It was most likely caused by different temperatures of the bottom and the upper chords of the main trusses. During a daytime the upper chords are more exposed to the sun than the lower chords that results in higher temperature.

Figure 9 also shows dynamic behaviour of the bridge. While the significant deflection of points UZL and UZP measured by LVDT sensors were downward, which responds to passing trains, some significant deflections of points Sys2 and Sys 3 measure by the DIC method were upwards. It can be seen from 16:00 to 17:00 and at 19:37. It is assumed that it was most likely caused by manipulation with the cameras, for example during setting up aperture. This can be another problem of the DIC method during long-term measurement.

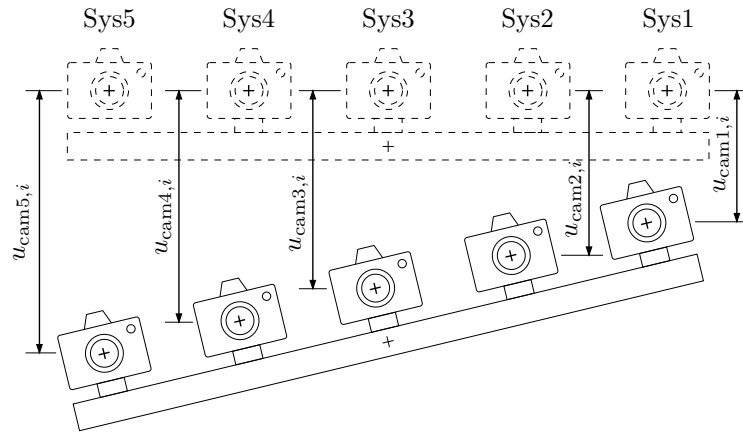
FIGURE 10. The simplified scheme showing 2D movement of cameras without rotation caused by uneven settlement of tripod feet. The vertical movement ($u_{cam2,i}; u_{cam3,i}; u_{cam4,i}$) can be calculated and used for the correction of results.

The uneven settlement of the tripod feet was observed during the first stage. It resulted in observable inclining of the camera tracking point Sys2 and consequently the incorrect result. The proposed solution was to measure two additional points (Sys1 and Sys5) which were located on the abutments, and therefore these points were considered to be fixed. The measured displacement of these points was not largely real and was caused by movement and rotation of the cameras. The displacement could be used for correction of the results. A method of correction is explained by simplified 2D scheme in Figure 10 and Equations (1) and (2).

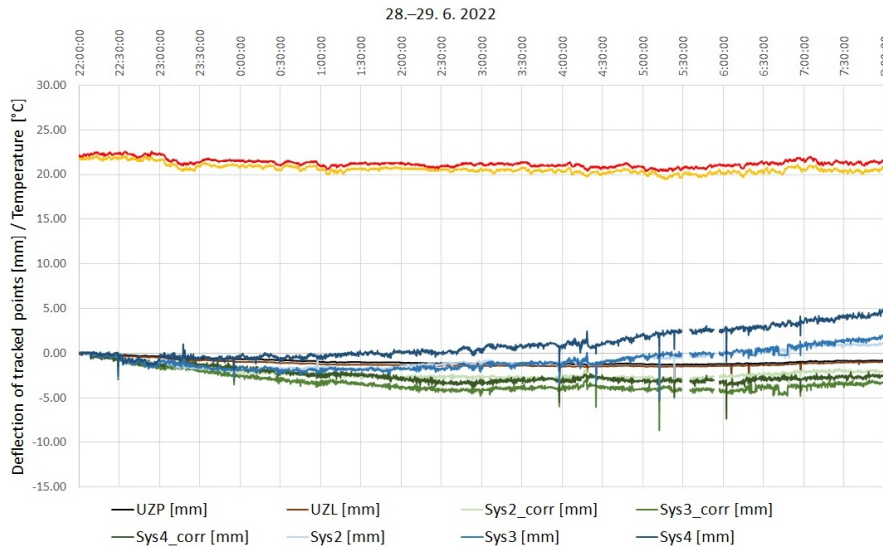
FIGURE 11. Influence of temperature changes on deflections of the tracked points during the second stage of the experiment. Deflections of points UZL, UZP were measured by the LVDT sensors. Deflections of points Sys2, Sys3, and Sys4 were measured by the DIC method. The corrected results Sys1_corr, Sys2_corr and Sys3_corr involve influence of uneven settlement of the tripod feet.

Figure 11 shows the influence of temperature changes on deflections of the tracked points during the second stage of the experiment. The picture shows the part of the experiment from 28th of June 22:00 to 29th of June 8:00 when both methods were in operation. There are a lot of gaps in measurement by the DIC method from 8:00 to 15:48 caused by lack of free disk space, changing weather conditions etc. so the results are not presented here. Unfortunately, during the 10-hour period showed in Figure 11 there were not significant changes in temperature. What is more important, Figure 11 shows a difference between the original (Sys2, Sys3 and Sys4) and the corrected results (Sys2_corr, Sys3_corr and Sys4_corr), or deflections, acquired by the DIC method. It can be seen that the difference between the original deflections measured by the DIC method and deflections measured by the LVTD sensor is increasing over time. This trend is not observable for corrected results. On the other hand, Figure 12 shows that the points which were supposed to be fixed (Sys1 and Sys5) also vibrated. Strong vibration of point Sys5 can be seen

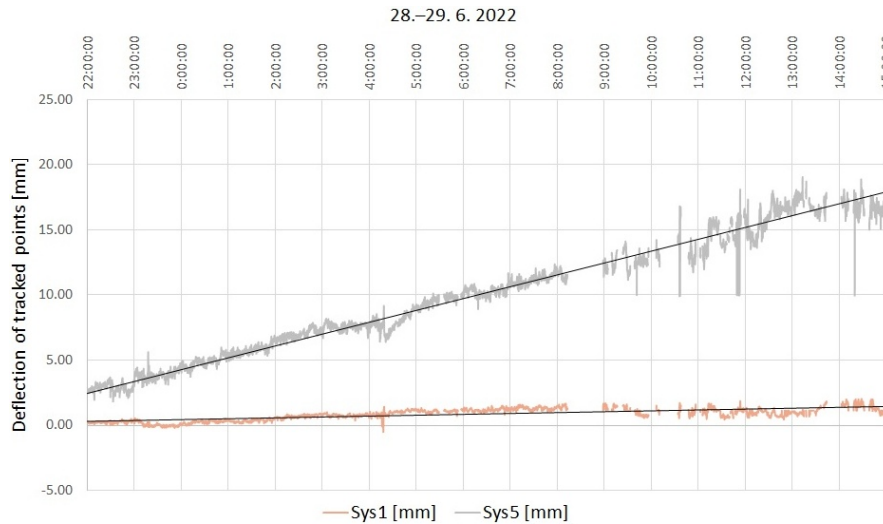
FIGURE 12. Measured displacement of points Sys1 and Sys5 which were supposed to be fixed. The black lines are linear trend lines. Strong vibrations of point Sys5 can be seen from 9:00. The vibrations were likely caused by multiple reasons – passing trains, diffraction of light, air shimmering etc.

from 9:00. The vibrations can be caused by multiple reason – passing trains, diffraction of light, air shimmering etc. This fact stimulates a discussion whether the position and fixation of these points was chosen right.
