Revitalization and Sustainability of Historic Tombs with Their Neighbourhood: A case from Turkey

Gülşen Dişli

Keywords: holistic preservation, Karyağdı Sultan Tomb, revitalization, sustainability, Turkey.

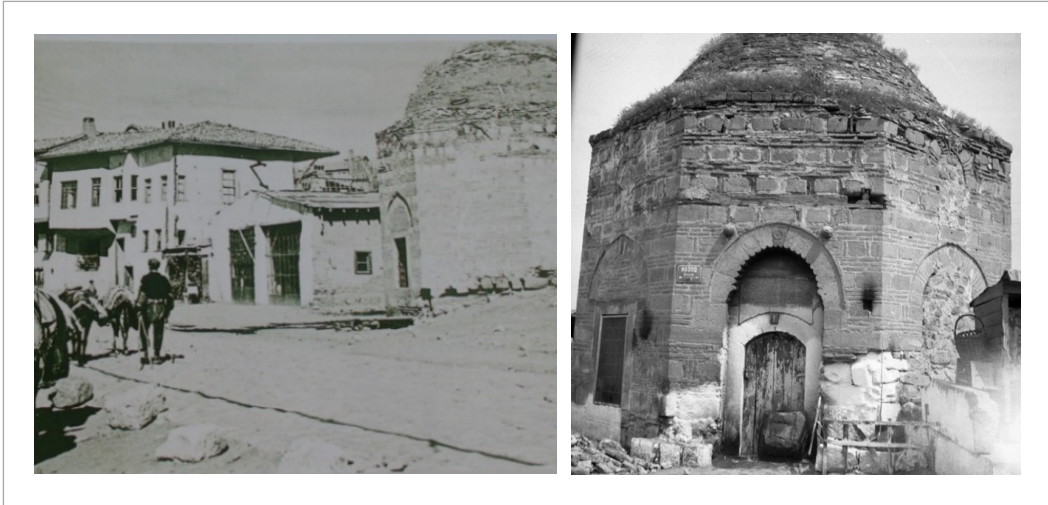
Fig. 2

Old photos of the tomb circa at the first half of the 20th century—general view (left) and a view from the east façade (right) (Archives of Directorate General of Foundations)

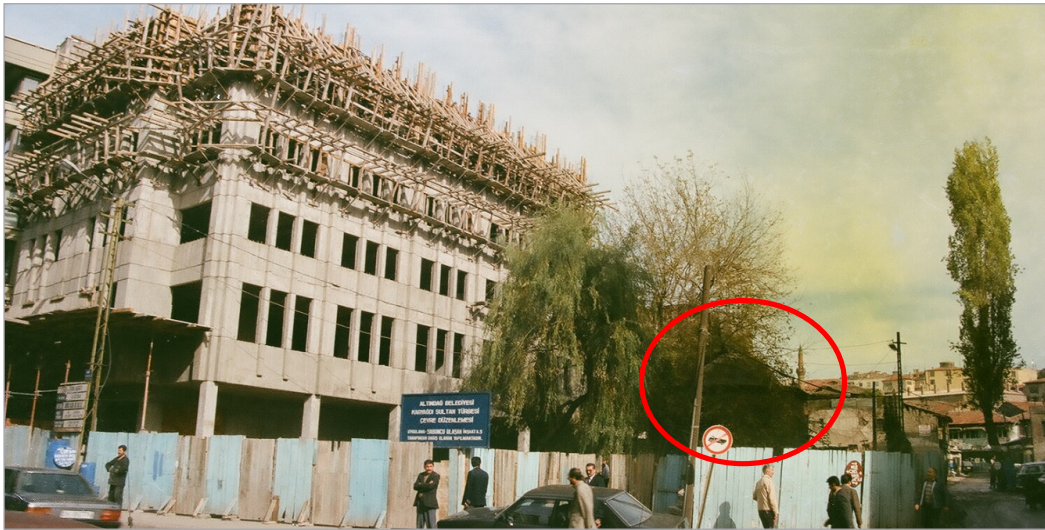
Fig. 3

A view from the west façade of the tomb with the construction of a new building on the northeast side in 1993 (Archives of Directorate General of Foundations)

According to its title deed, the owner of the building has been Directorate General of Foundations (DGF) since 1988. It was restored by DGF at that date, and its surrounding periphery by the Municipality in 1993, during which a four-story building was constructed on the north east side of the tomb (Fig. 3). Today, as a result of wrong public improvements, developments and regional planning strategies, the tomb could hardly be perceived among the concrete buildings (Fig. 4). There is a kiosk and wooden seats at the nearby periphery of the tomb with some shading trees, one of which has recently been cut, and the whole parcel that the tomb is located is paved with stone without any greenery.

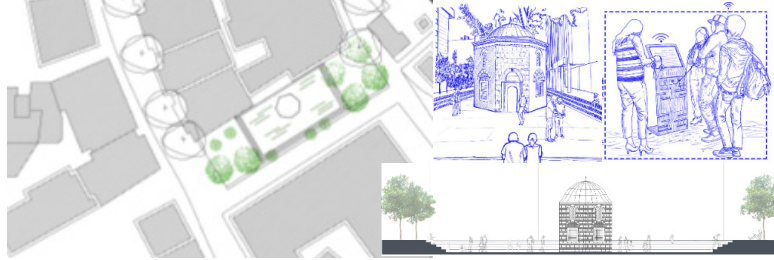
Design strategies/ideas	Drawings and illustrations showing the design scheme/ idea for the study area
<ul style="list-style-type: none"> – Site development. – Designing info platforms, kiosks, and sitting areas: resting on the stairs around the tomb. – Learning about religious and votive culture and tomb architecture in the region.

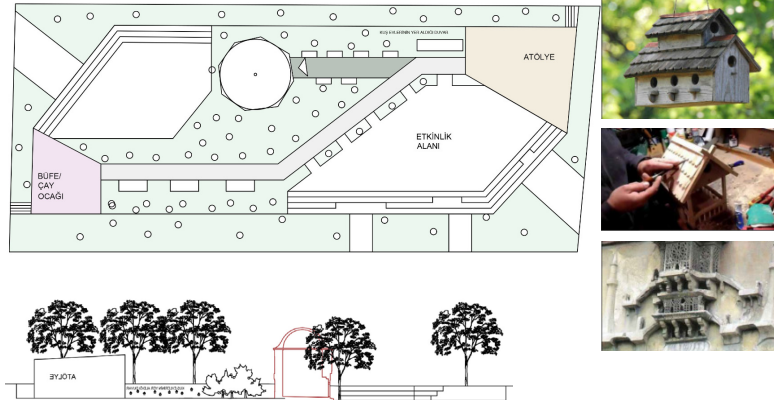
<p style="text-align: center;">Theme 1. "Meeting, Learning, and Resting"</p>
<ul style="list-style-type: none"> – Designing exhibition, activity, and meeting space with greenery, sitting platforms, wood workshop, bird houses, stairs, and wooden seats. – Considering the birds all around the tomb, bird houses will be located on the wall formed via level differences.

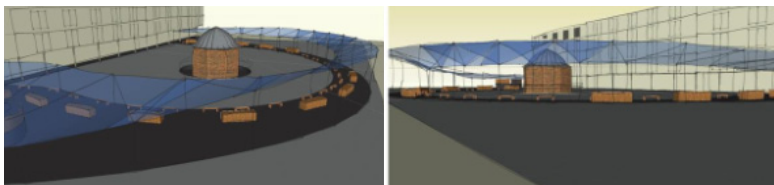
<p style="text-align: center;">Theme 3. "Shading Canopies"</p>

<p style="text-align: center;">Theme 2. "Animal Friendly Environments"</p>
<ul style="list-style-type: none"> – Social market place with a cover having water collection roof geometry and acting as a shading device. – Revitalization of the area by means of women accession and units for sales of works.

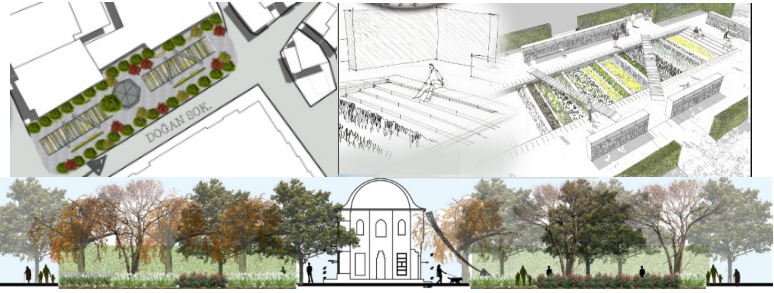
<p style="text-align: center;">Theme 4. "Nature, Visitor and Built Heritage"</p>

<ul style="list-style-type: none"> – Public meeting area with trees and sitting units around the tomb, greenery will form a cutting edge between the tomb and stores and roads. – Revitalization of votive culture by designing a meeting space for the users.
