# A Case Study on the Construction of a CLT Building Without a Preliminary Roof

A Case Study on the Construction of a CLT Building Without a Preliminary Roof

Journal of Sustainable  
Architecture and Civil Engineering  
Vol. 2 / No. 25 / 2019  
pp. 53-62  
DOI 10.5755/j01.sace.25.2.22263

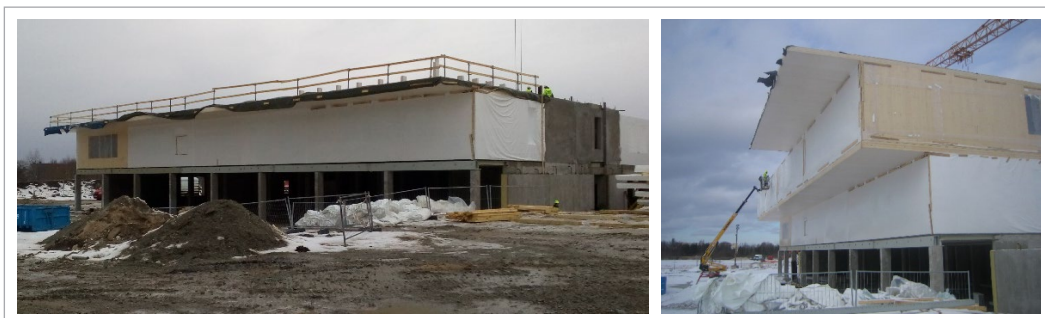
**Fig. 1**

Overall view of the installation process for the CLT element (left). External and vertical CLT elements getting additional protective canvas (right)

The case study building, Viimsi State Gymnasium school in Estonia, is one of the first public multi-storey buildings to be built mainly of CLT (Cross Laminated Timber). The design was produced by Novarc Group AS and KAMP Arhitektid OÜ in 2017, and the building was constructed by Merko Ehitus Eesti AS in 2018. The floor area was 4300 m<sup>2</sup> and construction cost was 6.1 million euros. CLT elements were used for the vertical and horizontal structure, Fig. 1.

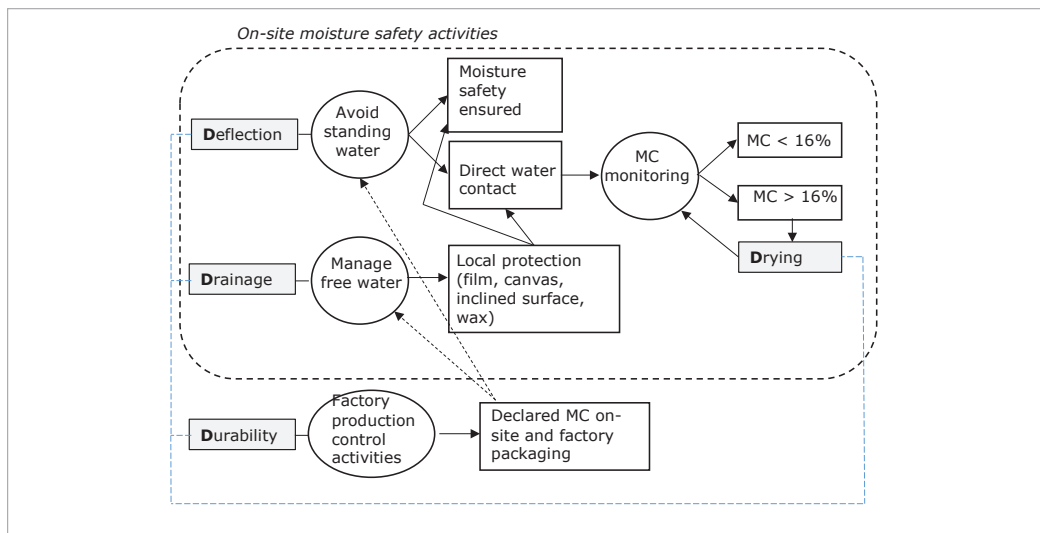
Fig. 2

4-D principles of moisture safety integrated into on-site activities and moisture content (MC) monitoring

The set up for this case study was to predict and map out the most critical positions of the CLT elements that were exposed to weather conditions during the installation process with minimal pre-cautionary measurements for moisture safety. Preliminary on-site activities followed the “4D principles” of FPIInnovations (Wang, 2016) – deflection, drainage, drying, and durable material, see Fig. 2.

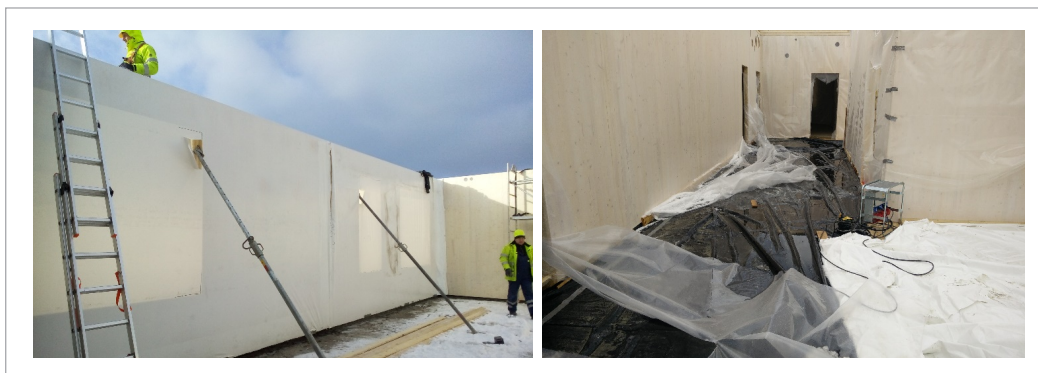
Fig. 3

CLT elements covered by PE foil before, during and after installation

Wall elements were transported in packaging PE-foil and were kept in it during storage on site and after installation. The covering film for the floor element was removed before installation because it was joint specific, Fig. 3.

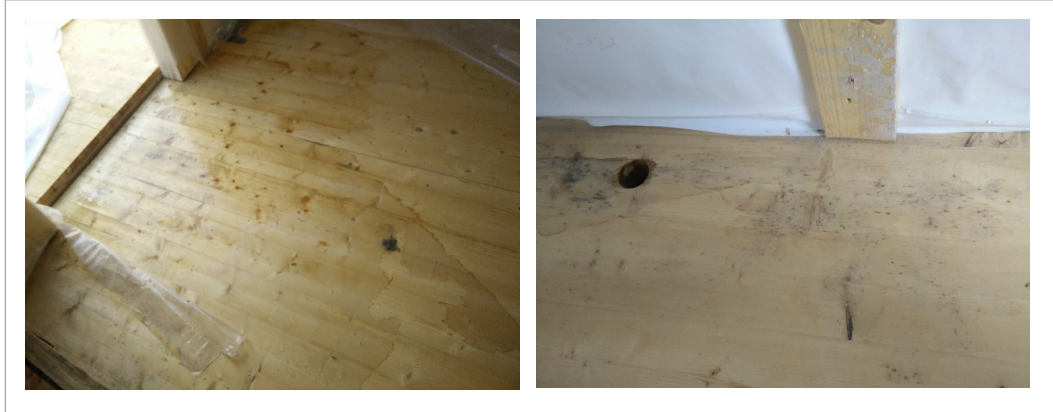
Fig. 8

Water (left) and microbial growth (right) on the CLT

Site visits indicated that even when the horizontal surfaces were covered with preliminary foil, microbial growth was not prevented and in extreme cases the growth could be seen with the naked eye.

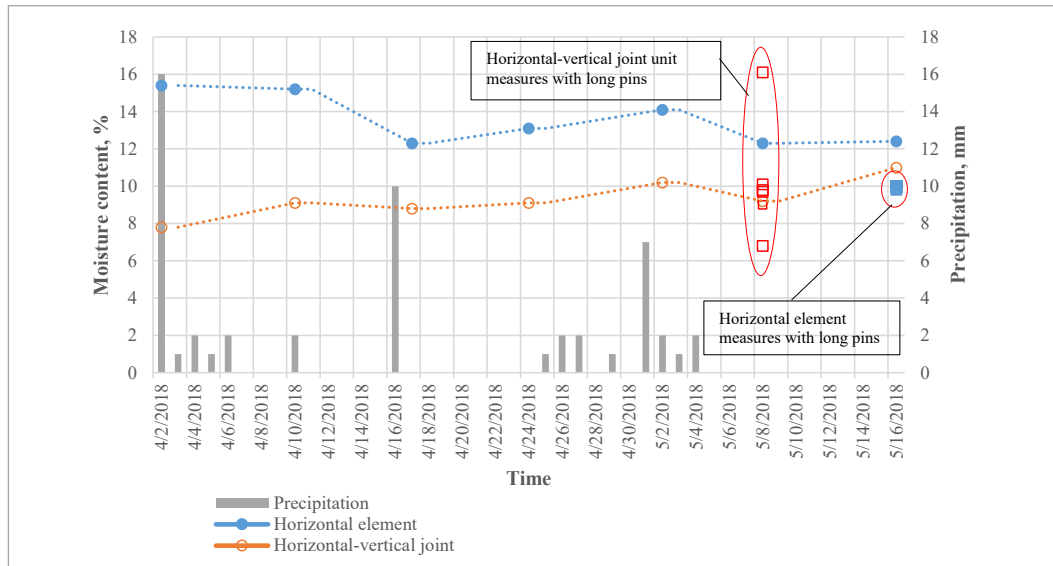
Fig. 9

The moisture content dynamics of the CLT elements after precipitation in the final phase of installation

The manufacturer declared the MC of the CLT was 13% ± 2%. In this case the study elements transported to the site had an initial water content of up to 13%, and mostly around 10% by mass. The MC of the CLT elements reached up to 15% by mass at the end of the installation process. Nevertheless a decreasing dynamic was apparent in time due to the sorption process, Fig. 9.

It was noted that the short pin electrodes (10 mm) clearly found higher moisture content in the horizontal elements than in the horizontal-vertical joints. However, the long pin electrodes (80 mm) indicated irregular moisture content results. If extremums are excluded, the average results are equivalent whatever the direction of the CLT element. This points to internal moisture safety for the CLT elements. However, precipitation type (rain/snow) wasn't measured separately, it can be stated that rain has higher effect on MC compared to snow that was constantly removed from horizontal surfaces. But without deflection and drainage activities, snowfall would have considerable risk on the MC increase in CLT elements when melted as described above.

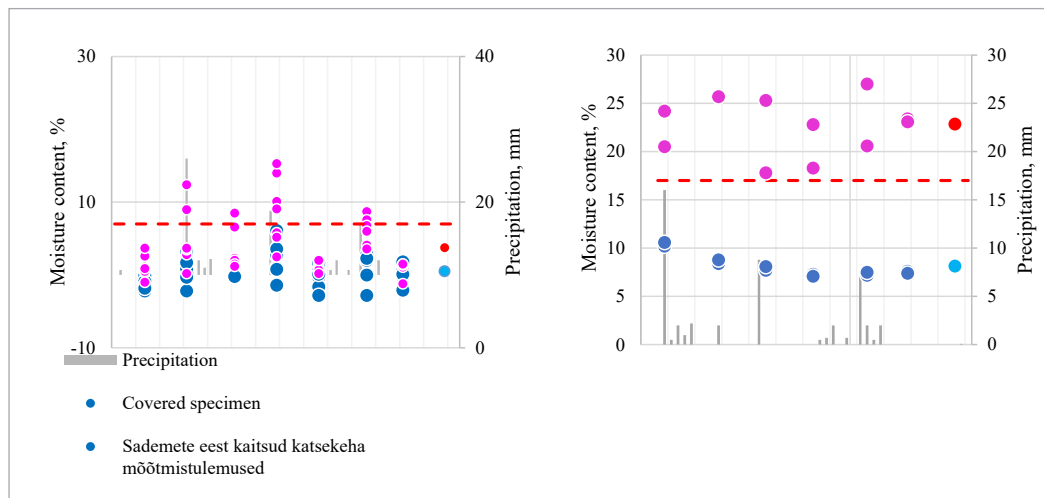
MC monitoring of the vertical CLT elements in polygon testing: external MC with short pins (left); internal MC with long pins (right)

Fig. 11 shows that the behaviour of the wall elements was similar but the MC was approximately 10 percentage points lower. The MC of the wall elements exceeded the upper safe limit and did not dry out during the final month of installation. The difference in the internal and surface moisture levels shows the importance of the measurement depth for the water content of the CLT elements. The key factor that must be pointed out for the horizontal-vertical joint performance is that the bottom end of the vertical element must be sealed with rubber or another waterproof layer to block capillary water migration, as seen previously in Fig. 6.
