## **Riverbank erosion in Hungary – with an outlook on environmental consequences**

ZOLTÁN SZALAI<sup>1,2</sup>, JÁNOS BALOGH<sup>1</sup> and GERGELY JAKAB<sup>1</sup>

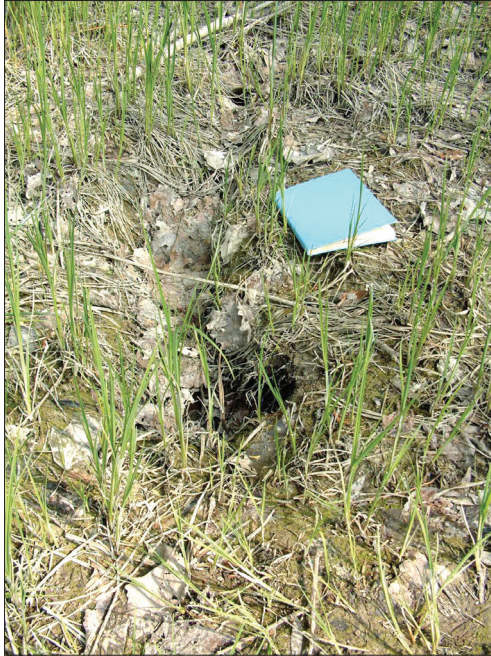
Photo 1. Pipe outflow (the Danube River, Háros Isle) (Photo by SZALAI, Z.)

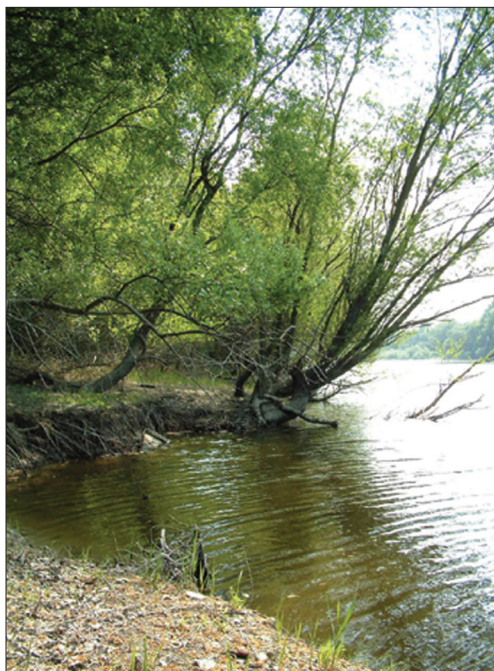
Photo 2. Near-bank dredging caused caving bluff along the Danube (Photo by SZALAI, Z.)

the bank slope angle increases. Moreover, near-bank dredging results in bluffs caving in along these sections (*Photo 2*).
