The Effect of Copper (II) Nitrate Addition and Tensile Stress on SCC of C44500 Material Tube

Farhan Adi Farrasandi¹, Firmansyah Sasmita², Husaini Ardy²

Materials Engineering Department, Faculty of Mechanical and Aerospace Engineering Bandung Institute of Technology (ITB), Bandung, Indonesia

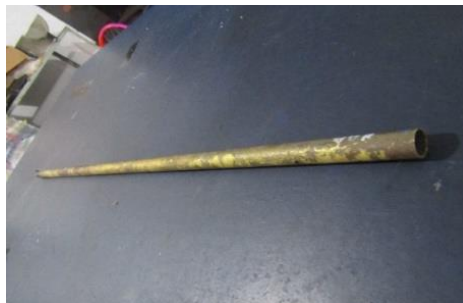
Figure 2. Initial Condition of Tube Sample

The preparation started with sample cutting for testing purposes. This tube has a diameter of $18.54 \text{ mm} \pm 0,01$ and $1,18 \text{ mm} \pm 0,01 \text{ mm}$. From the first observation, some crusts were found due to previous work in the petrochemical industry, as shown in Fig.2. Some specimens underwent tensile tests based on the ASTM E8 standard [9], as shown in Fig. 3. Whereas another piece was tested using OES (Optical Emission Spectroscopy) to identify and characterize the chemical composition of the tube, then directly compared to ASTM B111 [4].

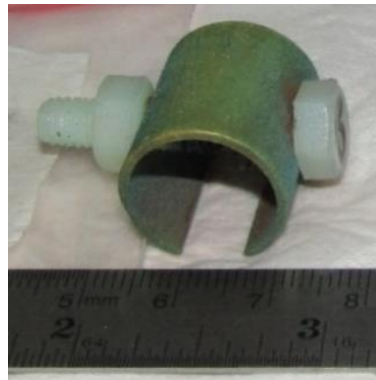
Figure 4. C-Ring Specimen following ASTM G38.

The C44500 tube, also known as Admiralty Brass, was cut into 18 small specimens following ASTM G38, as shown in Fig.4 [10]. These 18 specimens were distinguished based on the initial condition. Nine of them were washed by ceramic cleanser containing 20% of HCl for 30 minutes to reveal the dezincification effect along to cross-sections, while nine others were immersed directly into nitrate solution.

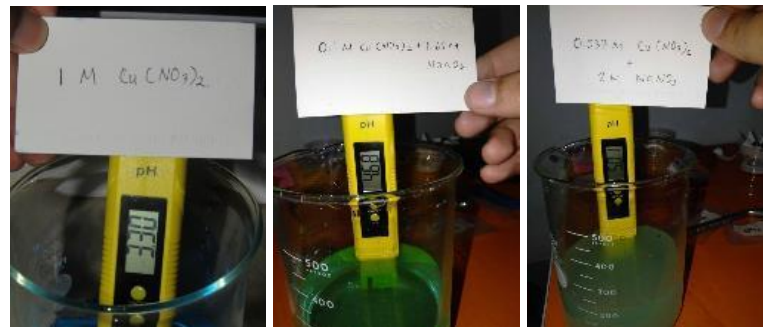
Figure 5. Measurement of pH

All nitrate solutions were tested using a pH meter to ensure the effects of Copper (II) Nitrate addition. The difference of nitrate-solution color represents each pH value, which depends on the amounts of Cu(NO₃)₂ that were added. Figure 5 shows the display of pH measurement.

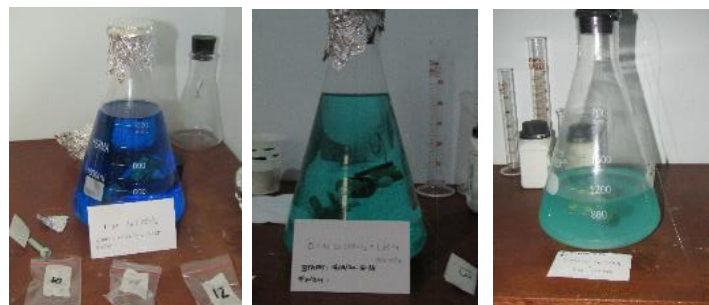
Figure 6. Immersion Test

After preparation had been done, all specimens were carried out and directly immersed into 2L Erlenmeyer contains nitrate solution distinguished based on concentrations (Fig. 6). An immersion test was done for 116-120 hours, assuming that crack propagation would occur less than 72-96 hours [13][14]. Instead of vaporizing the solution, this experimental study was conducted by immersing all specimens due to the high-temperature level required for vaporating nitrate solutions, at least from 170 °C to 308°C [15].

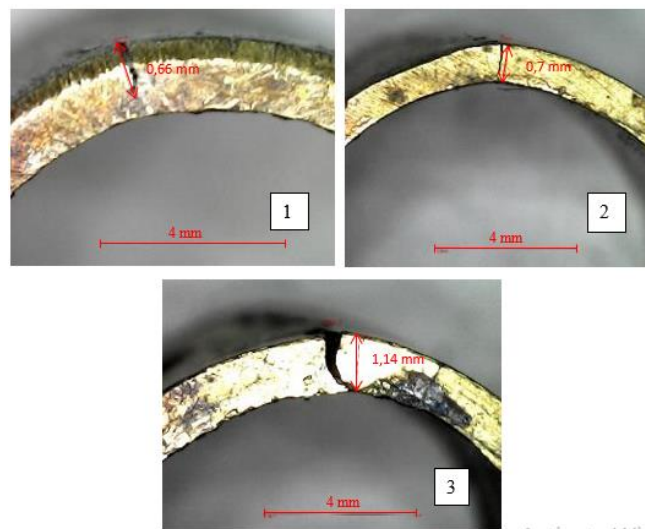
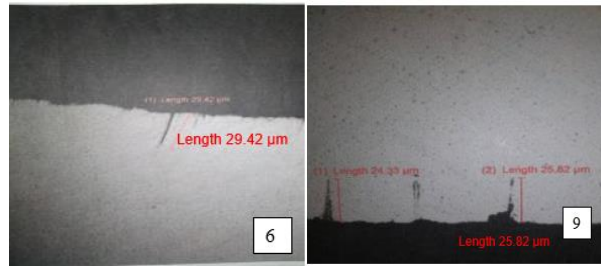
Figure 7. Crack Length Measurement

In order to determine the effect of dezincification on SCC propagation rate, crack depth measurements were made for specimens 1,2,3,6, and 9 as dezincified specimens and 10,11,12 specimens for not dezincified specimens. Measurement of crack length was immediately done after immersion test due to catastrophic SCC propagation, leading to failure. The observation was done using a stereomicroscope, and the results are shown by Fig. 7, then plotted into a bar diagram shown in Graph 1 and 2.

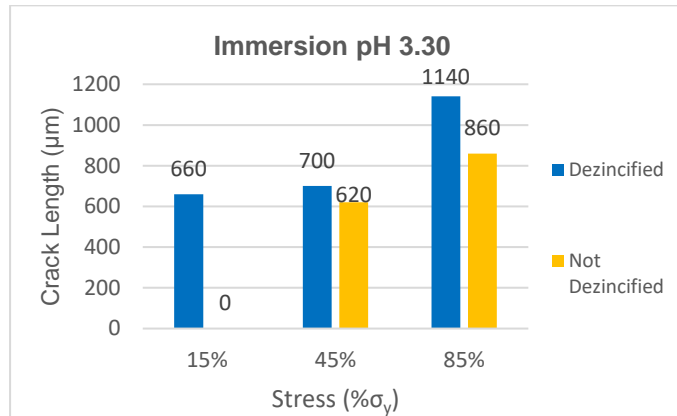
Graph 1. Crack Length Based on Stress Level

Based on results from Graph 1, it can be concluded that higher the tensile stress received by the specimen, the longer the crack depth. Otherwise, with a higher concentration of $\text{Cu}(\text{NO}_3)_2$, the SCC rate would increase significantly. The reduction of Cu supports this passivity breakdown, which explained the chemical reaction mechanism as shown below [7]:

From this study, it could be concluded that dezincification had a significant role which could affect severe crack of the specimen as the primary cause of increasing propagation rate, evidenced by all of the dezincified specimens were found cracked, especially in specimens 2 and 3, which severely failed due to catastrophic SCC. Those failed specimens were measured to obtain crack depth data immediately after the immersion test. The influence of dezincification as one of SCC's main factors in brass could also be proven by severe cracks that occurred from dezincified specimens that were longer than those not dezincified by observation at tensile stress between 45%-85% and immersion test into 1 M Cu(NO₃)₂. On the other hand, neither crack nor deformation was found at specimen 10 after being subjected to a tensile stress of 15% yield strength as the lowest parameter used.

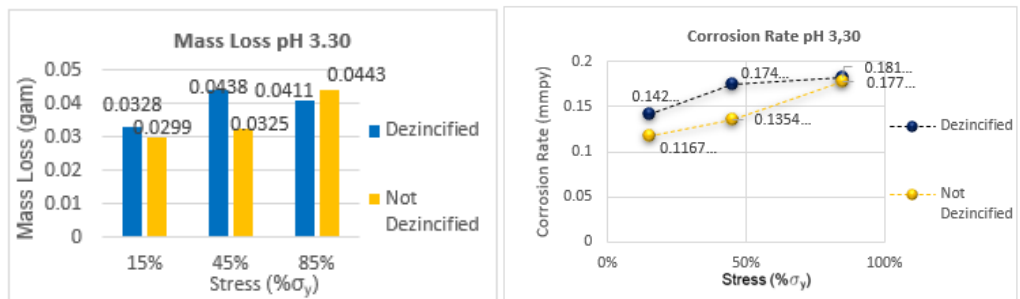
Graph 3. Mass Loss and Corrosion Rate at pH Level 3.30

Graph 3 shows the test results with pH 3.30, where the dezincified specimen had a higher corrosion rate than the not dezincified one, affecting all tensile stress levels. This phenomenon occurred because the solution only contained high concentrations of $\text{Cu}(\text{NO}_3)_2$ without NaNO_3 . Thus, the solution increases the corrosion rate and dissolved Cu ions from the specimen surfaces during immersion.

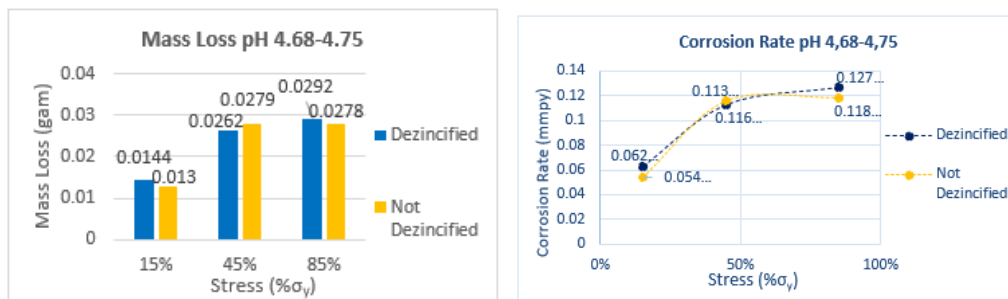
Graph 4. Mass Loss and Corrosion Rate at pH Level 4.68-4.75

Data obtained from Graphics 4 and 5, respectively, showed that the dezincification phenomenon affected increasing corrosion rate for all levels of tensile stress at a specific concentration of the solution, including a solution of pH 3.30. At the same time, no significant effect was found when immersion at solution pH of 4.68 – 4.75. However, an anomaly found at the highest pH solution, 5.01 – 5.9, showed that corrosion rate occurred at non-dezincified specimens were significantly higher than those of dezincified. Probably, this anomaly was influenced by the addition of NaNO_3 to increase the pH level. As a result, deposits which formed were corroded the specimen's surface uniformly.

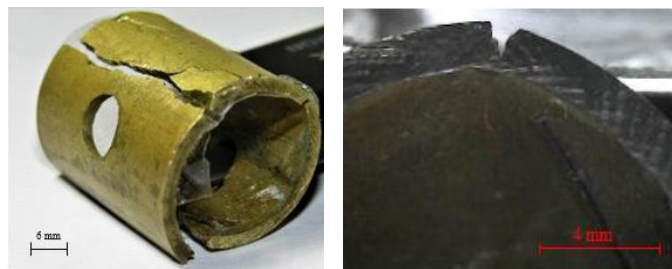
Figure 8. Specimens Condition After Immersion for Dezincified (left) and Non-Dezincified (right) Specimens

Figures 8 and 9, show that the fracture surface of specimen 3 had changed from yellow into a reddish color because dezincification affects the phenomenon of stress corrosion

cracking in admiralty brass. In contrast, the others that were not dezincified were changed into the dark due to Cu reduction during the immersion test.

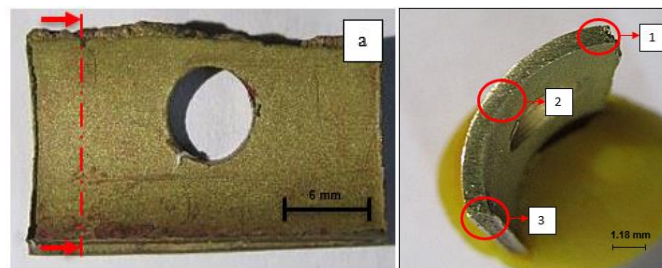
Figure 10. Cross-Section of Specimen 3

Metallography observation was conducted to determine the microstructure and appearance of the grain boundary condition of the specimen, determine the type of crack that occurred, and measure the depth of crack as a result of penetration by nitrate compounds. Before metallography, the specimen was cut with an observation point along the cross-section, followed by Figure 10 below. Specimen observations were divided into three parts to determine the effect of dezincification on stress corrosion cracking phenomenon and the type of dezincification that occurred in the specimen after being washed by 20% HCl ceramic cleaning solution for 30 minutes.

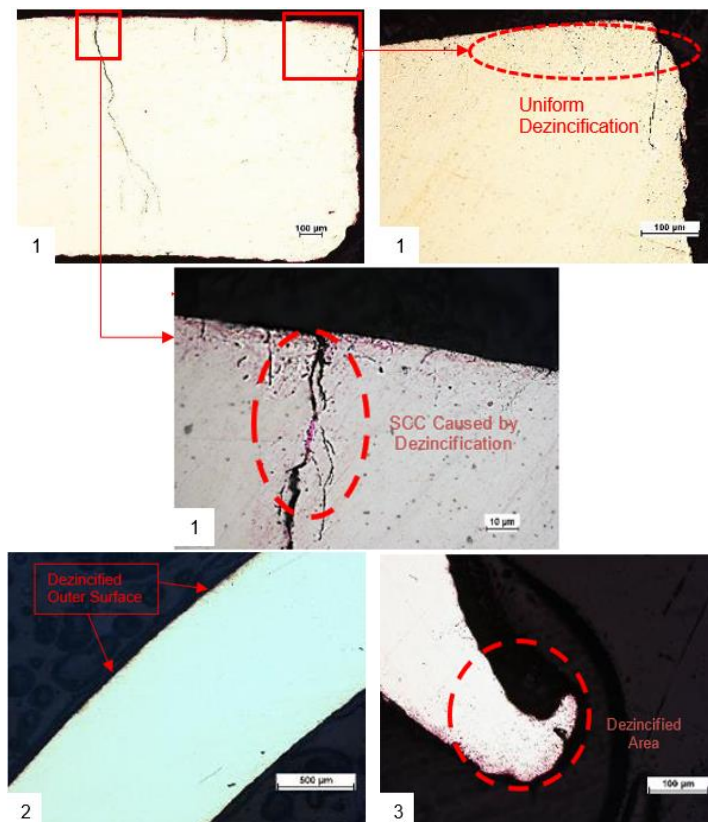
Figure 11. Metallography of Dezincified Specimen

Figure 11 shows the dezincification effect that led Admiralty Brass to become more vulnerable to SCC, as many cracks were found at the specimen tip caused by uniform dezincification. According to the metallurgical aspect, brass containing Zn > 15% often undergoes dezincification. The loss of Zn content in brass was also accelerated by conditions such as high temperature, increasing chloride content, low flow rates, and differential aeration [5]. The dezincified and non-dezincified specimens microstructures were observed, as shown in Figure 12.

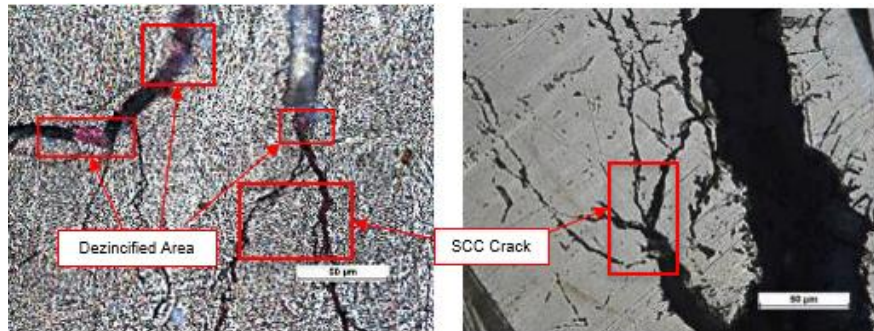
Figure 12. Crack Observation, Dezincified (left) and Not Dezincified (right)

Figure 12 shows the surface crack morphology in both dezincified and non-dezincified specimens. It can be seen that the dezincified specimen has a reddish surface around the crack area which indicates depletion in Zn (%wt) content due to dissolution by the HCl compound contained in the ceramic cleanser. As a result, the dezincified specimen would remain porous and brittle structures which accelerate SCC propagation [5].

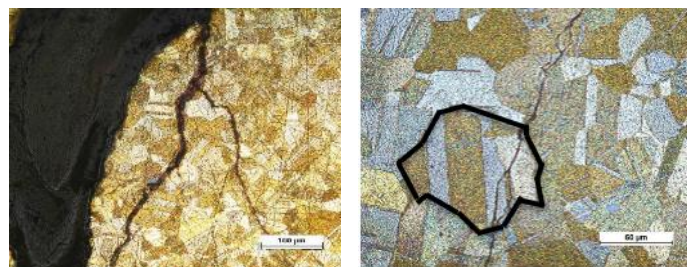
Figure 13. Microstructure of Transgranular Crack

Furthermore, metallography observation was also conducted to observe the cracks that occurred on admiralty brass. Generally, two possible types of crack occurred as the result of the SCC phenomenon; intergranular and transgranular. As shown by Figure 13, it was concluded that SCC in brass specimen would occur by transgranular crack:

Figure 13 above could explain that transgranular crack occurred at all of the brass specimens after immersion. This theory was referred to K. Lian *et al.*, who stated transgranular commonly occurred in brass with Zn content >18% wt), dezincified or not [16]. In addition, the two specimens also meet three prerequisite conditions that trigger the phenomenon of transgranular cracking, according to the theory proposed by Scully *et al.* [17]:

1. Alloy transition occurred both actively and passively, so the reaction would produce a surface with a higher potential. For example, the formation of oxides and/or metal elements.
2. An alloy that exhibits a coplanar dislocation arrangement caused the alloy matrix to have a higher hardness rate.
3. Specific electrochemical reactions occurred on the surface. For example, Cl⁻ penetrates the passive layer of alloy.

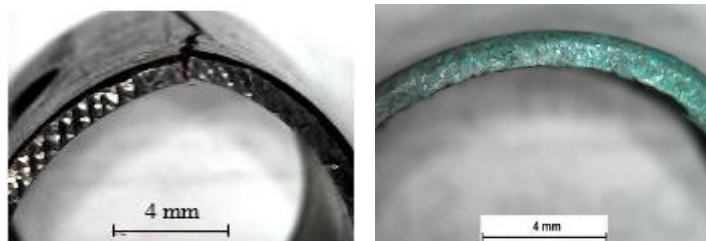
Figure 15. Change of Tube Colors After Immersion Test Into pH 2,7 and 5,01 solution

At the first observation, the specimen has golden yellow color shown in Figure 14. After immersion test into nitrate solution, the morphology of those specimens surface was changed into several colors, such as dark gray and greenish-blue forms, which depends on pH-level from each nitrate compound.

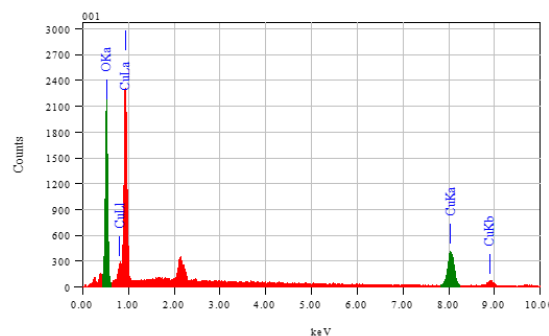
Figure 15. EDS Spectrum of Deposit Obtained from Immersion Into pH 5,01 Solution

The surface deposits were characterized using SEM-EDS with spot analysis in certain areas. Table 6 and Figure 21 below shows EDS results from deposits obtained from non-dezincified specimens. The specimen was immersed into a solution with pH 5.01, which produced green deposits, and a lower pH produced dark surfaces.

Based on spot analysis observation, only two elements were detected in the deposit, Cu, and O, without Zn as an alloying element, and other elements that could be considered impurities. The Cu_2O deposit was formed according to equation (9) to form a $\text{Cu}(\text{OH})_2$ with the increase in the solution pH.

The chemical reaction above could be assumed that Zn has completely dissolved during immersion. Thus, the deposited compound formed is $\text{Cu}(\text{OH})_2$, which is indicated by the ratio between Cu and O atoms were 3:7, equivalent to 1:2.3 [18].
