## Al-Qadisiyah Journal for Engineering Sciences

# Studying the effect of multicomponent nano-coating alloy on hydrogen embrittlement of AISI 1018 steel by gas-phase process

Zainab Z. Ali\*, Baha S. Mahdi and Ameen D. Althamer

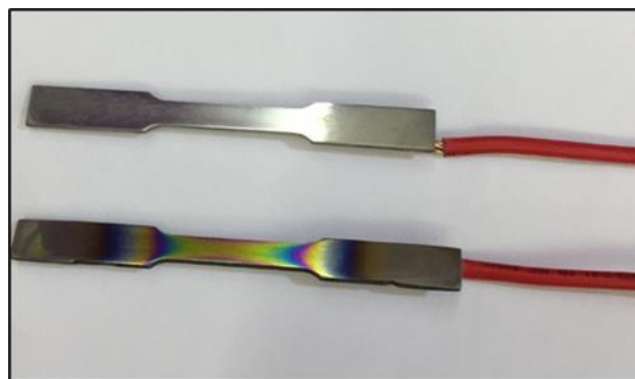
**Figure 2. Coated and uncoated work substrate before covering**

Tensile test specimens were prepared according to ASTM E8 with a gage length of 25 mm, and the total length for each specimen was 100 mm. The machining process for all specimens was done using a CNC machine, as shown in Fig. 2.

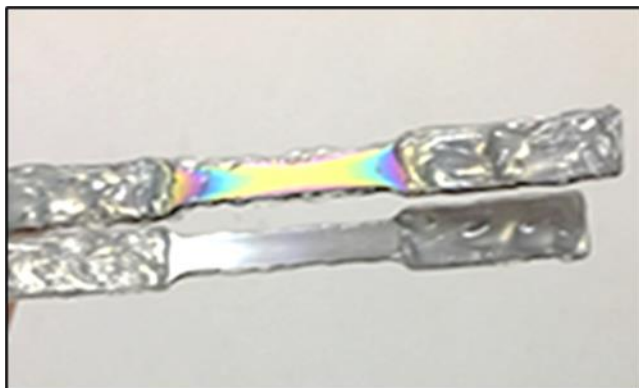
Figure 3. Partially covered tensile test specimens by epoxy resin

Firstly, the dog bone-shaped (tensile) specimens of mild steel were welded to one end of a copper wire by discharge welding, and then the other end of the wire was connected to the cathode wire of the power supply. The tensile specimens were covered with an acid-resistant insulating material (epoxy) except the gauge length remained uncoated, and the uncoated area calculated for specimens was about 250 mm<sup>2</sup>, as shown in figure -3-. The anode was a stainless-steel bar.
