Applications of Thermal Images for Monitoring Surficial Temperature Changes of Naked Slope

Abstract

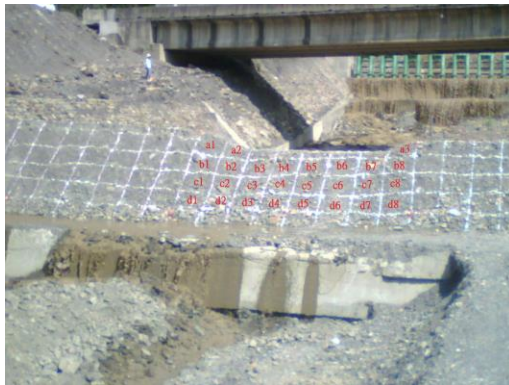
(a) Field photography

Corresponding thermography

Fig. 1 The artificial earth dam and corresponding thermal image (taken 10 April 2014)

2 min height and it blocked the entire creek [8]. Water was stopped upstream first and released during tests. The test was made on 10 April 2014, and modeled the failure processes and modes of natural earth dams. The thermal imager was set up on a bridge for monitoring of the upstream face of the dam and at the side bank for the downstream face (Fig. 1). Thermal images were taken every few minutes with the increasing water table during the test until the dam breached.

The surface of the earth dam downstream was divided into grids for monitoring the temperature changes. There are 27 grids monitored as marked in the image from left to right: a1~a3, b1~b8, c1~c8, and d1~d8 (Fig. 1). The temperature is taken as an average within the grid. Fifteen successive images were taken for the analysis. A positive value of the index shows the temperature is increasing. A negative index shows reduction in the temperature due to seepage and piping with the increasingly blocked water table.

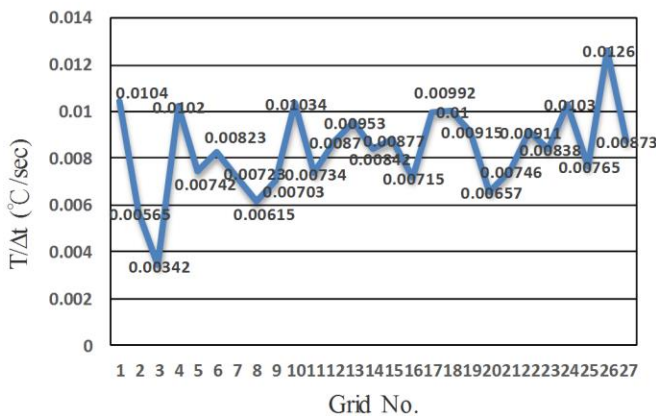
Fig. 2 Monitoring of surficial radiation temperature changes on 14:15:56

Monitoring began at 14:15:56 and ended at 14:34:26. The surficial temperature variations with time at the monitoring grids for the first two images are shown in Fig. 2. All the grids showed a positive index with increasing surficial temperature during the

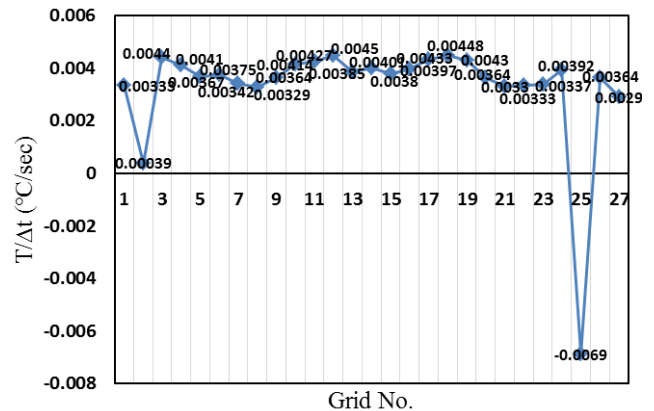
Fig. 3 Monitoring of surficial radiation temperature changes on 14:28:39

sunshine, at the beginning of the test. Soil erosion and piping occurred at grid No. 26 (d7 in Fig. 1) 12 minutes later with a negative value for the index (Fig. 3). With increasing time, another piping occurred in grid No. 8 (b5) (Fig. 4). It is speculated that the type of failure mode is seepage caused piping if the blocked water table is not rising at the current stage. The dam breached in a complex mode with piping first followed by overtopping failure (Fig. 5). The thermal images showed a clear lower index in the grids with potential seepage-induced piping failure, though the dam failed by overtopping with increasing river flow. Piping failure occurs in low permeability dam material with high soil shear strength under high discharge flow. It should be noted that the piping water in the upper grids could flow down to the lower grids without piping, causing a lower index in all these grids. The results show that the index ($T/\Delta t$) is suitable for monitoring surficial radiation temperature changes of naked slopes in a given time period and may be applied for monitoring potential landslide slopes.

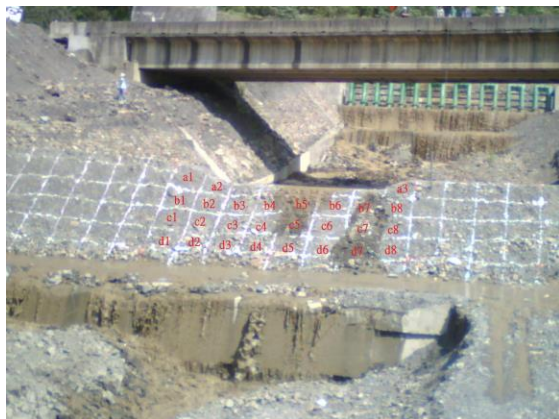
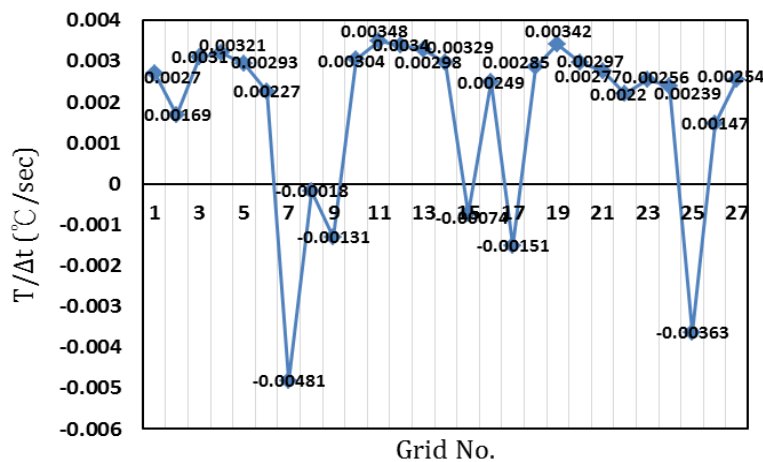
(a) Field photography

(b) Corresponding thermography

(c) The index ($T/\Delta t$) changes

Fig. 4 Monitoring of surficial radiation temperature changes on 14:33:55

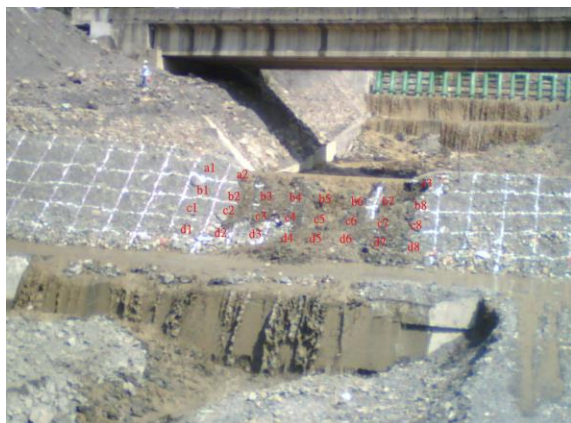
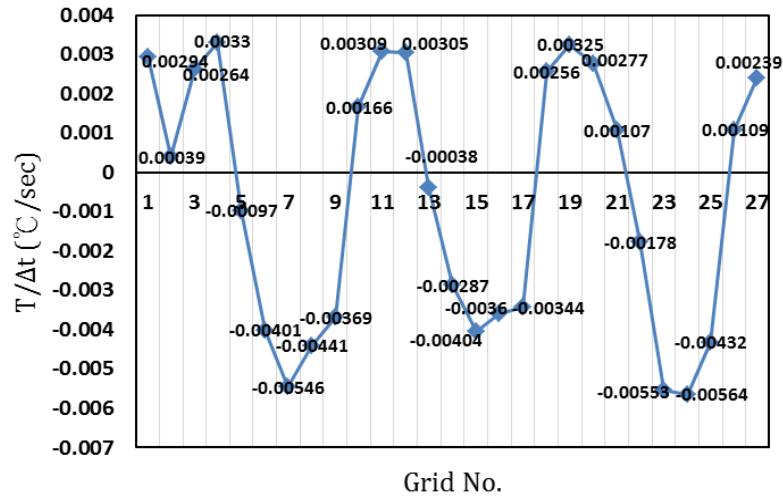
(a) Field photography

(b) Corresponding thermography

(c) The index ($T/\Delta t$) changes

Fig. 5 Monitoring of surficial radiation temperature changes on 14:34:26
