ARTHROPLASTY

Fatigue failure of the femoral component of a total knee arthroplasty: a case report and review of the literature

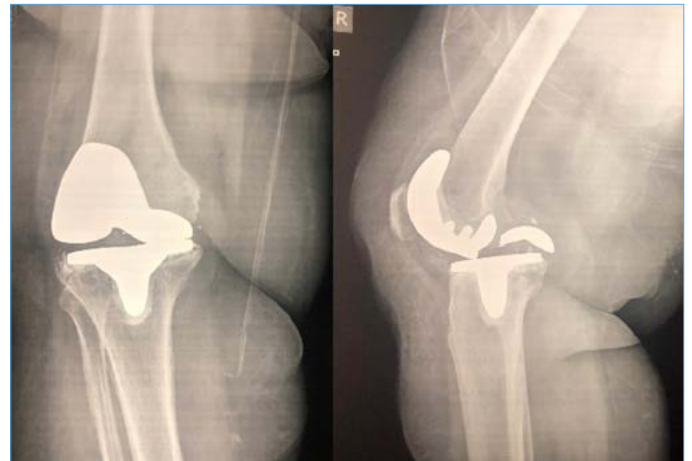
Figure 1. X-rays on arrival showing a broken femoral component and loosening of both components

of loosening of both the femoral and tibial components (*Figure 1*). Laboratory investigations were normal. White cell count (WCC) was $7.87 \times 10^9/L$; erythrocyte sedimentation rate (ESR) was 12 mm/hr; and a C-reactive protein (CRP) was 5 ml/L. Her American Knee Society Score¹ was 14. She gave consent for a revision TKA.

Incision was done through the old scar, with a medial parapatellar approach. No clinical signs of infection were observed. Intra-articular fluid was used for an alpha-defensin test, which was negative. The fractured femoral component was visualised, but the broken flange was only visualised after removal of the femoral implant (*Figure 2*). Both femoral and tibial components were found to be loose. Both metal implants were successfully removed without further bone destruction. Examination of the fractured medial posterior flange of the femoral component revealed no cement on the implant surface or on the medial posterior condyle. The lack of cement on the posterior condyle of the femur ruled out the possibility of cement debonding. The rest of the implant was well cemented (*Figure 3*). The polyethylene insert had signs of advanced wear, especially over the medial aspect. A thorough debridement was performed. A revision total knee replacement was performed using both augments and stems. Cultures taken intra-operatively were all negative.

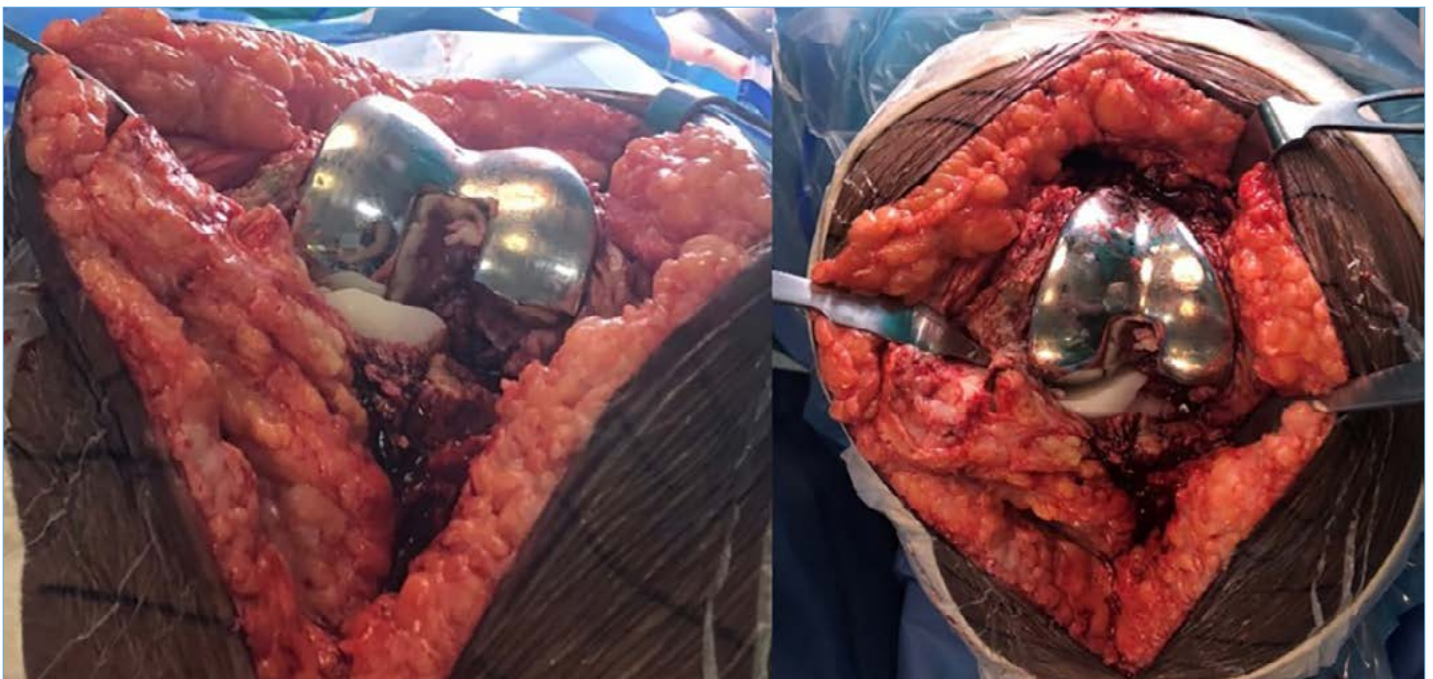
Figure 2. Broken femoral component noted at operation

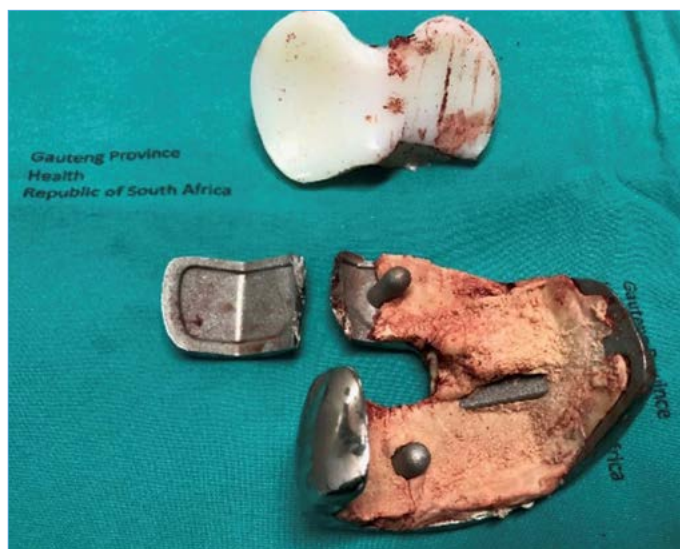
Figure 3. Broken femoral component and worn polyethylene insert after removal. Note the lack of cement on the posterior medial flange of the femoral component

due to the rarity of the incidence of component fracture compared to the overall trend in obesity in arthroplasty, it is unlikely to be the only risk factor. Vaninbroux *et al.*¹⁵ investigated the optimal cementing technique for the femoral component and concluded that it included cementing of the posterior flanges. Fracture of the femoral component remains rare, but loosening of the component and poor cementing technique can predispose certain implants to fail. Unfortunately, the lack of post-operative X-rays from the initial knee replacement prevents us from drawing any definitive conclusions regarding malposition of the components. Poor implant design, obesity, the use of uncemented femoral components and poor cementing technique appear to increase the risk of implant fatigue fracture.

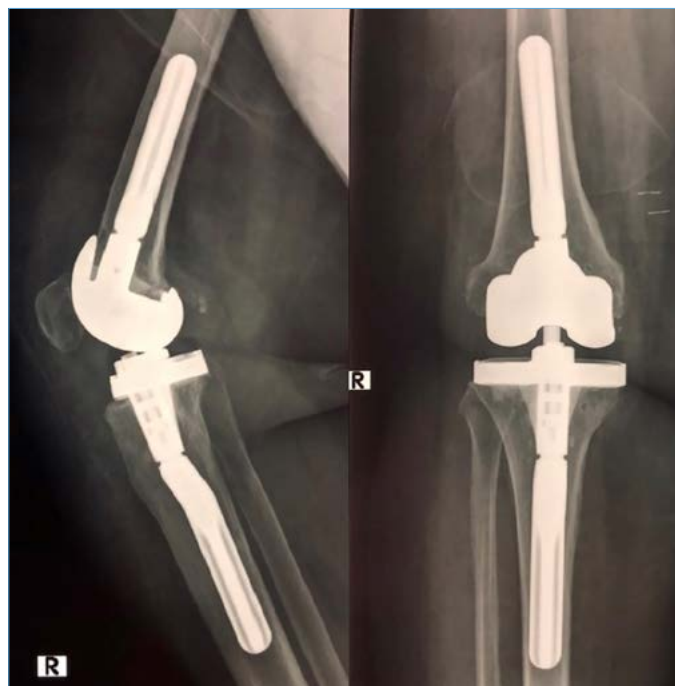
Our patient had no post-operative complications and was discharged once the wound was settled and appropriate level of rehabilitation was achieved with physiotherapy. She was seen 15 days after surgery and had no early wound complications. At the six-week follow-up, she was walking with one crutch and her range of movement was 0° – 0° – 95° . She was still attending regular physiotherapy. Repeat X-rays revealed no radiological signs of loosening (*Figure 4*).

Figure 4. Post-operative X-rays after the revision surgery
