Application of the DMAIC Method in Improving the Quality of Electric Power Steering Housing Products

PT. ABC is a manufacturing company that produces Electric Power Steering (EPS) Housing components. For the past three months, there have been problems with the EPS production process. The problem is related to the finding of defective products which on average reached 3.9% of the total production, and has exceeded the maximum limit allowed by the company, which is 2%. This study aims to overcome these problems by making improvements using the DMAIC method in the hope of finding the root cause of the emergence of defects and making improvements to reduce the number of defects that occur. The improvement results have shown that the number of defects reduced from 3086 pcs to 1948 pcs per 22 working days or decreased by 0.54% with an increase in sigma level from 3.95 to 4.01 sigma. In this case, DMAIC implementation is effectively reduced defects by 1.5% based on the sigma level. To achieve a 6-sigma level equivalent to a world-class industry, companies must make continuous improvements by fixing other root causes.

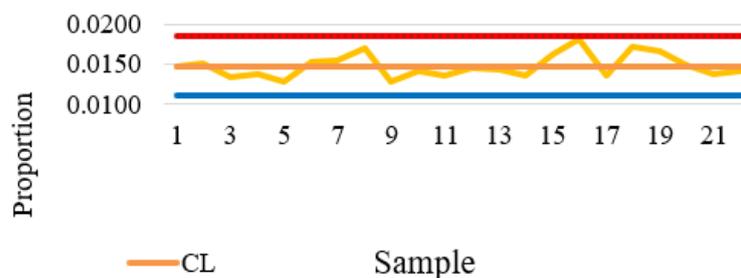
Figure 6. P-chart of M5 over thread defect products

It can be seen in Fig. 6 that all data are already within control limits, so there is no need to revise the p-chart. Next, calculate the process capability presented in the calculation below.

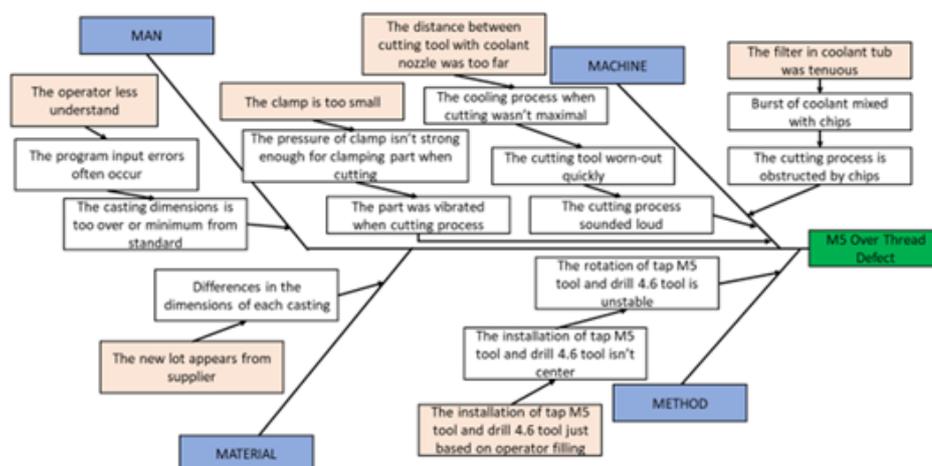
Figure 7. Cause and effect diagram

Causal diagrams are made based on brainstorming with line leaders, sub-leaders, and fellow operators. As a summary of the discussion, the fishbone analysis is shown in Fig. 7. The diagram shows that four-factor (man, machine, material, and method) contribute to the defective. Then actions need to be taken to overcome every root of cause.

Man factor, the dimensions of the EPS Housing product are varying due to frequent program input errors or dimensional input errors in the machine program. This happens due to the operator's lack of understanding the machine operation. Method factor, the rotation of the M5 tap tool and 4.6 drill is unstable or the tool shakes during the cutting process. This is because the installation of the tap and drill tool is not centered. After being traced, the main cause is when changing the tool the operator only centers the tool based on feeling. Material factor, there are differences in the dimensions of the blanks sent by the supplier. This happens because there is a new cavity sent by the supplier.

Machine factor, the cutting process is hampered by a large number of chips. When the cutting process takes place there are a lot of chips in the product and the coolant that should be white turns gray. This is because the coolant emitted from the nozzle has mixed with the chip. After exploring the main cause, the filter in the coolant tank is loose. The cutting process sounds loud and rough, this is because the tool wears out prematurely. Tools that wear out quickly are due to the cooling during the cutting process is not optimal (air coolant does not lead to the tool). After being traced, the main cause is the distance between the coolant nozzle and the tool is too far, so the coolant water does not radiate right into the tool. Part vibrates during the cutting process, this happens because the clamp pressure on the jig is not strong enough to hold the part during the cutting process. After being traced, the main cause is a clamp that is too small.

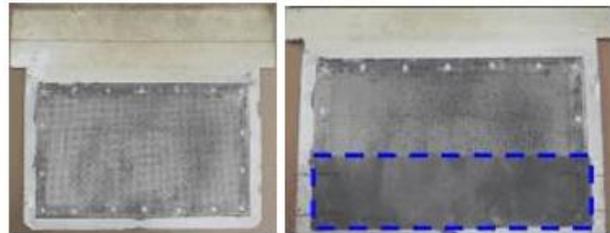
Figure 9. Filter before and after

Based on the FMEA analysis, it can be seen the importance of a failure mode. The higher the value, the more priority it is to be repaired immediately. In this case, the priority order of failure mode is obtained namely, the clamp is too small, the filter in the coolant tank is loose, the center tool installation when replacing the tool is only done based on the operator's feelings, the distance between the coolant and tool nozzles is too far, the operator lacks understanding and the presence of a new cavity from the supplier. From the sequence of problems, successive improvements will be made using the 5W + 1H method. Based on root cause analysis and FMEA. Some actions would be planned and executed. Repair begins by making Table 5W + 1H as shown in Table 3. After preparing the improvement proposal, repairs are carried out referring to the date and each PIC that has been decided. The repair process has an impact on all four factors. Figure 8 – 13 the situation of before and after improvement based on Table 3.

What	Factor	Why	How	When	Where	Who
	Machine	The clamp is too small	The replacement of the clamp is wider	25/09/2018		*Engineering*
	Machine	The filter in the coolant tube is tenuous	Add layers to the filter	26/09/2018		*Engineering*
	Method	Center tool installation when changing tools is only done based on operator feeling	Tool replacement is performed checking the center round out ± 0.03	25/09/2018		*Leader*
Ulir M5 *Over*	*Machine*	The distance between the coolant nozzle and the tool is too far	Attach a nozzle and point to the tool	27/09/2018	*Line EPS Housing*	*Engineering*
	Man	Lack of operator understanding	Hold refresh training	26/09/2018		*Leader*
	Material	There is a new cavity from the supplier	Add checking in the form of measurement by incoming	26/09/2018		*Quality*
