Study of Fatigue Fractography of Mild Steel Used in Automotive Industry

Ahmed Ameer Zainulabdeen

Department of Materials Engineering/ University of Technology

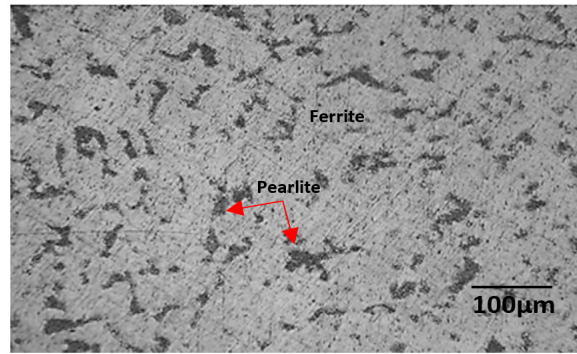
The microstructure of used steel is illustrated in Fig (2) with two magnifications. It is clear from Fig that the microstructure consists of pearlite regions (dark area) uniformly distributed with irregular shapes and imbedded in the matrix of ferrite (bright area). The percentage of pearlite content was about 17% (according to Image J software). More information can be concluded using X-ray Diffraction analysis which revealed the peaks of ferrite (pure iron) which it is the matrix of the used alloy as shown in Fig (3).

Fig. 2. Pictures show the microstructure of steel sample.

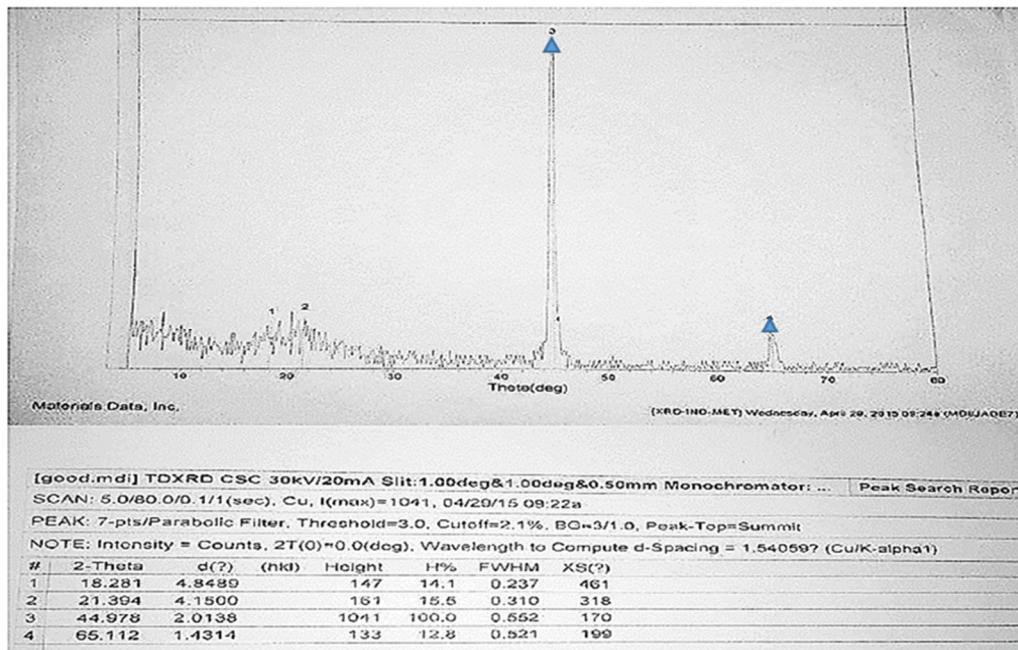
Fig. 3. XRD analysis of Sample.

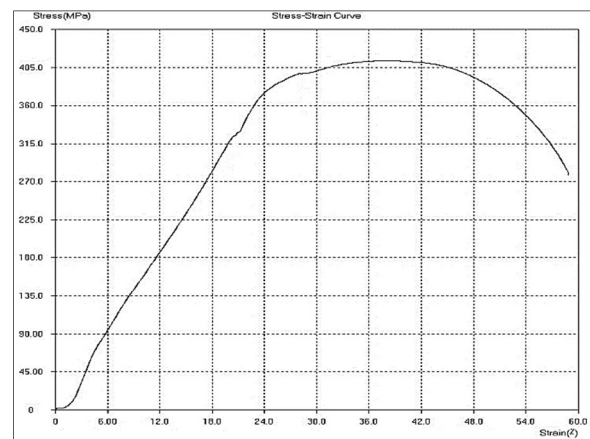
Table (2) and Fig (4) present the hardness and tensile properties of used steel. A high ductility level can be observed due to the high content of ferrite which is very suitable for most automotive applications. These results have good agreement with previous literatures [7].

Fig. 4. Stress-strain of As-received steel material (St 37).

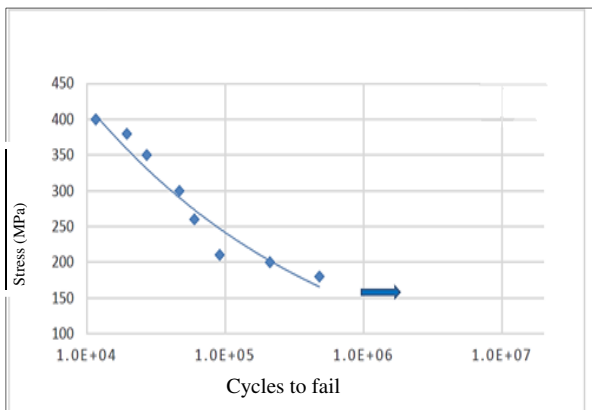
Rotating bending fatigue testing machine was used to determine Fatigue limit of used steel as a stress- number of cycle to failure (S-N) curve. Fig (5) and Table (3) shows the results of this test, which was 160 MPa, and this is deal with previous literatures [8].

Fig. 5. S-N curve for steel (St 37) in as received condition.
