Impacts on water transport networks after three widespread volcanic ashfalls in Andean Patagonian lakes

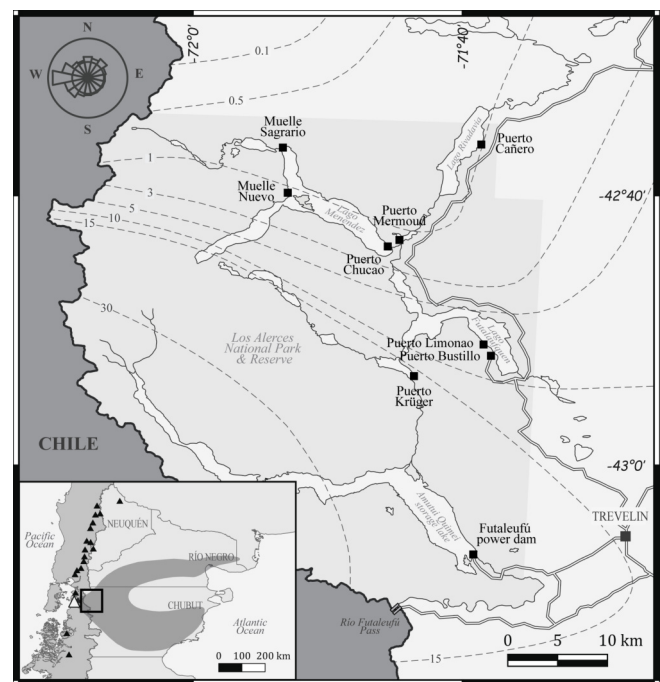
Figure 1: The Chaitén 2008 volcanic eruption and tephra fall distribution map (isopachs in millimeters, based on Watt et al. [2009] and Alfano et al. [2011]) in Los Alerces National Park and Reserve (area in gray), and location of the most-affected port sites. At the top left, the wind rose charts the relative distribution of annual wind (origin) direction frequencies. Bottom left, tephra fall distribution >0.1 mm.

The Chaitén (42.8° S– 72.6° W, Chile) volcanic eruption began with a strong explosive phase (VEI: 4 [Watt et al. 2009; Alfano et al. 2011]) on 2 May 2008 without significant precursory activity [Castro and Dingwell 2009; Lara 2009; Watt et al. 2009]. Explosive activity was most energetic during the first week, producing eruptive columns that reached a maximum height of 30 km [Watt et al. 2009]. The successive eruptive plumes dispersed rhyolitic products across the Andes and over Argentinean territory, with tephra deposition occurring over 1000 km away from the source [Watt et al. 2009; Alfano et al. 2011; Durant et al. 2012]. Explosive activity continued throughout the following months with much lower plume heights and little evidence of measurable ash fallout in Argentina [Watt et al. 2009]. The extensive ashfalls caused immediate to long-lasting environmental, social, and economic impacts on Chilean and Argentinean Patagonia [e.g. Martin et al. 2009; Stewart et al. 2009; Wilson et al. 2009a; b; Stewart et al. 2011; Wilson et al. 2012], including water activities in Los Alerces National Park and Reserve (Figure 1).

Los Alerces fluvio-lacustrine basin comprises a chain of glacial lakes connected by short river courses. The largest ports (Table 1), lodgings, and campsites sit on the eastern shores of Lago Rivadavia, Lago Verde, Lago Menéndez, and Lago Futalufquen, from where various tourist ships sail daily during the summer season. These ports, located up to 85 km away from the volcano, were affected by up to 15 mm of fine-grained rhyolitic ash (Figure 1). Even though all tourist facilities were almost entirely evacuated throughout the first days [Salgado et al. 2022], and shipping remained completely disrupted for almost six months, the ashfall caused widespread damage to berthed ships and ports. Visits of coastguard ships to the sparse communities inhabiting the surrounding were also slowed down by effect of volcanic ash. To the south of Los Alerces National Park, over 30 mm of fine-grained ash fell around the Amutui Quimei storage lake, upstream of the 448 MW Futaleufú power dam, located 90 km away from the volcano (Figure 1). Pumice fragments remained suspended in the lake for over eight weeks [Wilson et al. 2012] making the operability of supporting ships more difficult. Across the Andes, volcanic ashfalls also caused widespread impacts on maritime shipping, on the Chilean coast around the Chaitén township [Wilson et al. 2012].

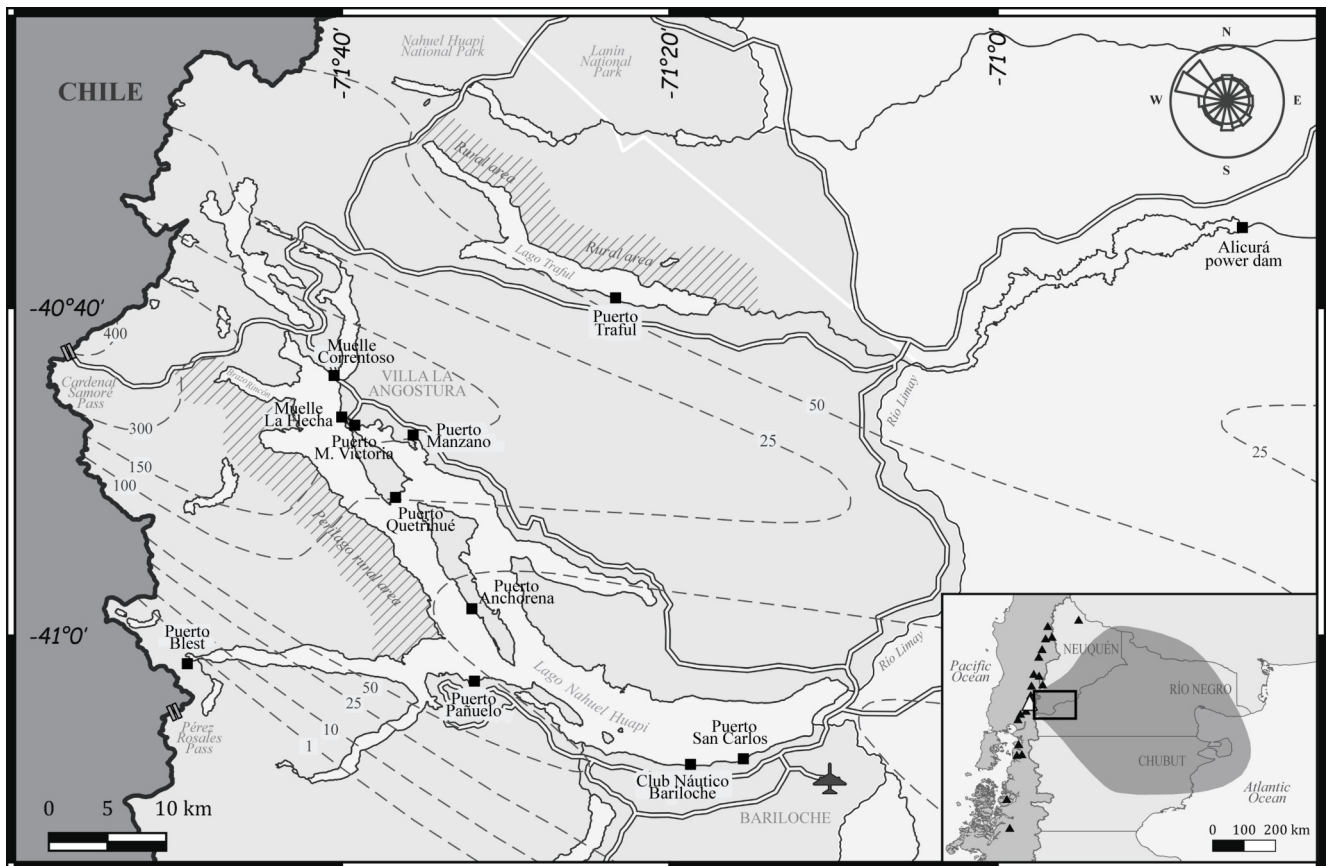
Figure 2: The Cordón Caulle 2011–2012 volcanic eruption and tephra fall distribution map (isopachs in millimeters, based on Villarosa and Utes [2013] and Alloway et al. [2015]) in the Nahuel Huapi National Park (area in gray), and location of the most-affected port sites. At the top right, the wind rose charts the relative distribution of annual wind (origin) direction frequencies. Bottom right, tephra fall distribution >1 mm.

et al. 2012; Schipper et al. 2013] causing widespread damage and economic losses [e.g. Wilson et al. 2013; Hayes et al. 2015; Craig et al. 2016; Elissondo et al. 2016; Stewart et al. 2016; Beigt et al. 2019]. Thick deposits of primary and remobilized tephra accumulated over the *Nahuel Huapi* and *Lanín* National Parks, affecting nautical activities in a great number of lakes, including the larger and heavily navigated *Lago Nahuel Huapi* (Figure 2).

The northwestern region of the *Lago Nahuel Huapi* fluvio-lacustrine basin was affected by the most sizeable accumulation of tephra [Villarosa and Outes 2013; Alloway et al. 2015], including the heavily navigated areas around Villa La Angostura, a tourist village located 50 km away from the eruptive center (Figure 2) and impacted by between 150 and 170 mm of lapilli to very fine-grained rhyolitic ash. All tourist passenger ships managed to return to the city amidst almost zero visibility that same afternoon, after which shipping was suspended for 45 consecutive days. In this region, the sinking of ships as large as primary passenger ships possibly stood out as one of the most striking consequences of the eruption (Figure 4). Various evacuation attempts failed because of the effects of volcanic ashfall and pumice rafts on ships, although water transport resources proved vital for managing post-event recovery actions in the *Perilago* [Figure 2; PNNH 2019], a rural area on the western shores of the lake, inaccessible by ground transport [Salgado et al. 2022]. Despite large rafts of pumice were rapidly dragged away by prevailing winds, many inconveniences persisted over time, even a decade after the eruption, associated with the fluvial remobilization of large deposits of tephra. Similar scenarios were also observed in *Lago Traful* (Figure 2), a smaller lake located over 50 km away from Cordon Caulle, which received up to 85 mm of medium to fine-grained ash at its western end [Villarosa and Outes 2013; Alloway et al. 2015]. On the southern shore of the lake sits Villa Trafal (Table 1; Figure 2), a very small but heavily visited port hamlet, where ~50 mm of medium to fine-grained ash accumulations were measured accumulating near the port.

The southern shore of the *Lago Nahuel Huapi* was affected by primary ashfall thicknesses increasing steeply towards its middle central part (Figure 2). In this area, *Puerto Pañuelo*, *Club Náutico Bariloche*, and *Puerto San Carlos* (Table 1; Figure 2) stand as three of the largest and most transited port sites, where various and severe volcanic ash impacts were surveyed. These ports are located between 75 and 100 km away from the Cordon Caulle and received up to 50 mm of medium to coarse-grained ash. Lake authorities prohibited shipping for eight days (although commercial shipping only restarted several months later), stranding eight workers in *Puerto Blest* (Table 1; Figure 2), a tourist destination only accessible via waterways [Salgado et al. 2022]. During the first few days, the direct fallout of finer ash created a very thin coating of floating pumice over the lake. However, shipping conditions worsened dramatically throughout the following weeks, as wind dragged immense volumes of thicker and coarser pumice rafts, causing severe impacts on ships and the ports' sea-side domains. This situation triggered various improvised measures amongst port authorities to halt the ingress of pumice rafts into the harbors (Section 5). In this part of the lake, many

The effects of pumice rafts were not restricted to lacustrine environments: large masses of floating pumice also drifted along the *Río Limay*, the single outflow from *Lago Nahuel Huapi*, reaching the 1.050 MW *Alicurá* power dam (Figure 2), where pumice raft thicknesses of over 40 cm were measured. The dam sits 110 km away from the volcano and was also impacted by the primary fallout of about 20 mm of medium to fine-grained ash [Villarosa and Outes 2013; Alloway et al. 2015]. Supporting ships in the reservoir were likewise affected by both primary ashfalls and pumice rafts.

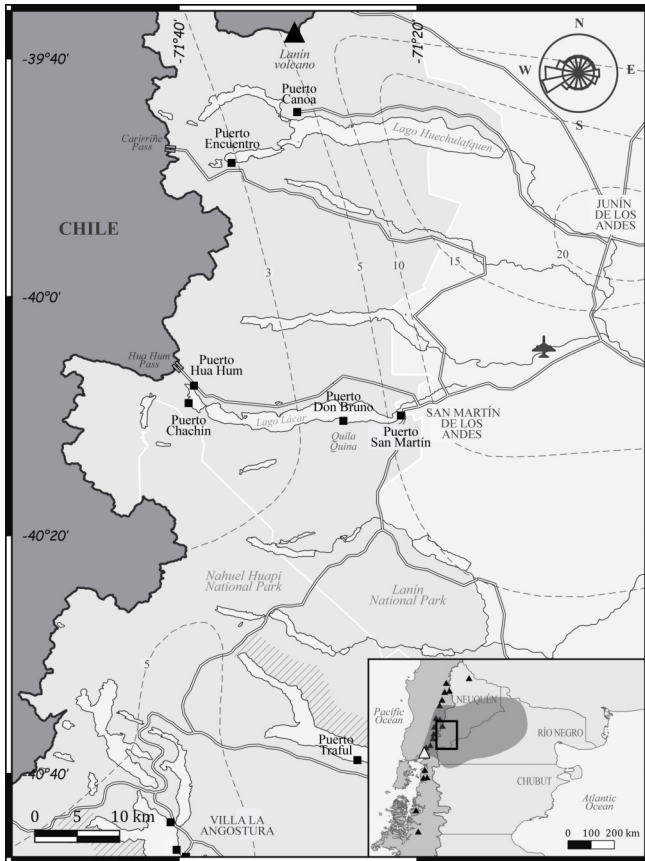
Figure 3: The Calbuco 2015 volcanic eruption and tephra fall distribution map (isopachs in millimeters) in the Nahuel Huapi and Lanín National Parks (areas in gray), and location of the most-affected port sites. At the top right, the wind rose charts the relative distribution of annual wind (origin) direction frequencies. Bottom right, tephra fall distribution >0.1 mm.

Almost four years after the Cordon Caulle eruption, the Calbuco volcano (41.3° S–72.6° W, Chile) reawakened in April 2015 with an intense sub-Plinian eruption [VEI: 4; Romero et al. 2016; Van Eaton et al. 2016]. Beginning with little warning [SERNAGEOMIN 2015; Arzilli et al. 2019], the eruption comprised two major pulses, occurring on 22 and 23 April, with associated stratospheric eruptive columns [SERNAGEOMIN 2015]. A third and minor pulse occurred later on 30 April, generating lower columns [SERNAGEOMIN 2015; Castruccio et al. 2016; Romero et al. 2016]. The predominantly northeast dispersion of ash [Castruccio et al. 2016; Romero et al. 2016; Van Eaton et al. 2016] impacted a region of Patagonia previously affected by the 2011–2012 ashfall, and the most affected lakes were found to be the *Lago Lácar* and *Nonthué*, and the *Lago Huechulafquen* and *Epulafquen* (Figure 3).

Northwards, on the northern shore of *Lago Huechulafquen* sits *Puerto Canoa* (Table 1; Figure 3), a remote but much-visited port handling a single catamaran, plus many other smaller ships. During the 2011–2012 Cordon Caulle eruption, only trace amounts of very fine ash reached the area, and no

damage was reported. However, these lakes were the most affected by the 2015 Calbuco eruption, receiving up to 15 mm of ash at their eastern ends (Figure 3). *Puerto Canoa*, located almost 200 km away from the volcano, received 3 mm of fine-grained dacitic-andesitic ash, sufficient to cause some sort of damage to berthed and uncovered ships.
