THE BÍLINA TUNNEL – SELECTED GEOTECHNICAL ASPECTS OF A PROPOSED UNDERGROUND STRUCTURE

ABSTRACT. Every workday the city of Bílina, with the I/13 road running through it, suffers from traffic congestion. The road is designed as dual carriageway outside Bílina but only as a single carriageway inside the city. Three roundabouts further complicate the situation. As a solution a 1,3 km long tunnel going under the city was proposed. The preliminary geotechnical investigation describes the geological conditions of the area, suggests the most appropriate localisation details of the tunnel, points out several complications that can be expected and finally offers solutions to mitigate them.

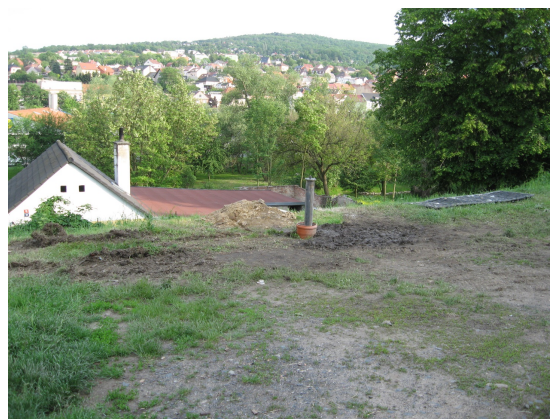
FIGURE 2. Temporary water pressure resistant steel casing of a borehole during realisation (located in an orange KG-System PVC sewage pipe backfilled in the manually dug trench).

The second phase was aimed at the mined part of the tunnel [4]. The above-mentioned drilling technology was applied to reach the bedrock. After that, boreholes were cased with a water pressure resistant steel casing (the result of the CISS requirements); the boring continued with a diamond encrusted drill bit and a double tube core barrel up to the final depth.

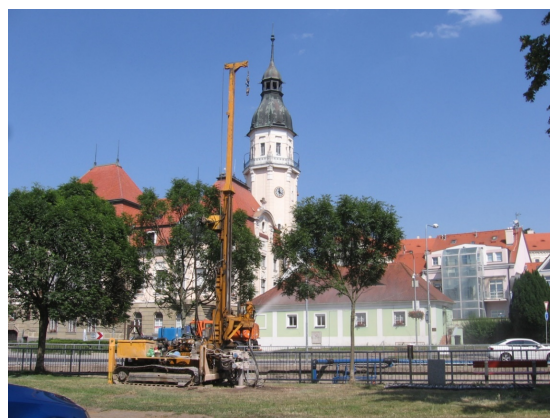
FIGURE 3. Groundwater monitoring well realisation, to the left in the background the historical building of Bílina city hall.

In the cased groundwater monitoring wells aquifer tests (short-term pumping and recovery tests) were performed.

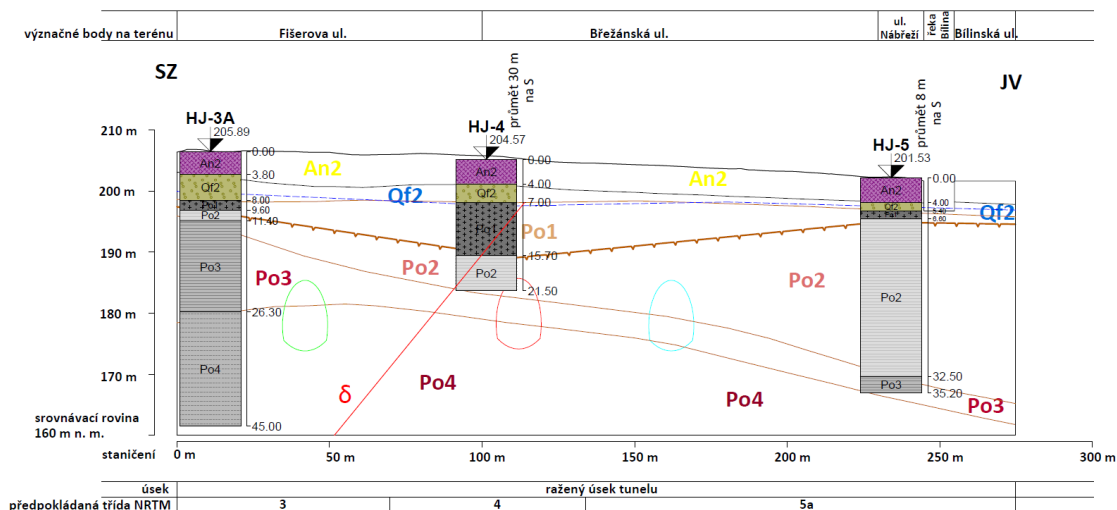
FIGURE 4. Transverse geologic cross-section including individual tunnel alignment alternatives (vertical exaggeration x2).

The preliminary geotechnical investigation for the Bílina Tunnel described the geological environment of the area. Based on deeper boreholes that reached the bedrock and the field and laboratory tests carried out, the western tunnel alignment alternative was recommended for realisation. Results indicate that with increasing distance from the river the quality of the orthogneiss also increases, or rather the degree of weathering of the tectonically deformed bedrock decreases. For subsequent investigation and design, certain measures were proposed that can facilitate these works, e.g. moving of the tunnel alignment further away from the river or relocation of the portal areas. This is however complicated by other non-geological factors (for example, existence of a railroad and district heating pipes in the area).
