High-cycle fatigue strength of a pultruded composite material

C. Colombo, M. Guagliano, L. Vergani

ABSTRACT. Dealing with composites in polymeric matrix, the pultruded ones are among the more suitable for large production rates and volumes. For this reason, their use is increasing also in structural applications in civil and mechanical engineering.

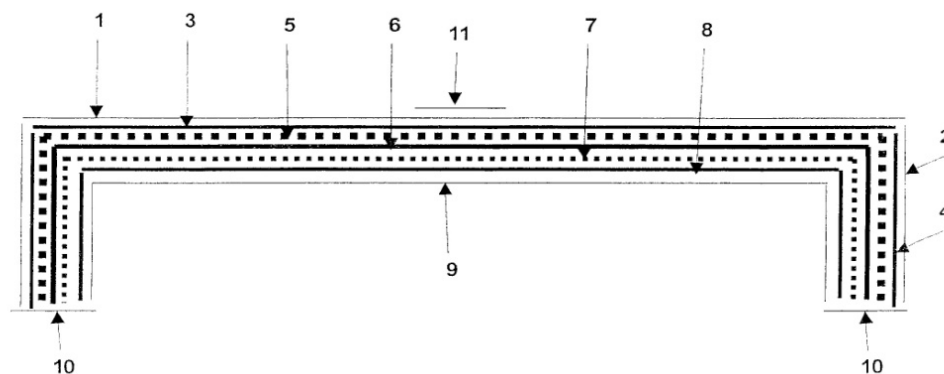
In Fig. 1 it is shown the section from which the specimens were cut: these latter were obtained from the longer side. In the same figure it is shown the the lay-up of the material and different layers can be observed: their composition is described in Tab. 1. It can be noted that most of glass fibers (84%) are unidirectional (Roving) while the remaining part (16%) is randomly distributed.

Figure 1: Section of the pultruded bar from which the specimens were cut.

Sontara is a thin layer used on the surface to prevent surface damage due to impacts or to the aggressive environment effects. Reemay is a surface writing. Both Sontara and Reemay does not modify mass and mechanical characteristics of the material.

Table 1: Chemical composition of the layers of the pultruded material (the position refers to Fig. 1).

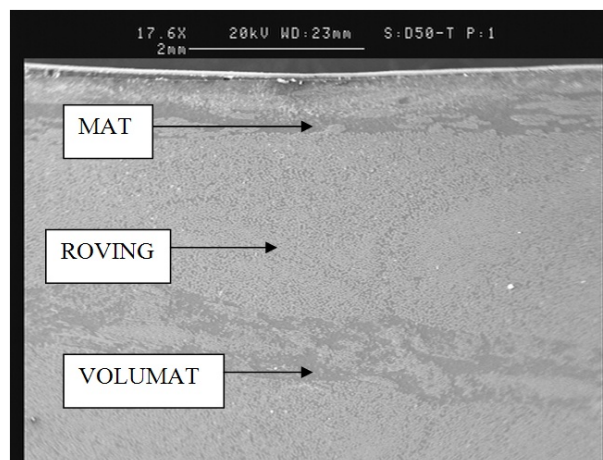
In Fig.2 it is shown a micrograph of the transversal section taken at the SEM showing the main layers of the material. From the SEM observation it was possible to effectively define the layer disposition in a section (Fig. 3).

Figure 2: SEM micrograph showing Mat, Roving and Volumat layers.

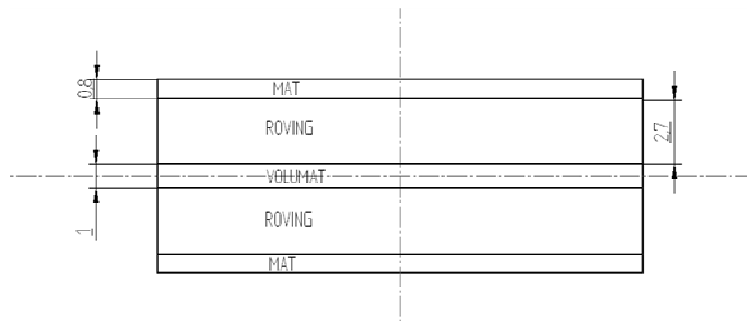
Figure 3: Layer disposition in a generic section of the samples.

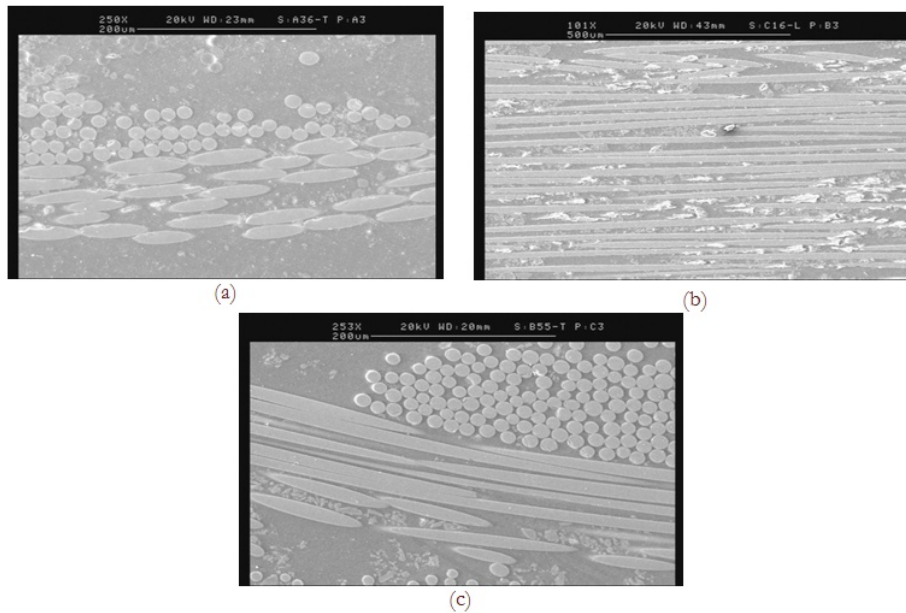
In Fig. 4 the SEM micrographs of these layer is shown. It can be noted that the fibers in the Roving are nearly aligned, equal-spaced and parallel. Also the different fiber percentages of Mat and Volumat can be noted.

Figure 4: SEM micrographs of Mat (a), Roving (b) and Volumat (c) layers.

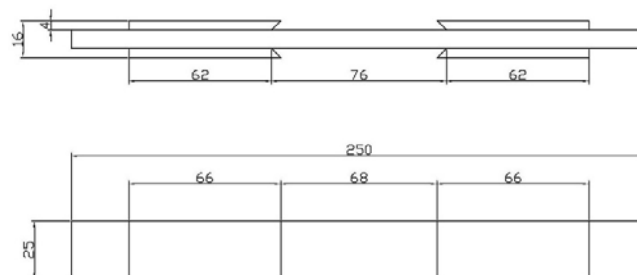
Figure 5: Shape and dimensions in mm of the samples used in the static tests.

The static behaviour characterization of the pultruded material was obtained by means of tensile and compression tests. Five samples for each kind of test were executed by using a Schenck Hydropuls 250kN universal test machine. The tensile tests were executed according the ASTM D 3039/D 3039 M-00 standard, while as regards the compression tests the EN ISO 527-5: 1997 standard was applied. The specimens were cut along the longitudinal direction and presented a rectangular constant cross section, as indicated in the standards that were used. The same sample type was used in both the tensile tests and the compression ones; in Fig. 5 their dimensions are shown together with the aluminium grips that were glued to the specimens. An extensometer was applied to measure the deformation of the specimens.

Axial fatigue tests ($R=-1$) were executed, being the aim the determination of the S-N curve of the material and to verify the existence of a fatigue limit. The specimens have constant section and their geometry is the same as in Fig.5. The specimens were considered run-out if failure did not occur till 10.000.000 cycles. Tests were performed in loop load control and the imposed frequency was 5 Hz; no temperature increment was observed. Fifteen specimens were used to determine the fatigue limit according the stair-case procedure while other nine specimens were tested to determine the leaning part of the S-N curve according to the procedure included in the ASTM E 739-91. In Fig. 8 the results are shown: it is possible to observe the limited dispersion of the data. If the applied stress decrease from 120 MPa

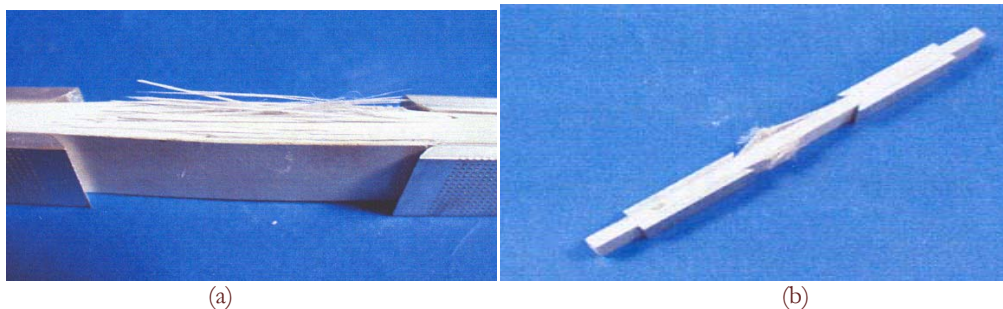
In Fig. 6 the typical aspect of a DGM failure is shown.

Figure 6: Typical aspect of a DGM failure: (a) tensile failure, (b) compression failure.

Table 2: Summary of the results of the static tests (DGM= edge Delamination Gage Middle, XGM=eXplosive Gage Middle)

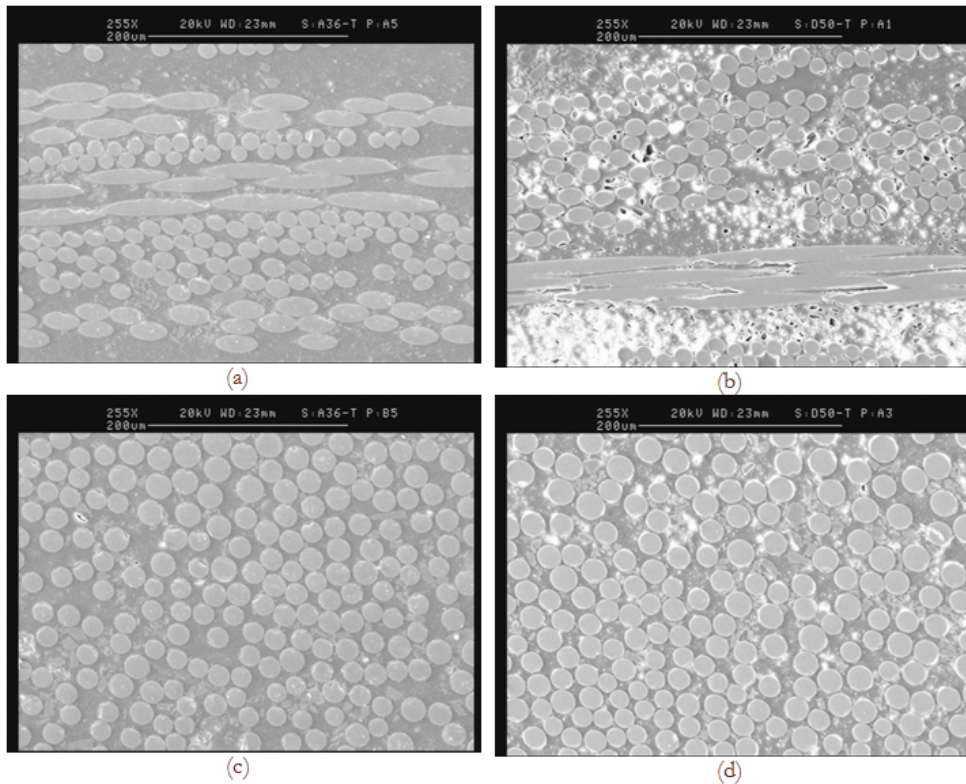
Figure 7: Damage evolution for increasing stress values (transversal section): (a) Mat 200 MPa, (b) Mat 340 MPa, (c) Roving 200 MPa, (d) Roving 340 MPa.

Some interrupted tensile and compressive tests were also executed, being the aim to investigate the development of the damage by means of observations at the SEM. These analyses allowed to assess the progressive nature of damage in the different layers of material. In particular cracks between the fibers and the matrix were observed with increasing length with the load, while their number remained about the same till the final rupture. However some broken fibers were noted in the Roving layer for high values of the stresses. In Fig. 7 some SEM images showing the damage evolution are shown: Figs 7a and 7b show the damage evolution in the Mat at 200MPa and 340 MPa: the interface crack evolution between the matrix and the fibers can be easily observed. Figs 7c and 7d show the Roving and also in this case the most evident damage type is the formation of interface cracks.

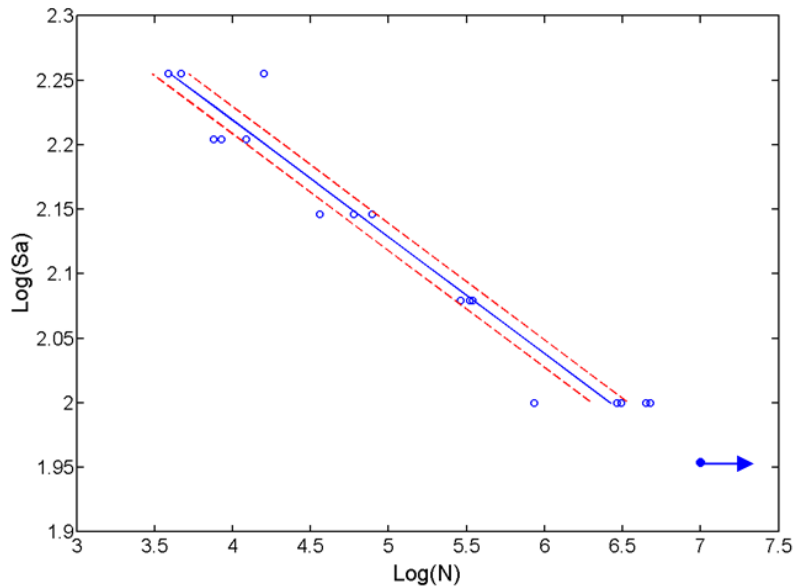
Figure 8: Experimentally determined S-N curve of the pultruded material.

(○: broken specimens; ●: fatigue limit; — maximum likelihood estimation for the mean, --- confidence limits for the model at 95%)

to 80 MPa, the endurance passes from around 550.000 cycles to more than 10 millions cycles (run-out tests). It can be deduced that this material has a fatigue limit and, according to the stair case method, its value was calculated as 90 MPa.

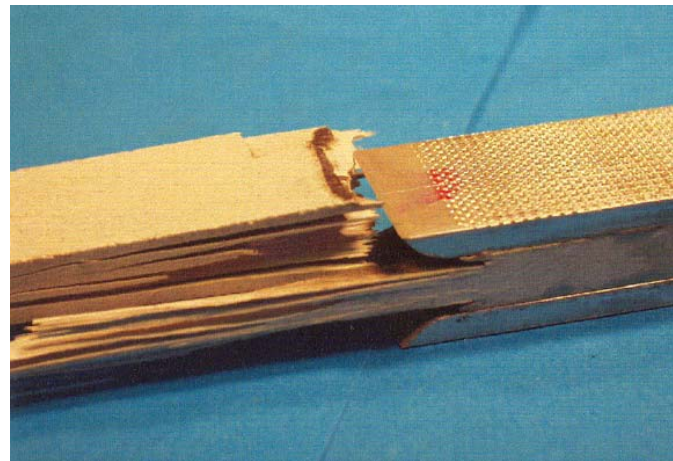
Most of the failures happened near the gripping zone, like in Fig. 9; this denotes a probable influence of the gripping system onto the obtained results and it is in agreement with the results reported in [9] where the influence of the specimens shape was analysed and where it is found that this kind of specimens gives the lowest fatigue strength.

Figure 9: A fatigue broken specimen near the gripping zone.

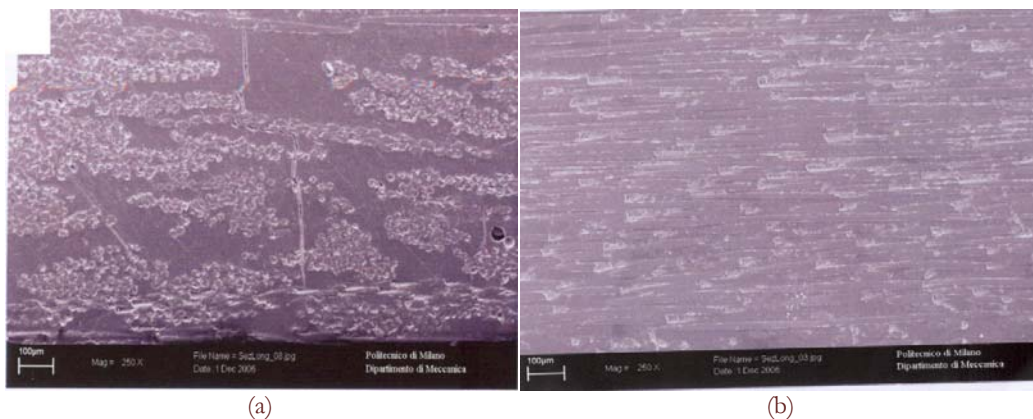
Also in this case SEM observations have been performed on run-out specimens to evaluate the fatigue damage. Pictures showing SEM images after 10 millions cycles are reported in Fig. 10, that refers to longitudinal sections: the presence of arrested cracks can be noted.

Figure 10: SEM images of the fatigue specimens: (a) Mat, (b) Roving.

On the basis of the analysis of SEM observation a quantitative estimation of the fatigue damage was made by counting the number of different defects in the layer that form the pultruded material. The results are shown in Tab. 3 and evidence that debonding (crack between matrix and fibers) in the Mat layer is the main responsible of the fatigue damage of this material
