Bricked vaults of the 18th century Valencian hall churches: graphical representation, constructive and pathological analysis

Beatriz Sáez Riquelme¹

¹ *Departamento Ennginyeria de Sistemes Industrials i Dissey, Universitat Jaume I*

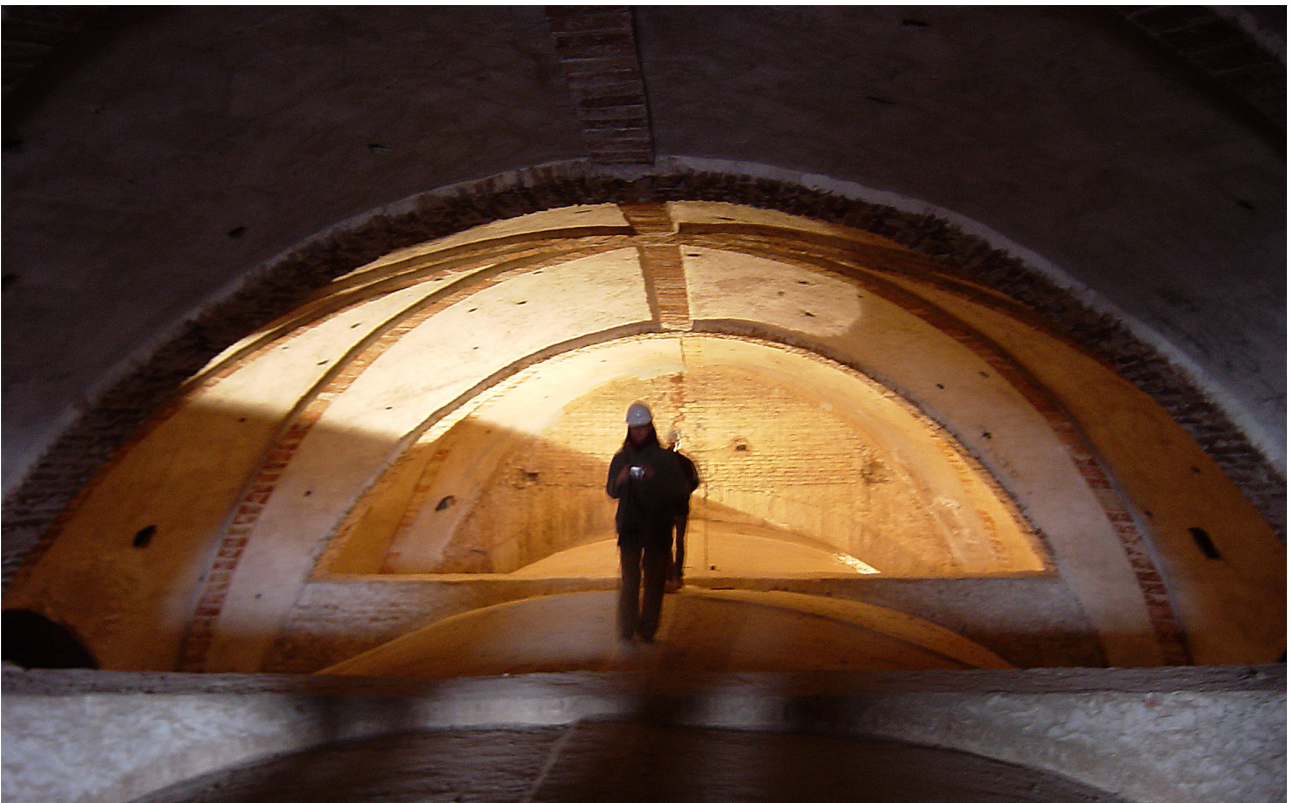
Figure 1.

Vaults of the archpriestal church of Vila-real

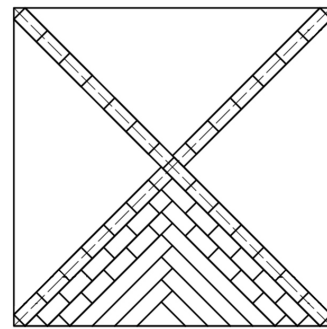
Figure 7.

Brick disposition on groined vaults with guiding arches and brick rowlocks parallel to them: vaults on the lateral naves of Culla

The construction of this type of vaults began by bricking the guiding arches with solid bricks bound on their header face and arranged according to the diagonals of the surfaces to be covered. The vault was then completed by contiguous rowlocks of bricks arranged parallel to the guiding arches.

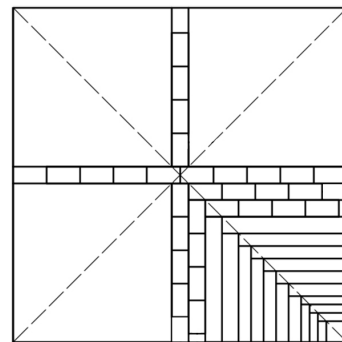
Figure 8.

Brick disposition on groined vaults with guiding arches and brick rowlocks perpendicular to the perimeter: lateral naves of Culla

Just as in the previous examples, the guiding arches were bricked first, with solid bricks bound on their header faces. However, in this case, they ran from one face to the opposite. The vault was then completed with parallel rowlocks of bricks, flush to the guiding arches, being especially circumspect that the joints of their header faces were not aligned.

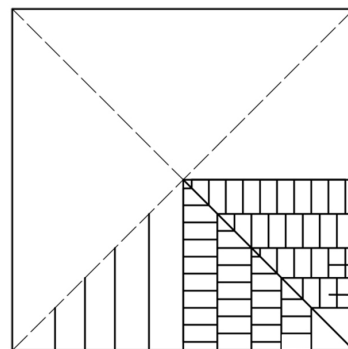
Figure 9.

Brick disposition on groined vaults with header work bricks: organ hall of Castell de Cabres

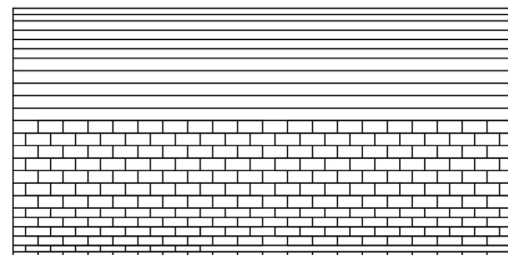
Figure 12.

Brick disposition on barrel vaults with horizontal rowlocks: apse of Benifairó de les Valls
